Preliminary Site Investigation

Macquarie Centre Redevelopment
Stage 1 Concept Development Application
Macquarie Park NSW

Prepared for
AMP Capital
c/- Lend Lease

Project 85160.01 Rev 2
December 2015

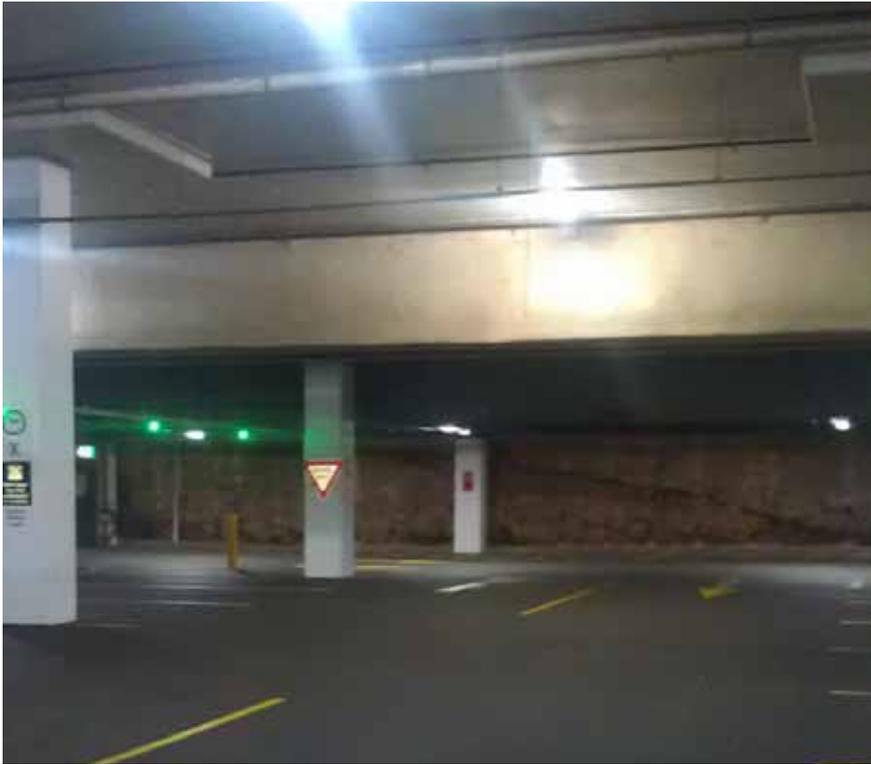
- Hardstand cut into sandstone in basement (Photo 1);
- Ultratune mechanical workshop, which is located in the southern portion of the express car park, is likely to store chemicals (e.g. oils, degreasers), and grease traps are likely (Photo 2);
- A grease trap was observed in the northern end in compactus area (Photo 3);
- Usual stormwater and sewer pits were observed, as well as fire hydrants;
- There was a ramp to the upper car park/loading dock which leads up to Big W parcel pick up area which may have been filled (Photo 4).

Photo 1 - Express carpark - basement cut into sandstone

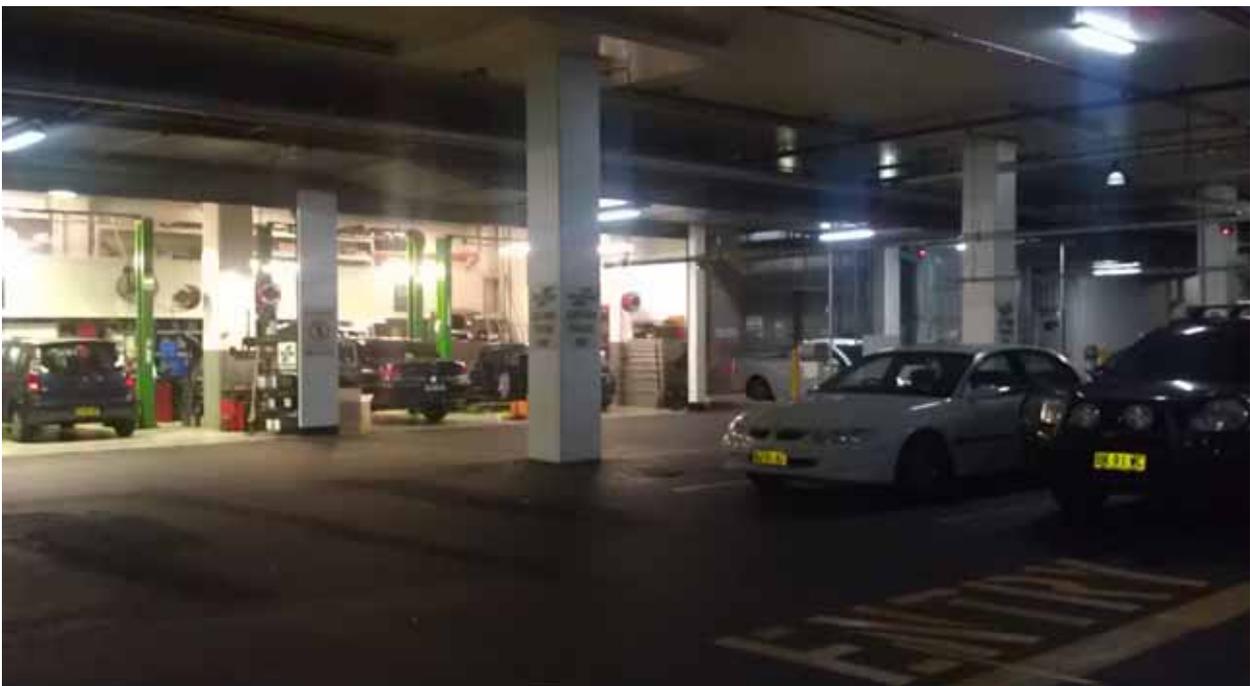
Photo 2 - Express car park - Ultratune workshop

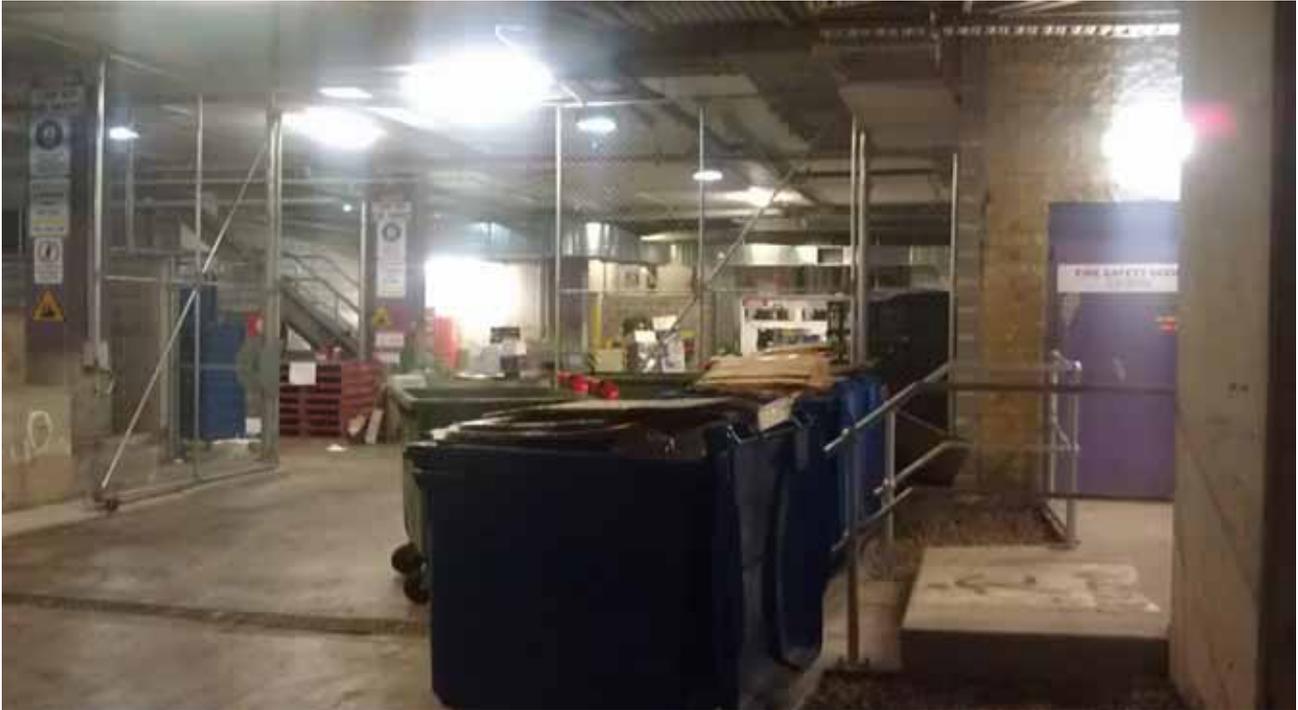
Photo 3 - Compactus with grease trap

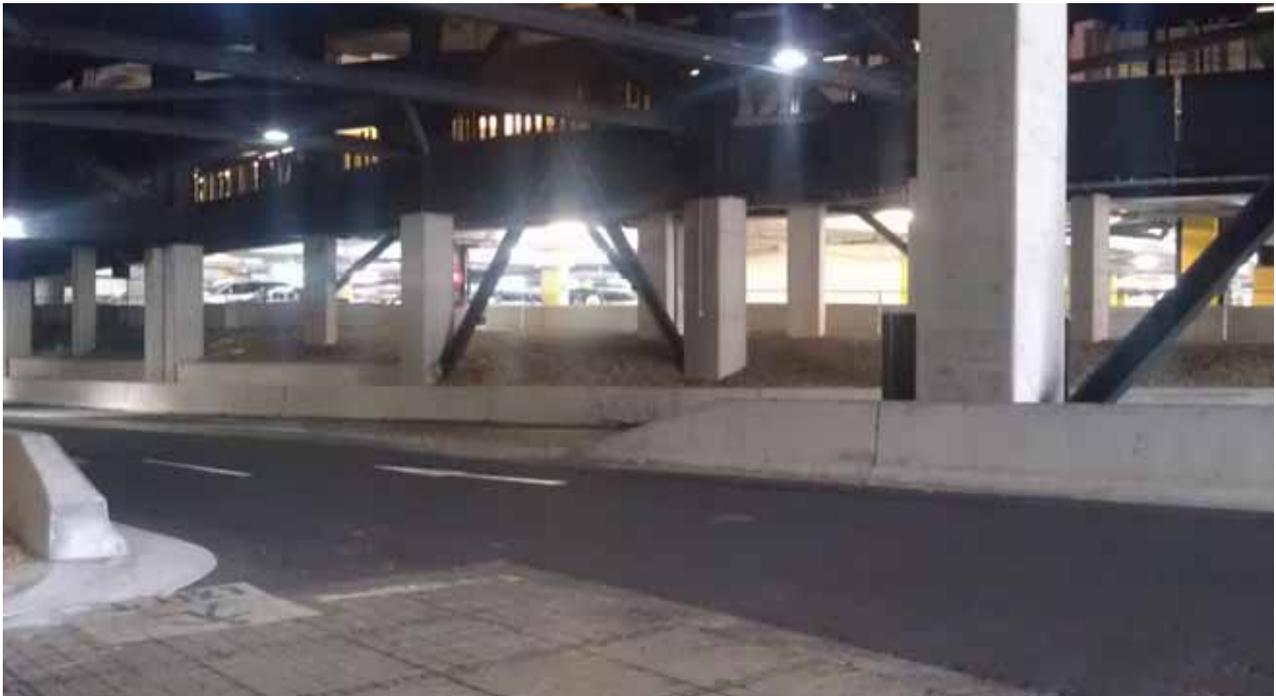
Photo 4 - Potentially filled ramp to loading dock

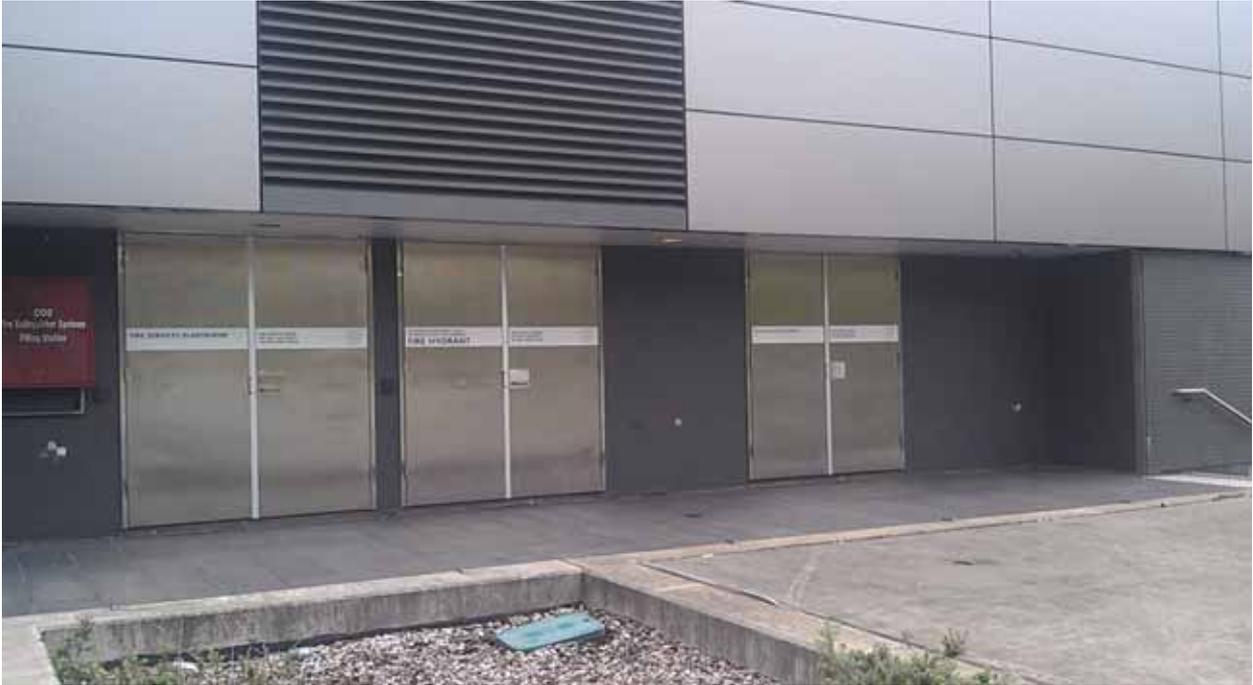
- A fire hydrant plant on the hill was observed and may be filled in some sections along the entrance to the train station (Photo 5).

Photo 5 - Fire hydrant plant area off Waterloo Road

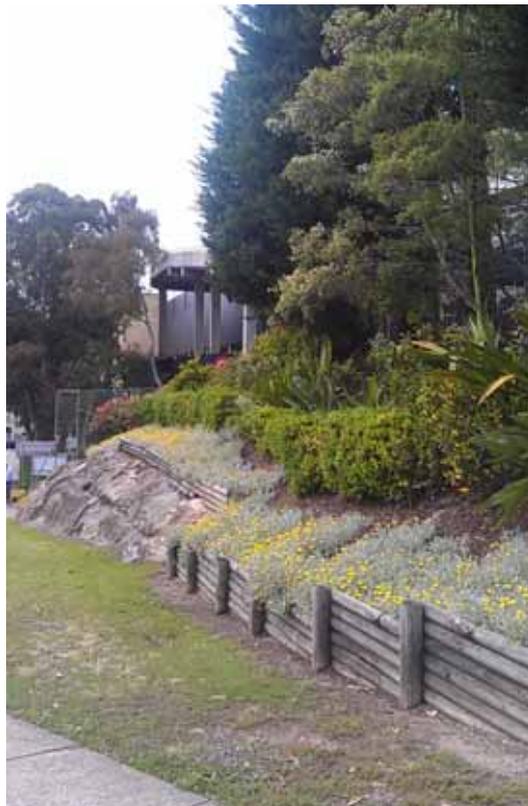
Photo 6 - Sandstone and garden beds along Talavera Road
