## **Appendix H Coating Condition Assessment Report**

**To:** Anand Thakur  
**From:** Gideon Chapman (prepared by George Symonds)  
**Subject:** Angas Street Bridge Paint Study Outcomes  
**Our ref:** PS213457-WSP-SYD-STR-MEM-00001 Rev1  
**Date:** 1 April 2025

## Angas Street Bridge Coating Condition Assessment Report

Remedy Asset Protection (RemedyAP) performed a condition assessment of coatings applied to Angas Street bridge steel structure, in Meadowbank.

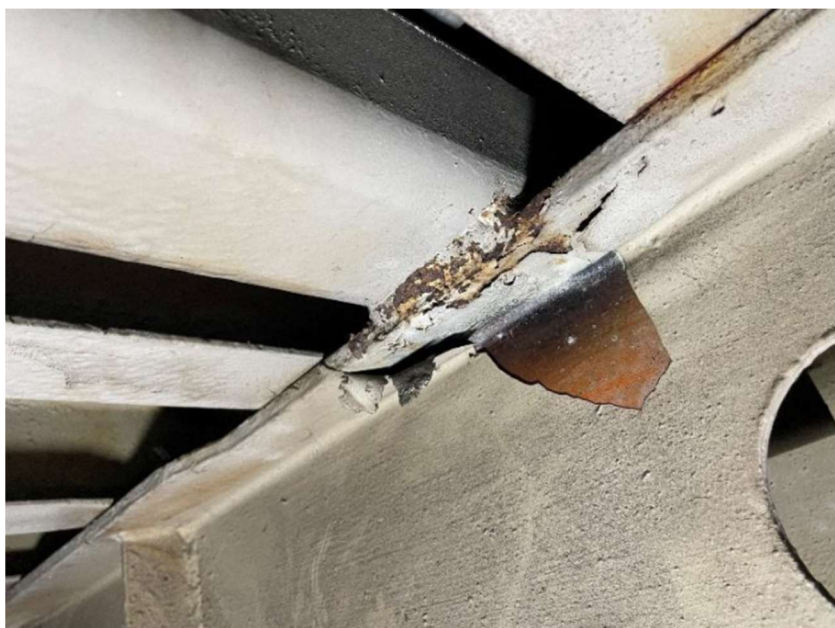
3. Steel corrosion was identified at interface regions between bridge elements. For example, where transverse members sit on longitudinal members and vice versa (see example photograph below).

Effectively cleaning out the corrosion product and repainting in these regions is likely to be too difficult in situ.

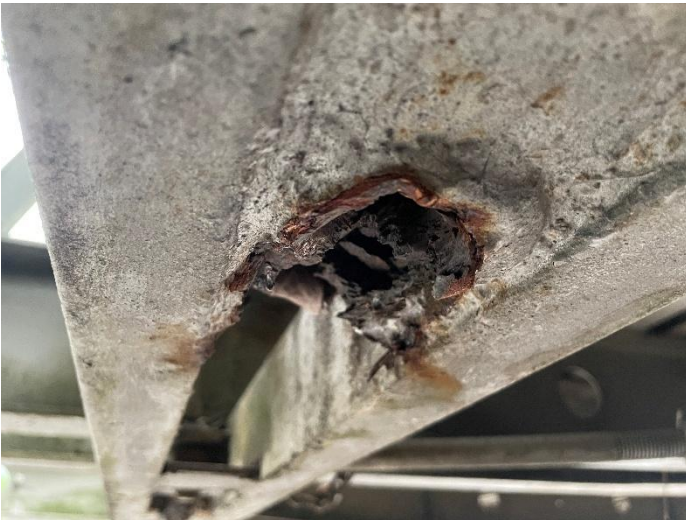
Evidence of heavy corrosion was visible in ~ 5% of areas on the two truss bottom chords on eastern and southern elevations.

Figure 1- Heavy spot corrosion on bottom chord

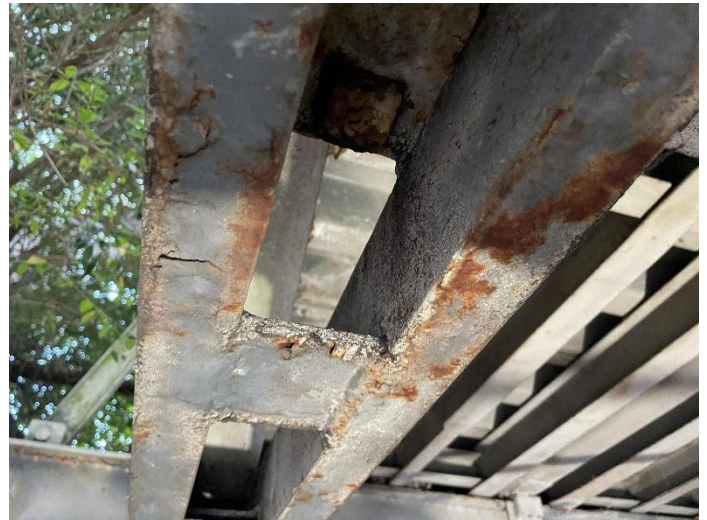
Coating delamination was observed on ~30% of these bottom chords. Surface rust was visible on ~ 20% of the surface.

Figure 2- Coating delamination and surface rust on bottom chord

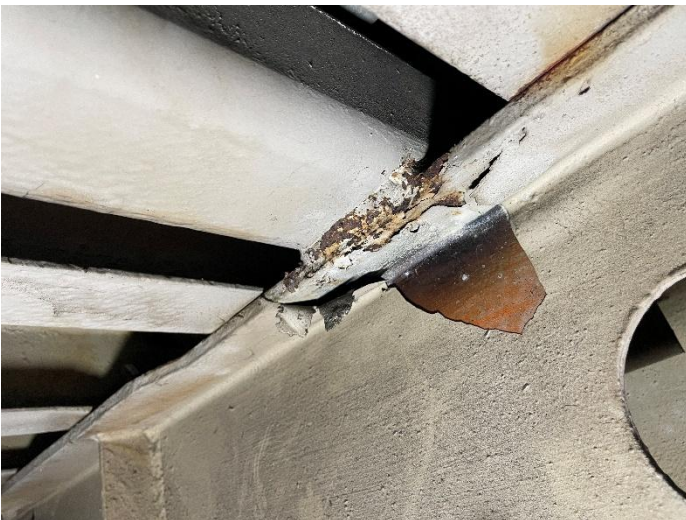
Coating flaking and delamination was observed in ~ 20% of areas. The topcoat could be easily removed from the primer by using a putty knife. Surface rust was visible on ~10 % of the surface.

Figure 3- Flaking defect on transom

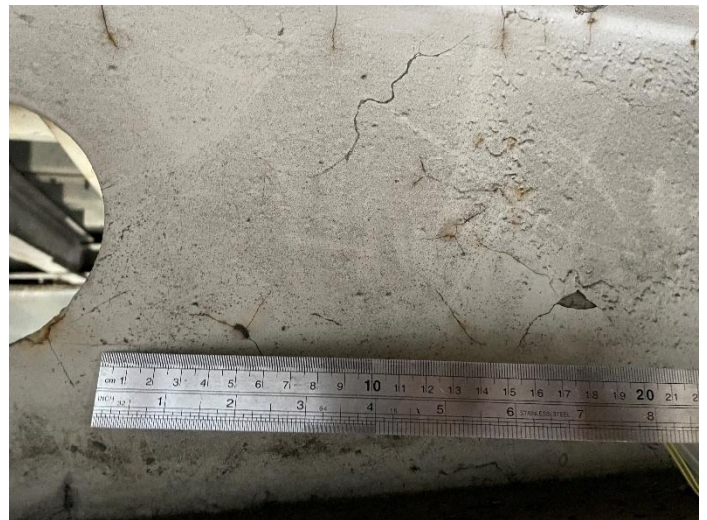
Figure 4- Flaked coating on transom

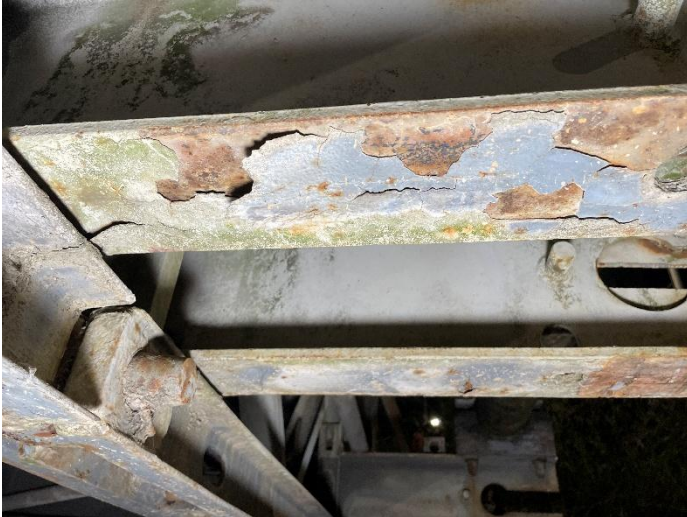
Figure 5 Coating flaking and surface rust

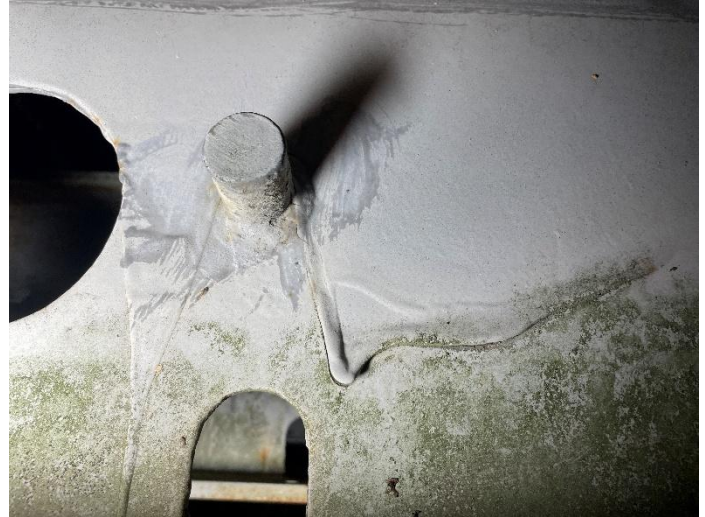
Evidence of previous poor-quality coating touch-ups was visible in some areas.

Figure 6 Evidence of poor coating touch-ups

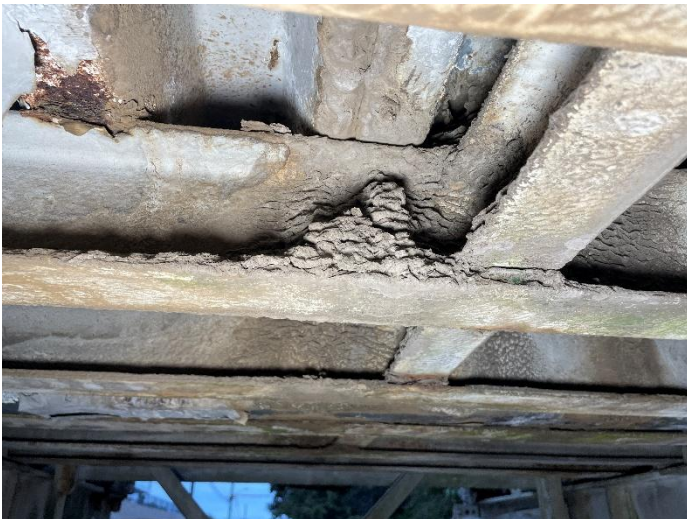
Figure 7 Accumulation of contamination

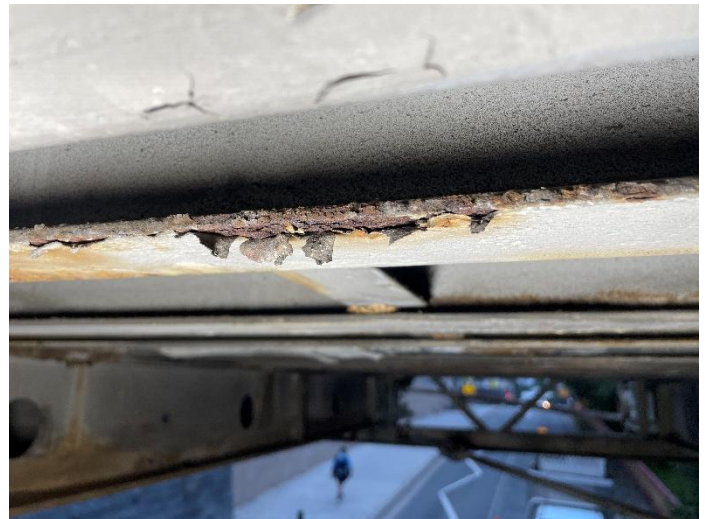
Corrosion was advanced on ~ 5% of edges, mostly on the southern elevation.

The coating delamination was observed in ~ 10% of the northern elevation.

Figure 8 Coating delamination and corrosion on edges

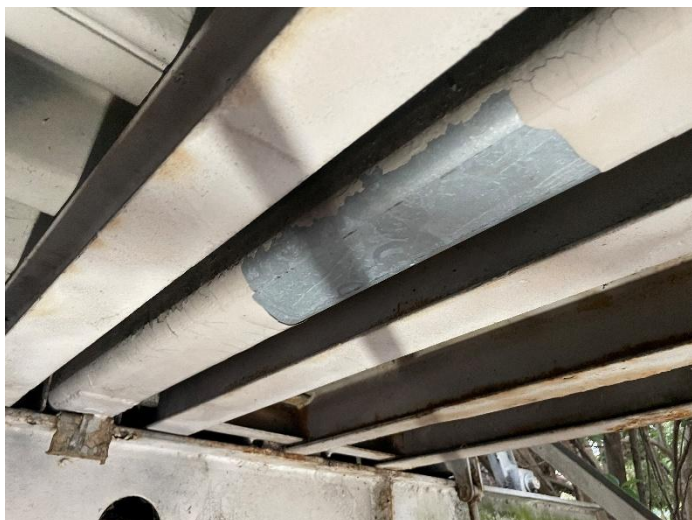
The galvanised hollow structural sections were over-coated with paint. The paint was delaminated from the galvanised, in ~ 30% of areas. Poor adhesion of paint was visible on the majority of galvanised hollow sections on both southern and northern elevations.

Figure 9 Delaminated paint from galvanised substrate

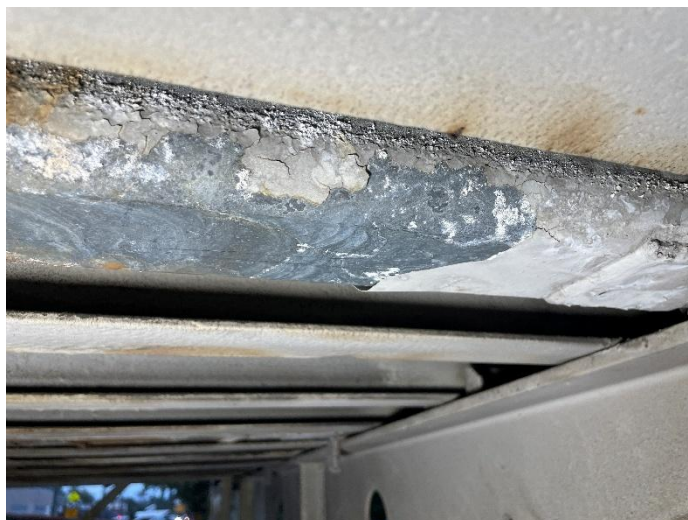
Figure 10 Poor adhesion between paint and galvanised coating

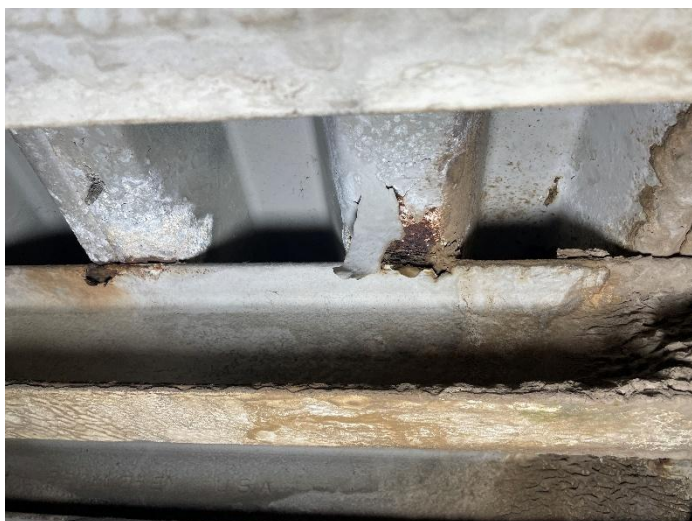
Corrosion was visible on ~10% of connection points and faying surfaces. This was observed in connection points between different stringers, and between decking sheets and stringers.

Figure 11 Corrosion between girders and trough decking sheets

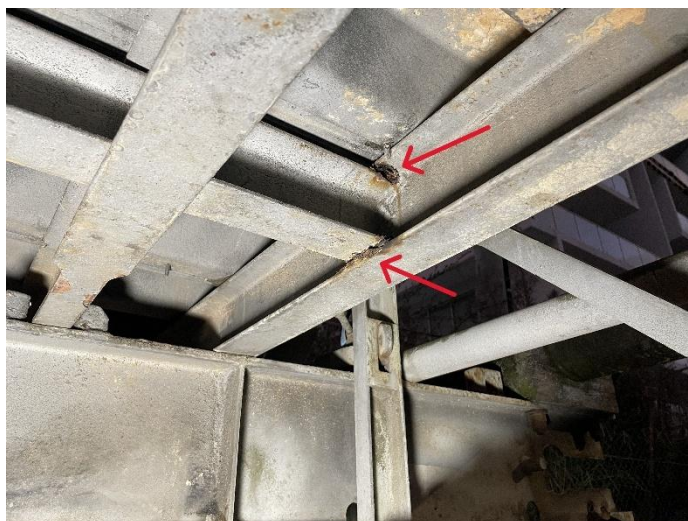
Figure 12 Corrosion on welds

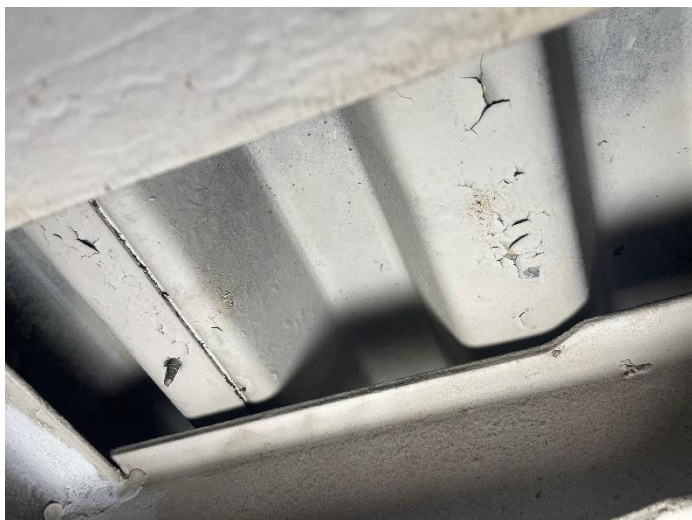
The galvanised trough decking sheets (Bondek) were over-coated with paint. The paint was delaminated from the galvanised in ~ 20% of the surface. Evidence of poor adhesion between paint and galvanised was visible in different areas.

Figure 13 Delamination between paint and galvanised substrate

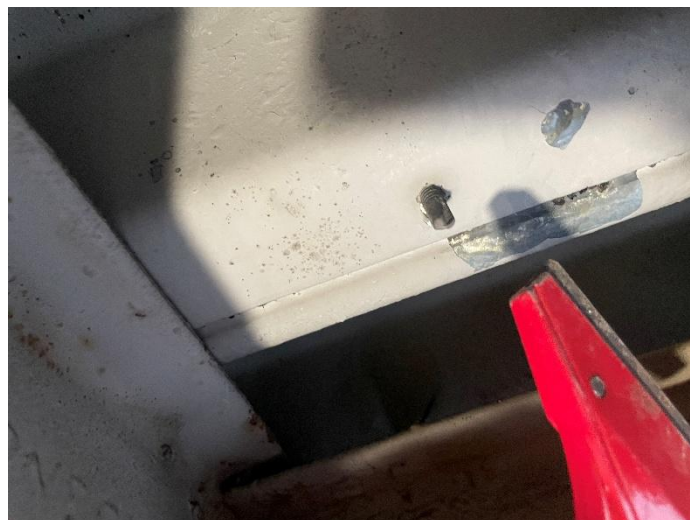
Figure 14 Poor adhesion between paint and galvanised

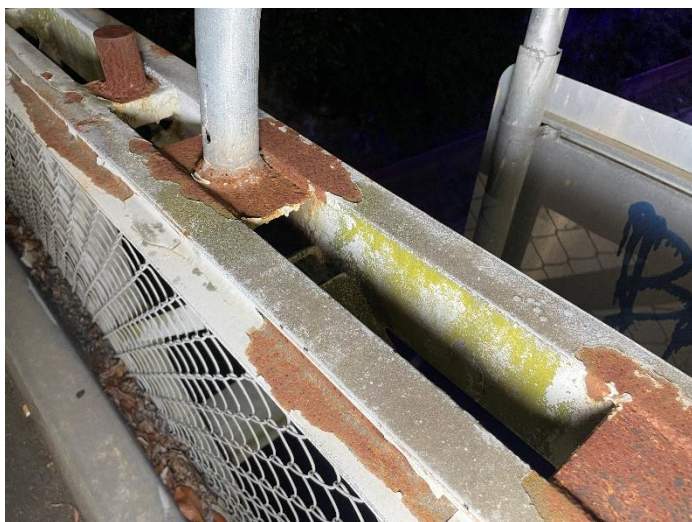
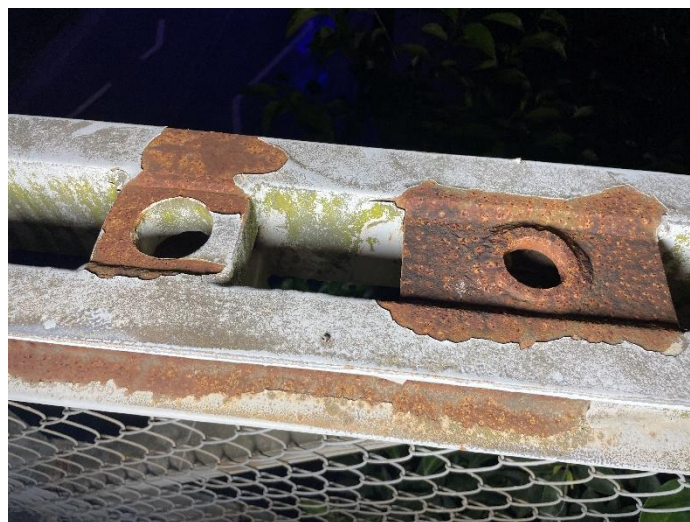
The coating was delaminated from the substrate in ~ 40% of top chord surfaces on both eastern and western elevations.

Surface rust was visible on ~30% of the surface.

Figure 15 Coating delamination and surface rust

Figure 16 Coating delamination and surface rust

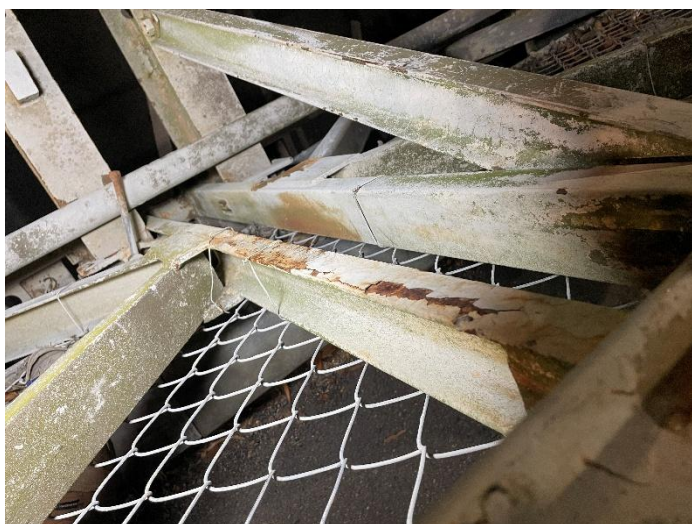
Coating delamination between primer and topcoat was visible in ~ 30% of posts and connection plates.

Figure 17 Coating delamination on posts and diagonal bracings

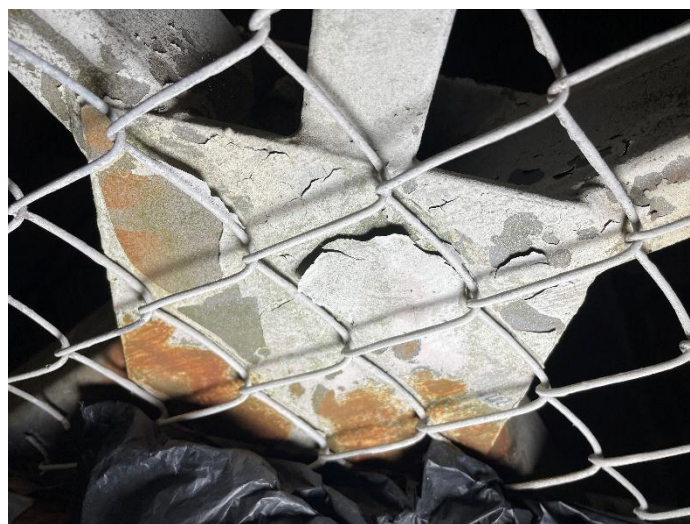
Figure 18 Coating delamination on connection plate
