Appendix B

Tree Assessment

ARBORICULTURAL ASSESSMENT

SITE ADDRESS
PROPOSED RYDE RIVER WALK

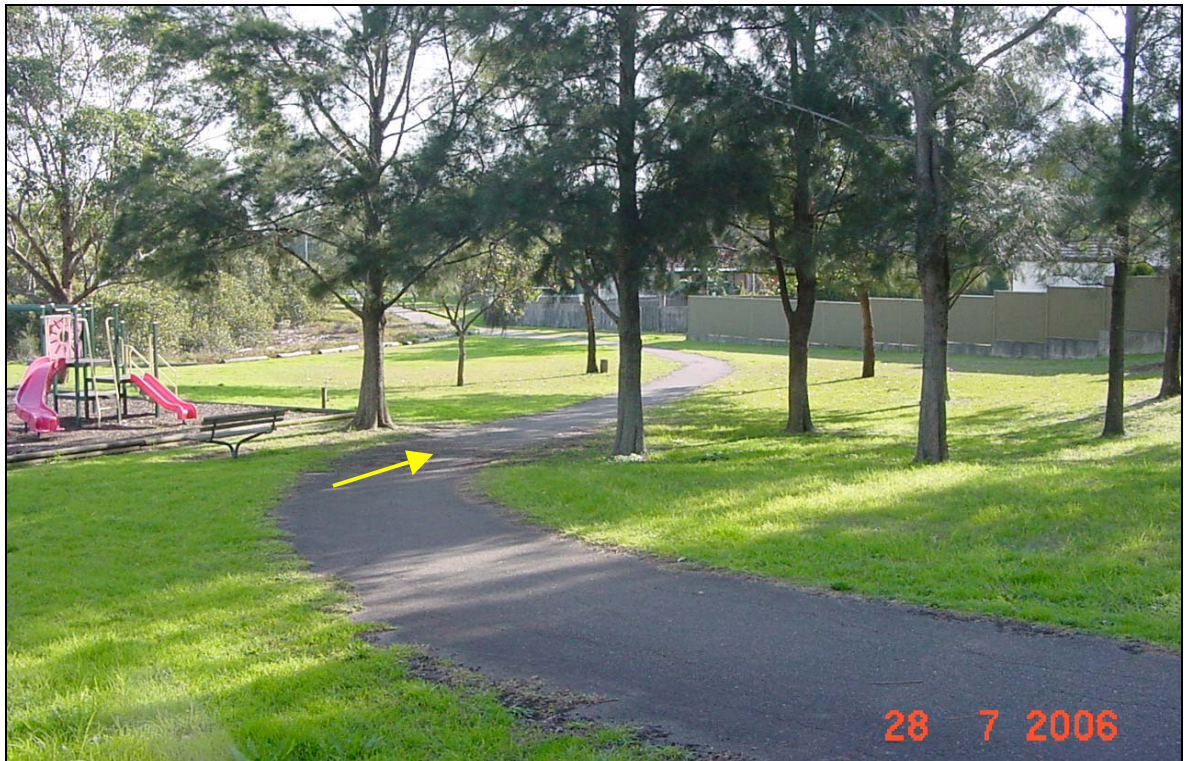
Figure 2 MELROSE PARK

There is a significant group of semi-mature Eucalypts and Casuarinas in this park. An existing asphalt path curves between a number of the trees. There is some visible upheaval of the pavement surface between two She-oaks (see Figure 2). Whilst the damage is only minor at this stage, it is likely to increase in severity as the tree's roots extend and increase in girth. The surface will become an increasing trip hazard, particularly at night when visibility is reduced.

Looking west to Koonadan Reserve. Location of minor pavement damage caused by tree roots indicated with yellow arrow.

A gradual 'hump' in the path may overcome this problem, without adversely affecting tree root growth. The current path and upgrading of same shouldn't have any adverse impacts on trees in this park subject to specific arboricultural advice.

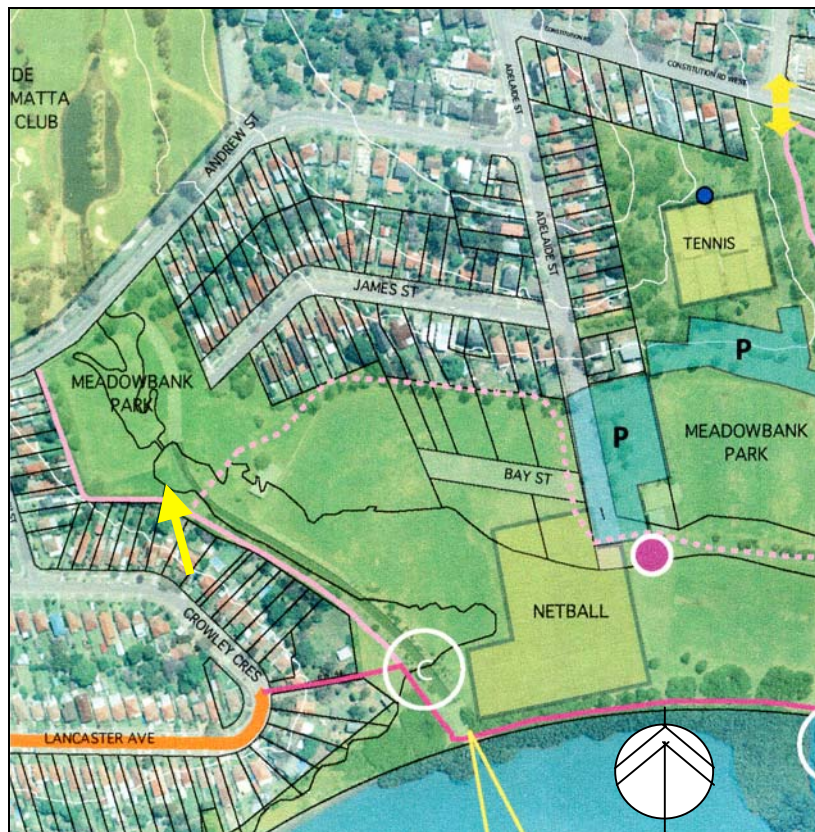
Figure 3 MEADOWBANK PARK
Location of row of Brush Boxes (yellow arrow).

A significant row of Brush Boxes (*Lophostemon confertus*) is located alongside an existing path at the rear of houses facing Crowley Crescent. (Figure 3)

The proposed path appears to well clear of these trees, and no impacts to these trees would be expected as a result of new path construction.

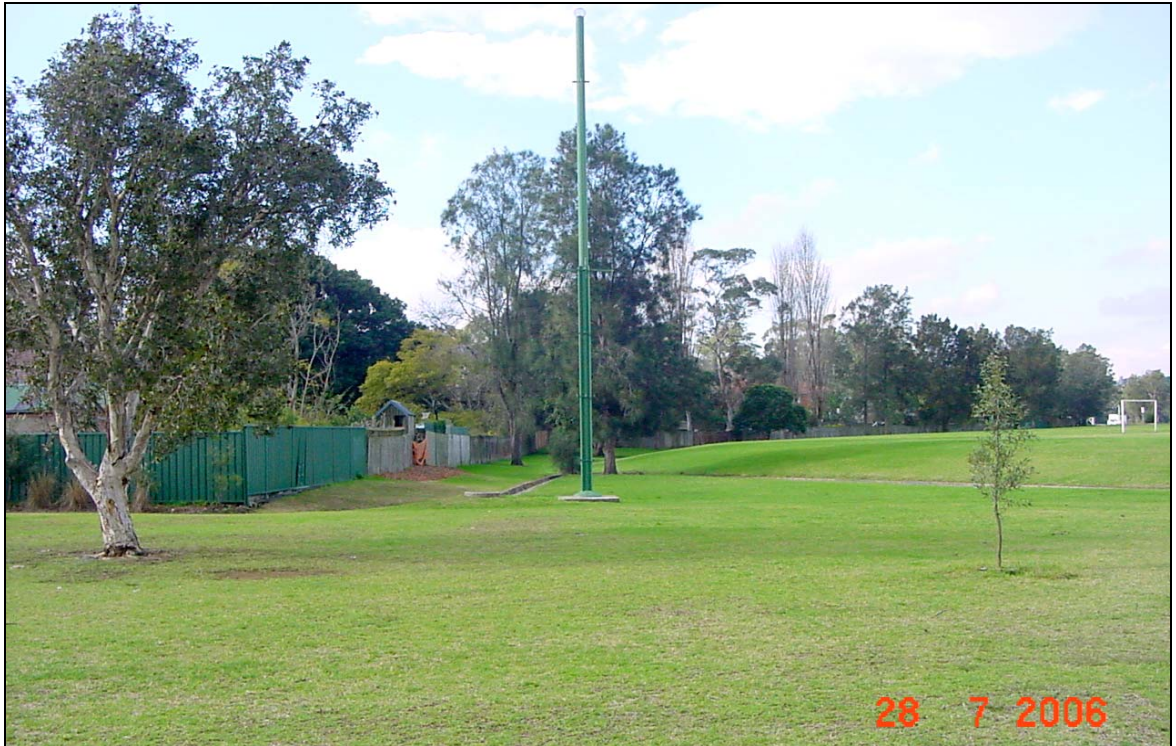
Figure 5 MEADOWBANK PARK

Looking east to rear of properties facing James Street. There is ample space available between the two trees for a 2.5 metre wide path.

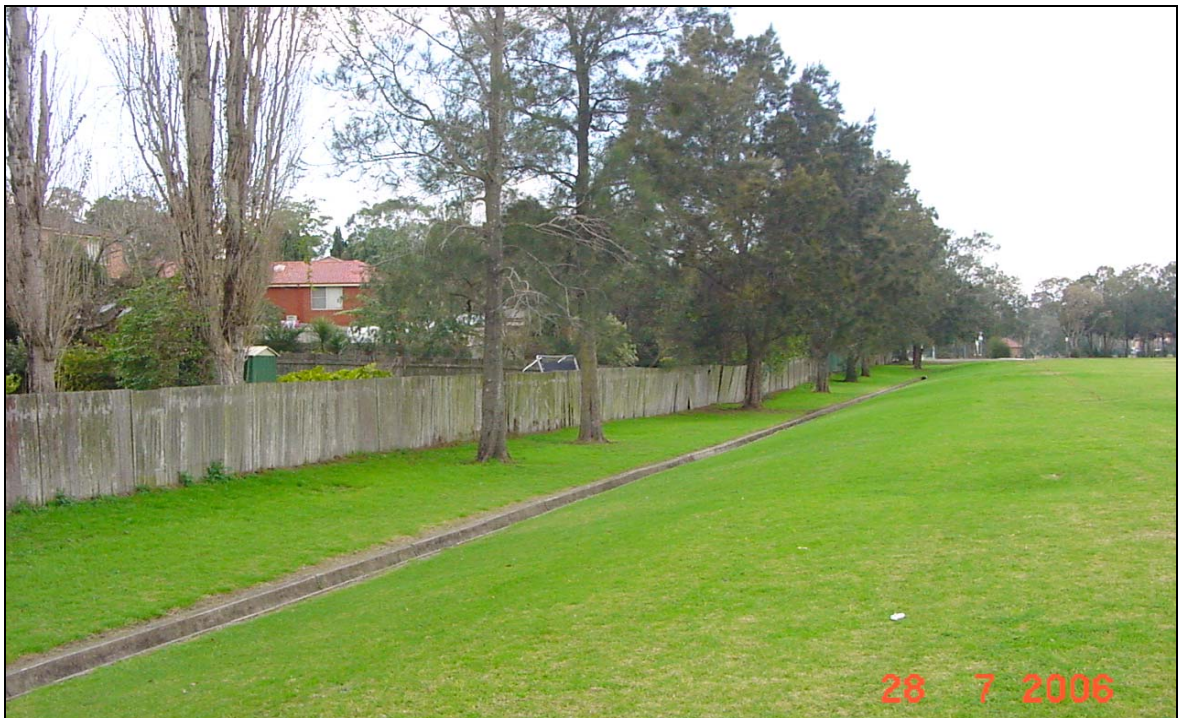
Figure 6 MEADOWBANK PARK

3.2.6 There is little scope for any hard surface path between these trees in Figure 6, and the adjoining private properties, or between the trees and the concrete canal running along the south side of the trees. Any path along this side of the park would need to skirt the adjacent soccer fields, and possibly be banked on one side to achieve a fairly level and uniform pathway to link the west end of Meadowbank Park to the east section.

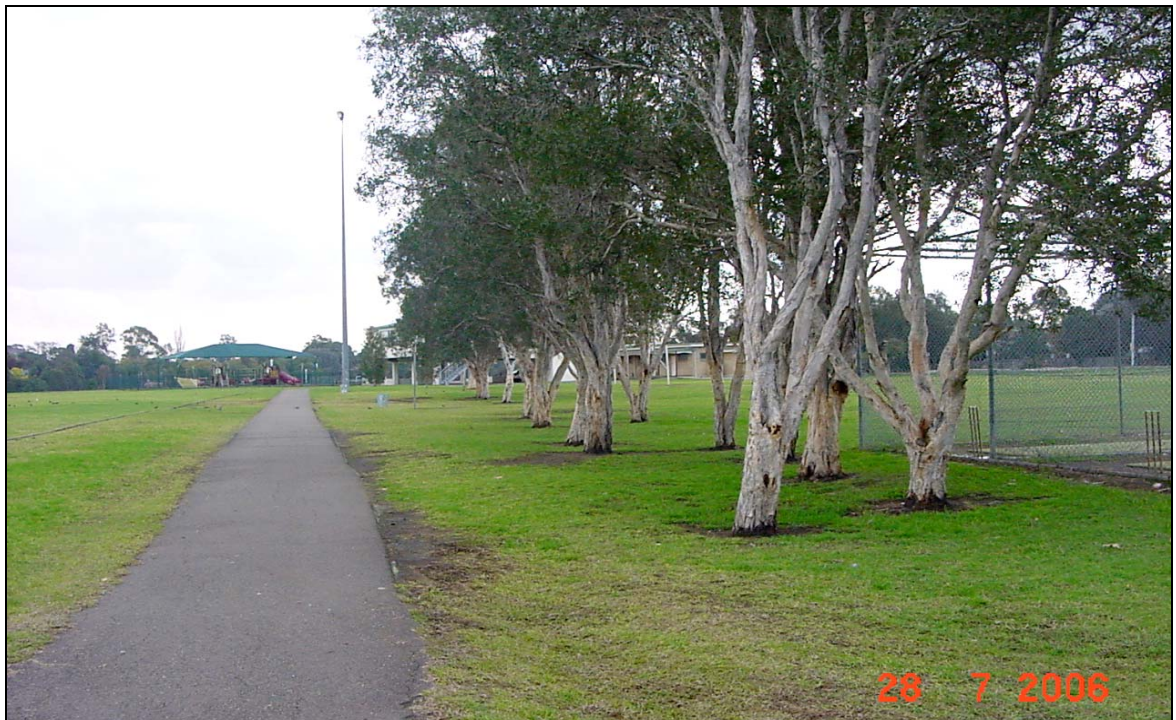
Figure 7 MEADOWBANK PARK

Looking west towards netball clubhouse and courts. The trees are adjacent to the existing cricket practice enclosures.

3.2.7 This section of the existing path shown above in Figure 7 may be upgraded, although it should not encroach further towards the existing trees without further assessment and advice from an arboriculturist.

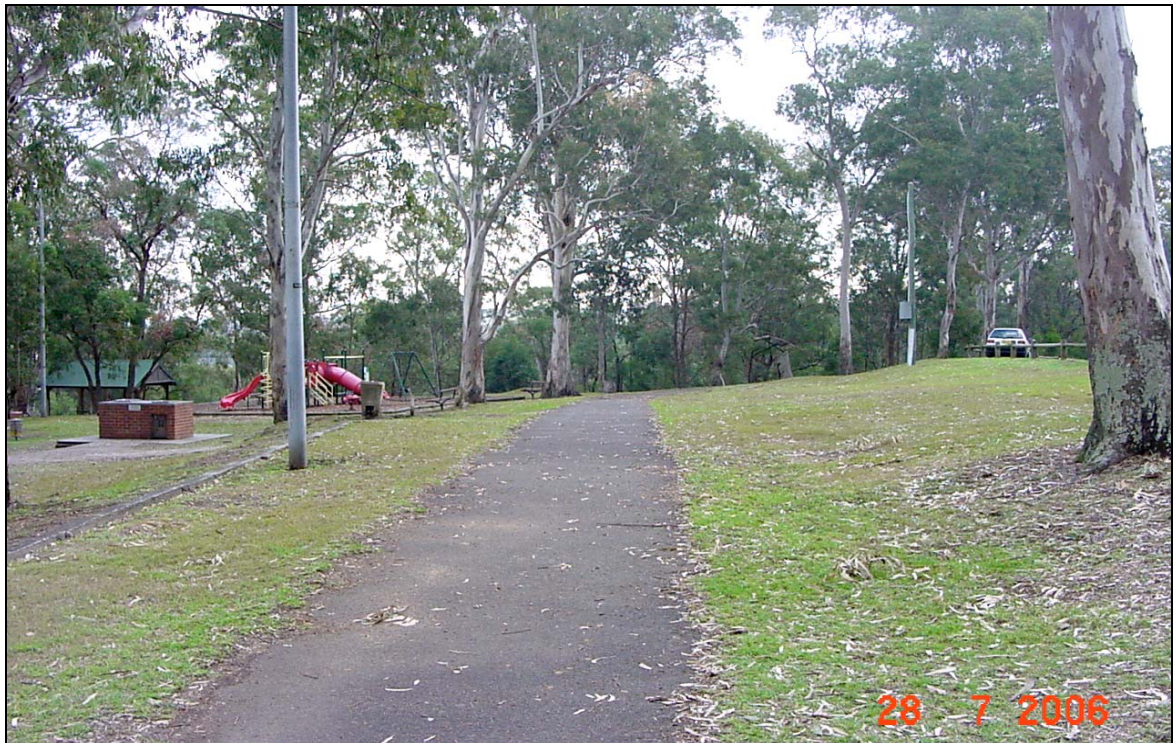
Figure 9 MEMORIAL PARK

3.2.11 It was noted during my inspection that several mature Forest Red Gums have structural defects ranging from minor to severe. These trees should be individually assessed by a competent arboriculturist to determine their hazard potential, and the level of risk associated with their retention near paths or other areas used by the public.

Looking west. Meadow Crescent is to the right of the photograph. An existing path is running between the barbecue area and the street. Several large trees are located near the path. Any future widening of paths may impact on tree root systems.

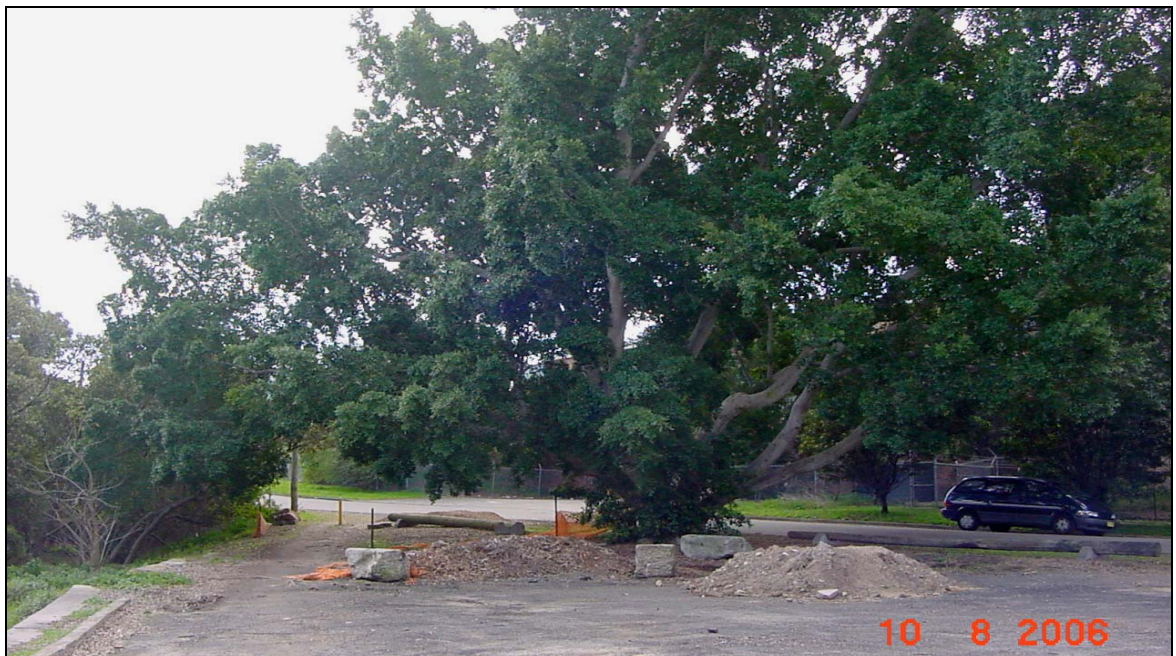
Figure10 ANDERSON PARK

A large Hills Weeping Fig (*Ficus microphylla* var. *hillii*) is located at the northwest end of the public car park, adjacent to Rothesay Avenue (Figure 10).

An unformed dirt track passes below the canopy of the tree and over the root zone.

Looking northwest towards Rothesay Avenue. Large Hill's Fig at edge of car park.

A 3.5 metre wide shared path is achievable subject to arboricultural advice. Some pruning of the canopy over the pathway to maintain adequate clearance for pedestrians and cyclists would be required.

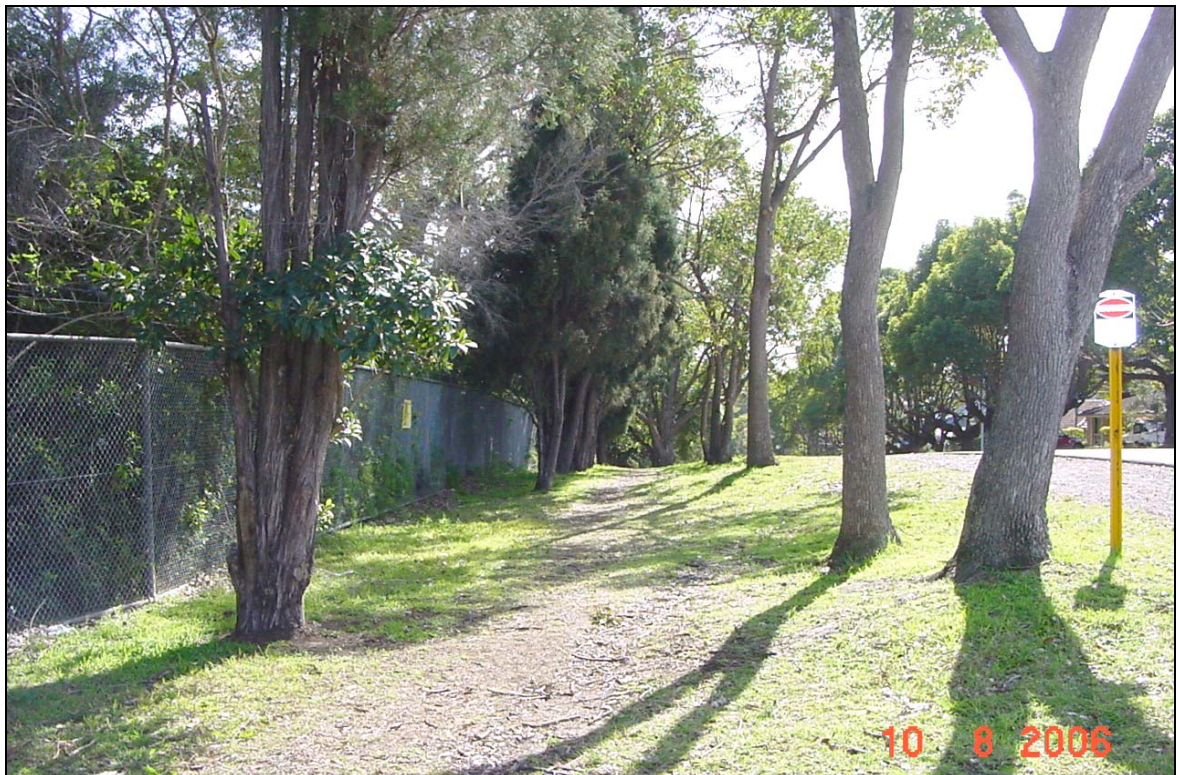
Figure 11 WATERVIEW STREET

A double row of Cypresses (*Cupressus* sp) and Camphor Laurels (*Cinnamomum camphora*) lines the west side of the road reserve along Waterview Street. (Figure 11)

It is unlikely a 2.5 metre wide path of this type can be accommodated between these trees without some impact on the roots.

It was noted the street is not kerbed and guttered along the west side. The distance from the edge of the road surface to the closest row of trees is several metres. It is possible a cycle lane could be accommodated in this location, and the pedestrian path installed between the two rows of trees.

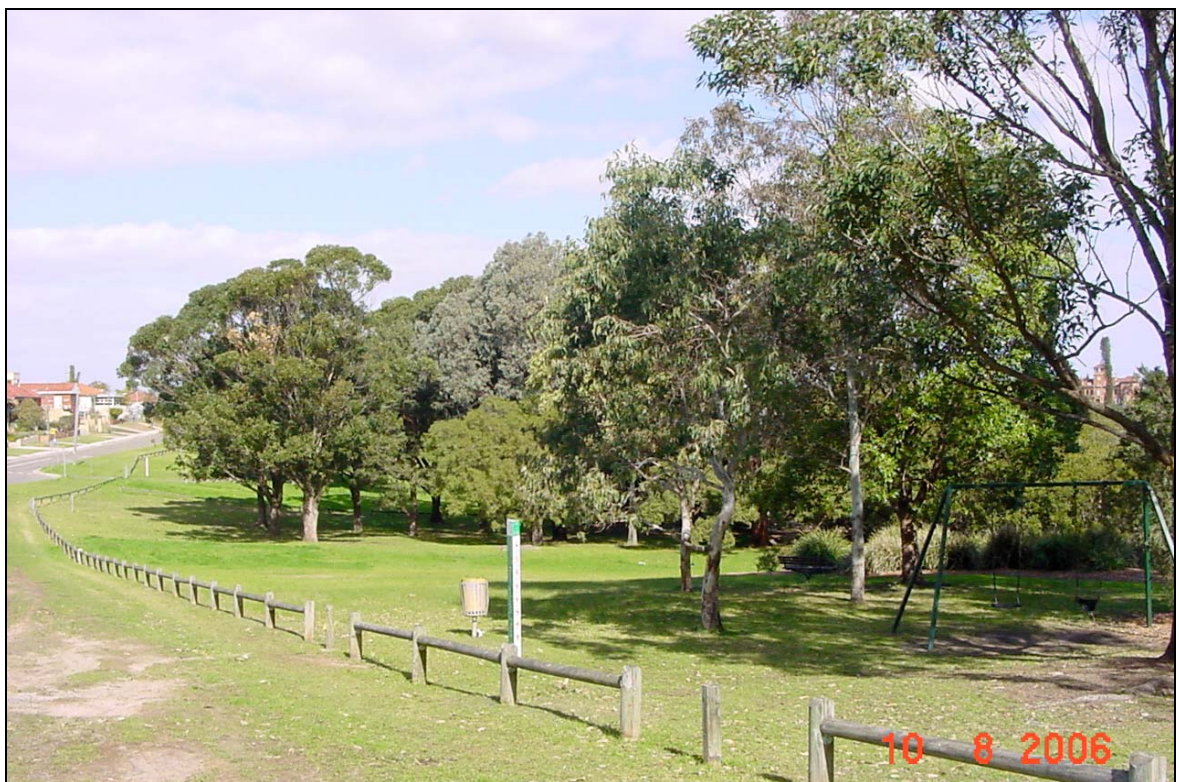
Figure 12 KISSING POINT PARK
Looking south towards the tree group in Area C.

There are approximately fourteen (14) mature and semi-mature trees in this area, including Swamp Mahoganies, Turpentines and Hills' Figs (Figure 12).

The proposed Type 3 path is located within the tree group. This path appears to meander through the group. There is an unformed path (a 'desire' line) between the existing Figs and the shore, which may be a more suitable location for the path. As the ground is undulating through this section, it may require short, elevated sections to span depressions, and avoid significant tree roots.

The proposed Type 2 east path can easily skirt the trees, and be located close to the park's east boundary.

It is preferable to incorporate the existing 'desire' line, rather than to cause impacts on other trees by diverting a path through the group.

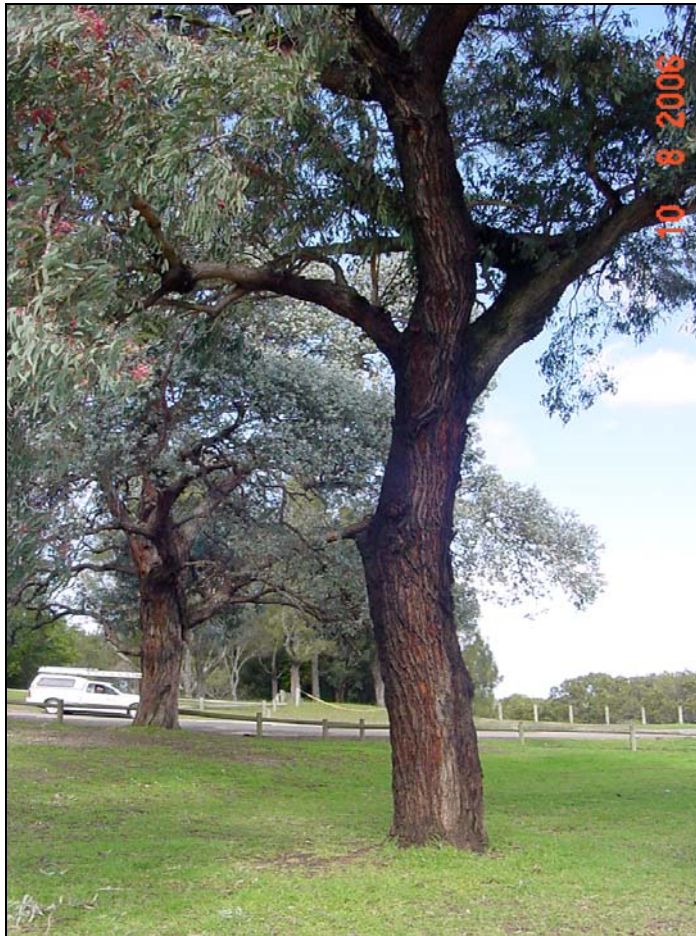
Figure 13 KISSING POINT PARK

A large Red Ironbark (*Eucalyptus sideroxylon*) and Argyle Apple (*Eucalyptus cinerea*) are growing near the north side of Yaralla Road (Figure 13).

Two significant trees that would require special attention prior to any final path design within 10 metres of the trees. No path should completely encircle the trees.

A path could be located equidistantly between the two trees, subject to further assessment by an arboriculturist to determine the best methods for path construction.

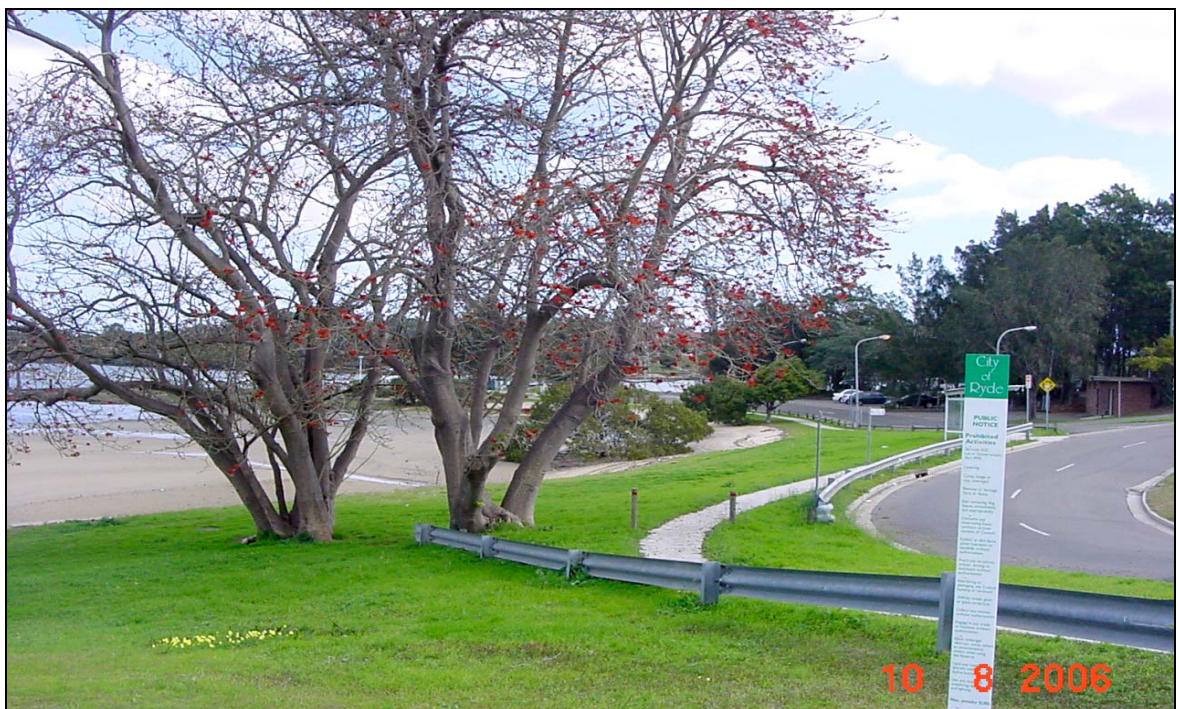
Figure 15 KISSING POINT PARK

3.4.6 The two Coral trees (*Erythrina x sykesii*) in Figure 15 are visually important. The species, however, is known to be brittle. Any new paths should be kept out of the dripline of the trees to minimise any risk of injury by failing branches.

Alternatively the existing path should be utilised as the link to the eastern section of Kissing Point Park.

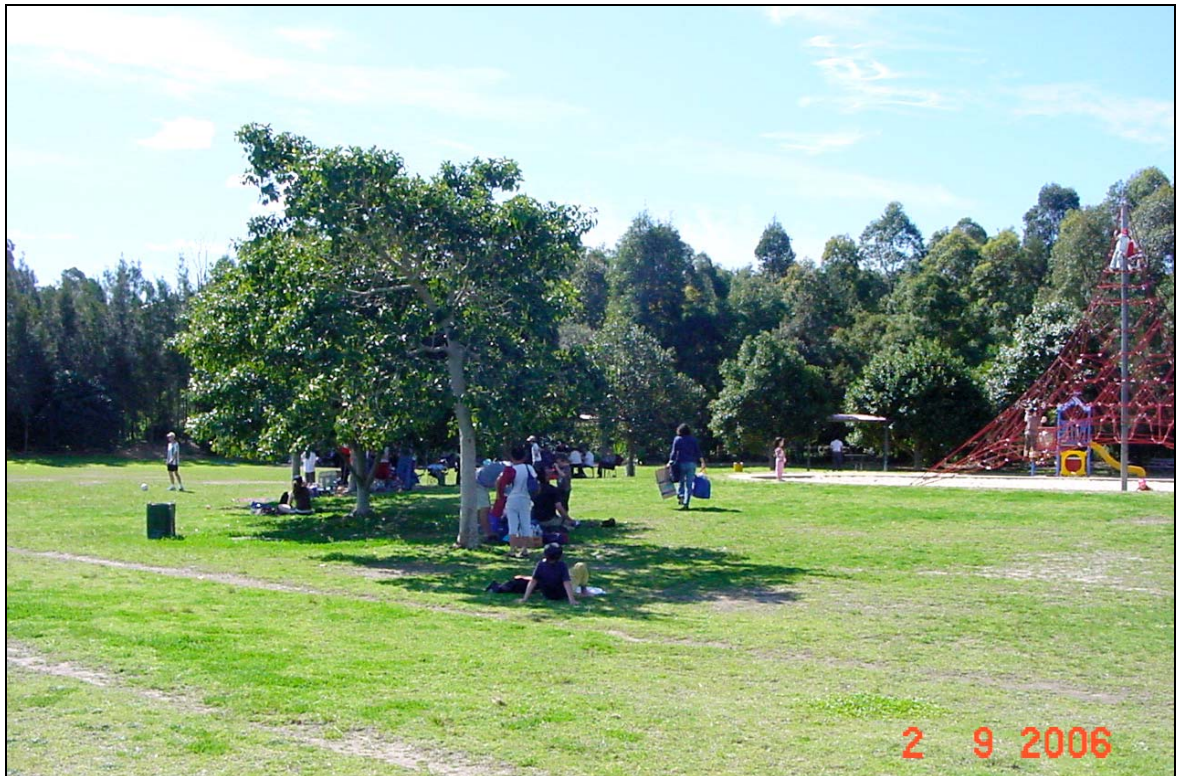
Figure 18 PUTNEY PARK

Looking northeast. A group of 10 semi-mature Figs partially encircling the smaller playground area.

- 3.5.4 The proposed path around the smaller playground should be kept at least 4 – 5 metres away from the existing Figs, to allow adequate root spread. As the trees mature, their canopies will provide useful shade for park users. The use of any path in this immediate area by cyclists should be discouraged. This area is used by families. Young and active children could be at risk of being knocked over by cyclists. Consideration should be given to increasing the distance from the path to the trees, so families can spread out in the shade, or remove the proposed path entirely from this area.

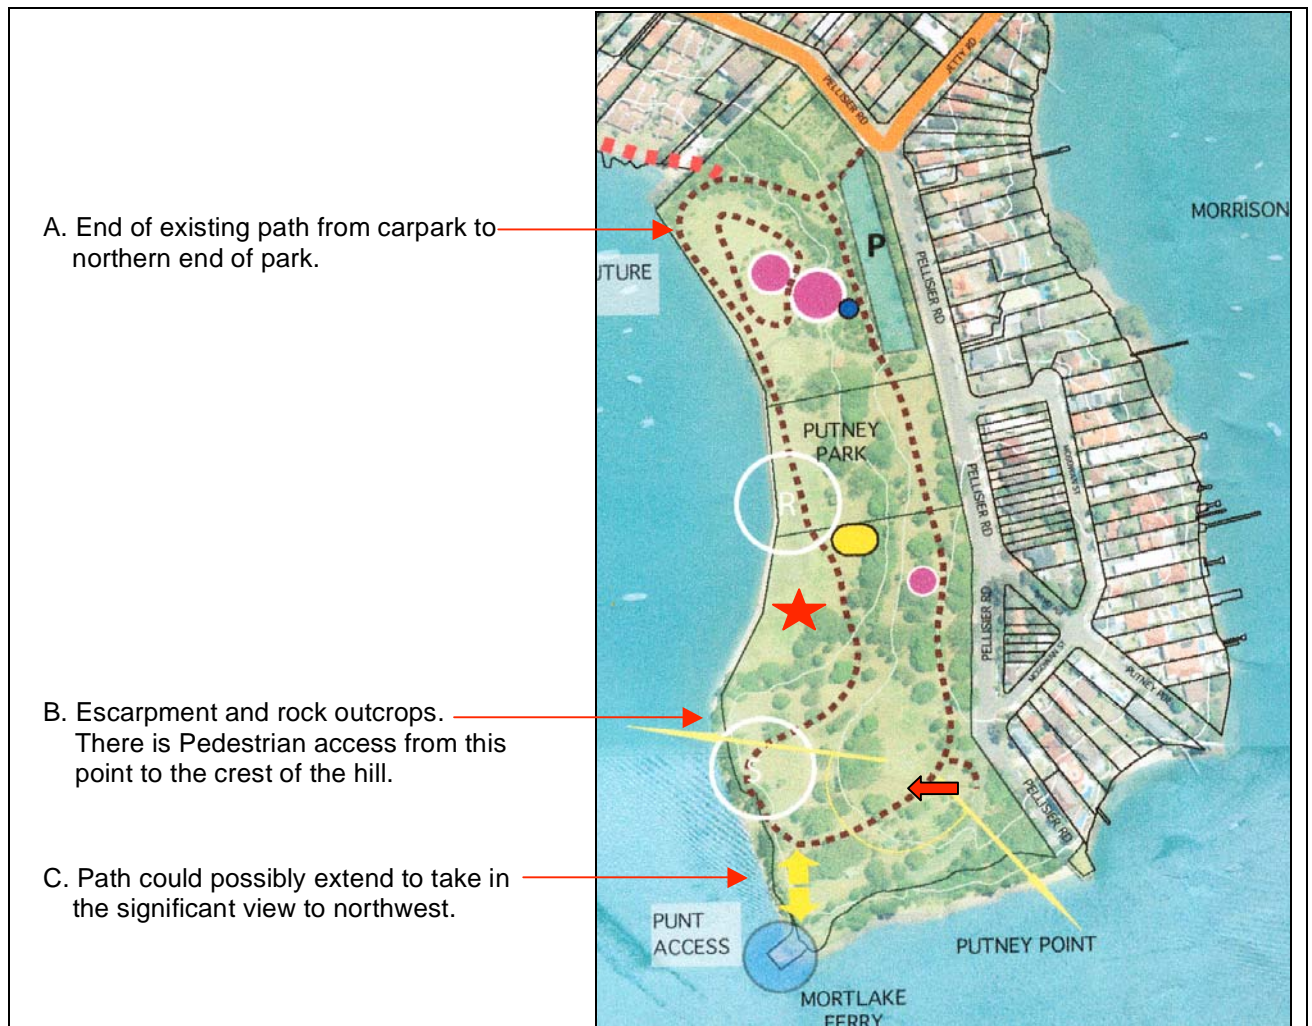
Figure 19 PUTNEY PARK

3.5.6 The proposed path needs to skirt several mature trees, some of which need to be investigated for hazard potential.

The proposed track could be extended as shown, as there is an excellent view corridor to the northwest and public toilets with established access paths in close proximity.

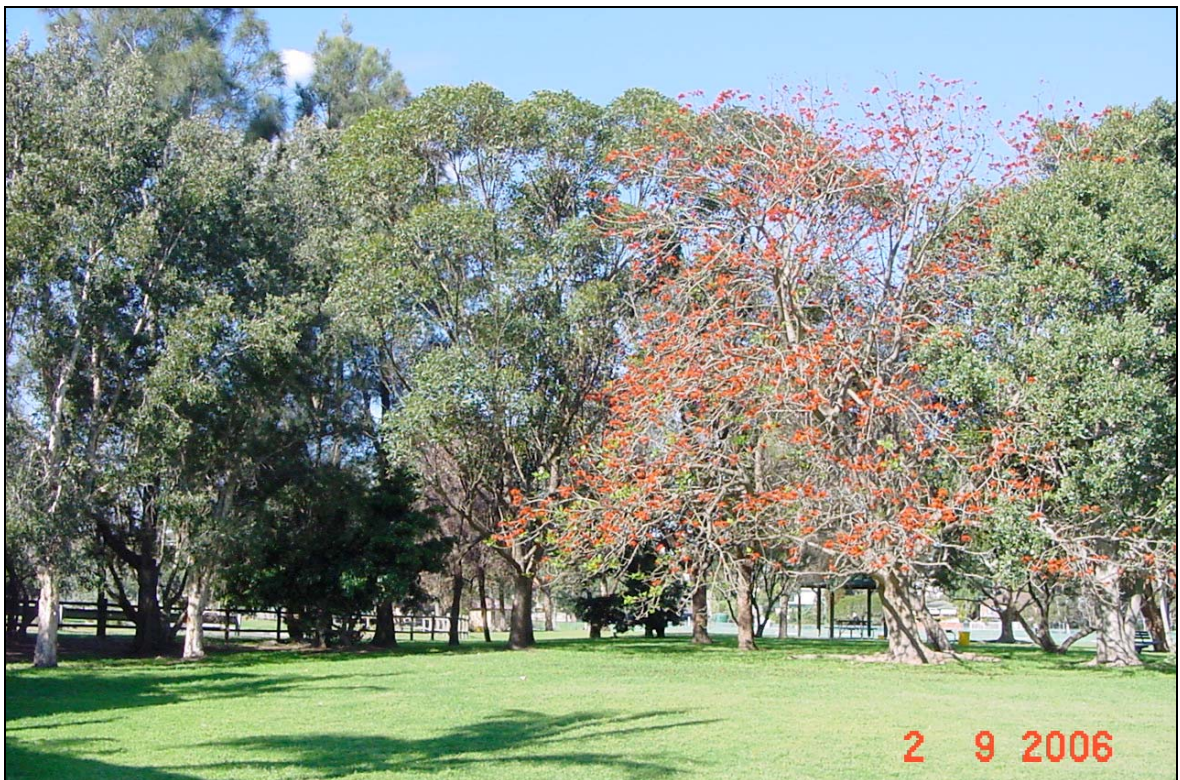
Figure 20 MORRISONS BAY PARK

3.6.2 A 3 metre wide path is proposed through this group of trees - (Figure 20). Unless selective tree removal is carried out, this path width cannot be achieved. An alternative would be to direct the path to the south and east of this group, however, that may impact on the playing fields nearby. This would require further investigation to determine the feasibility of path location, either through the tree group or skirting the group.

Looking northeast towards the parking area. A 3 metre path is proposed through this group of trees.

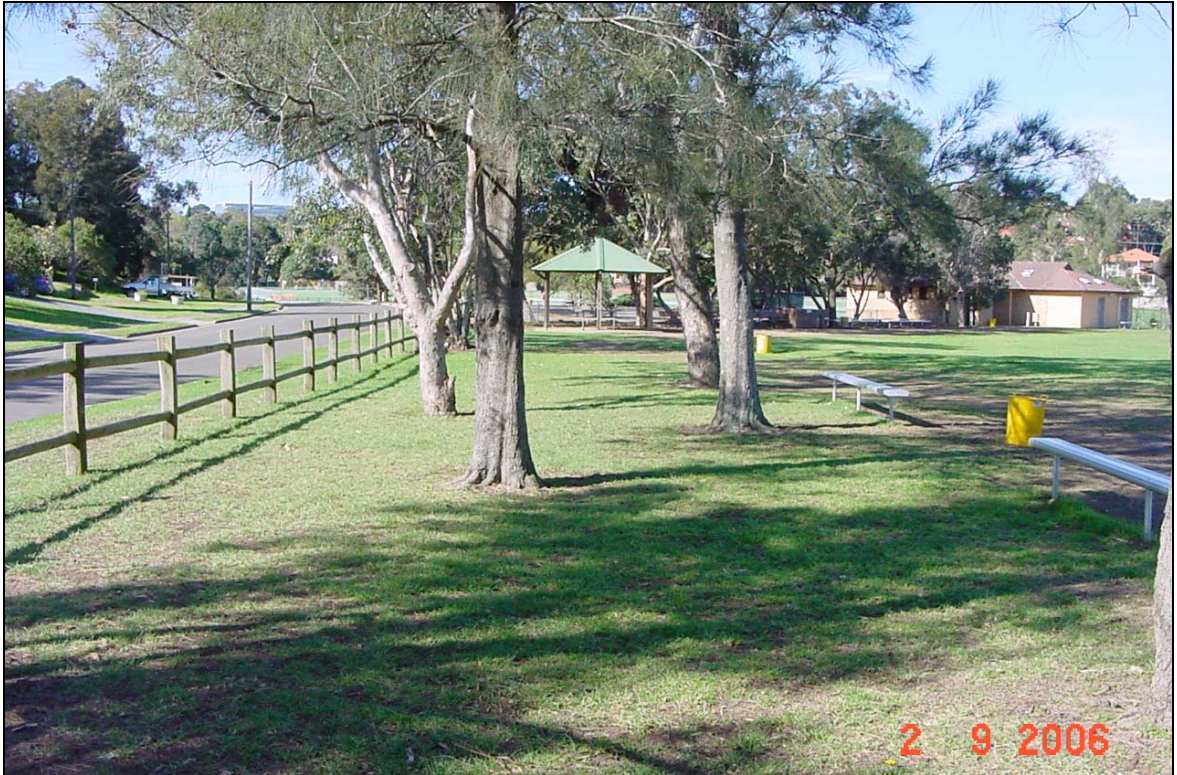
Figure 21 MORRISONS BAY PARK
Looking northeast, adjacent to Frances Road. Note spectator benches to right of trees.

- 3.6.3 The trees within the park, (mainly She-oaks – Figure 21) and adjacent to Frances Road, could only accommodate a narrow path of around 1200mm width, unless selective removal of one or two trees is considered.

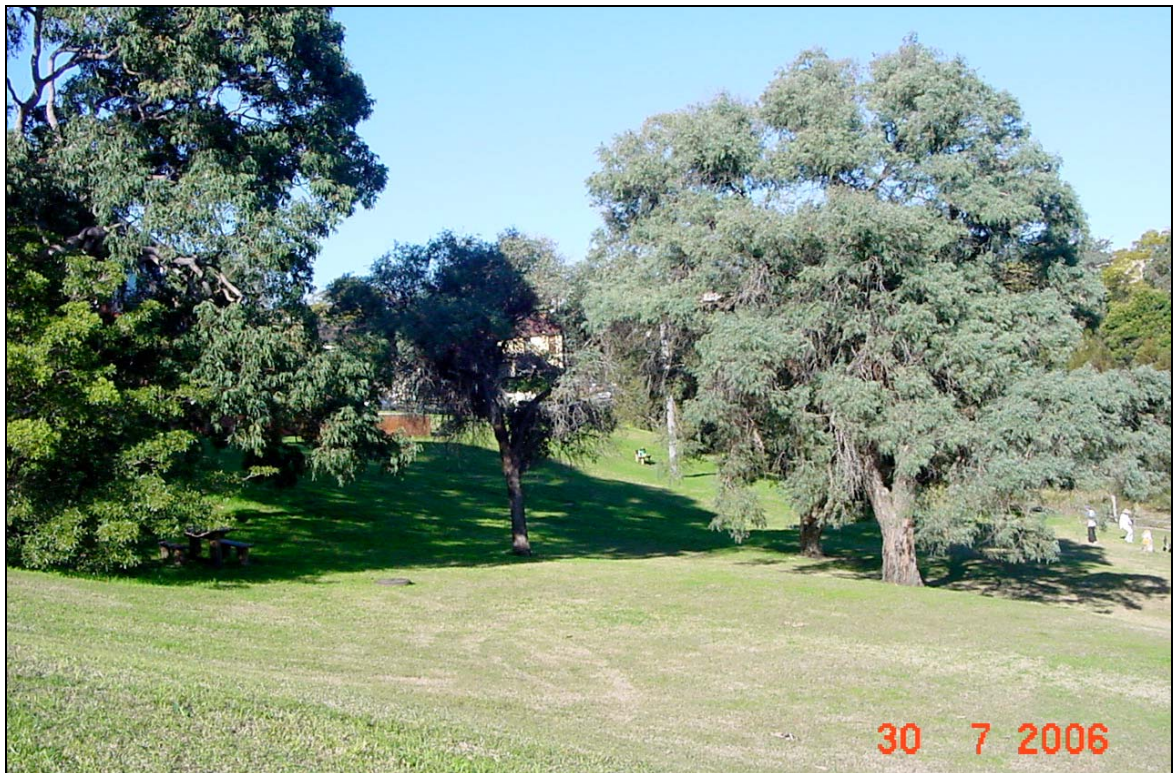
Figure 25 GLADES BAY PARK

The type 3 shared trail path can be accommodated through this group of trees in Figure 25. As the ground level is undulating, a safe and even path may be difficult to achieve in proximity to these trees, without impact on tree roots. The paths should either follow the existing gradients, or 'bridge' existing depressions. This should be subject to more detailed investigation to ensure the construction methods adopted will not adversely affect the tree.

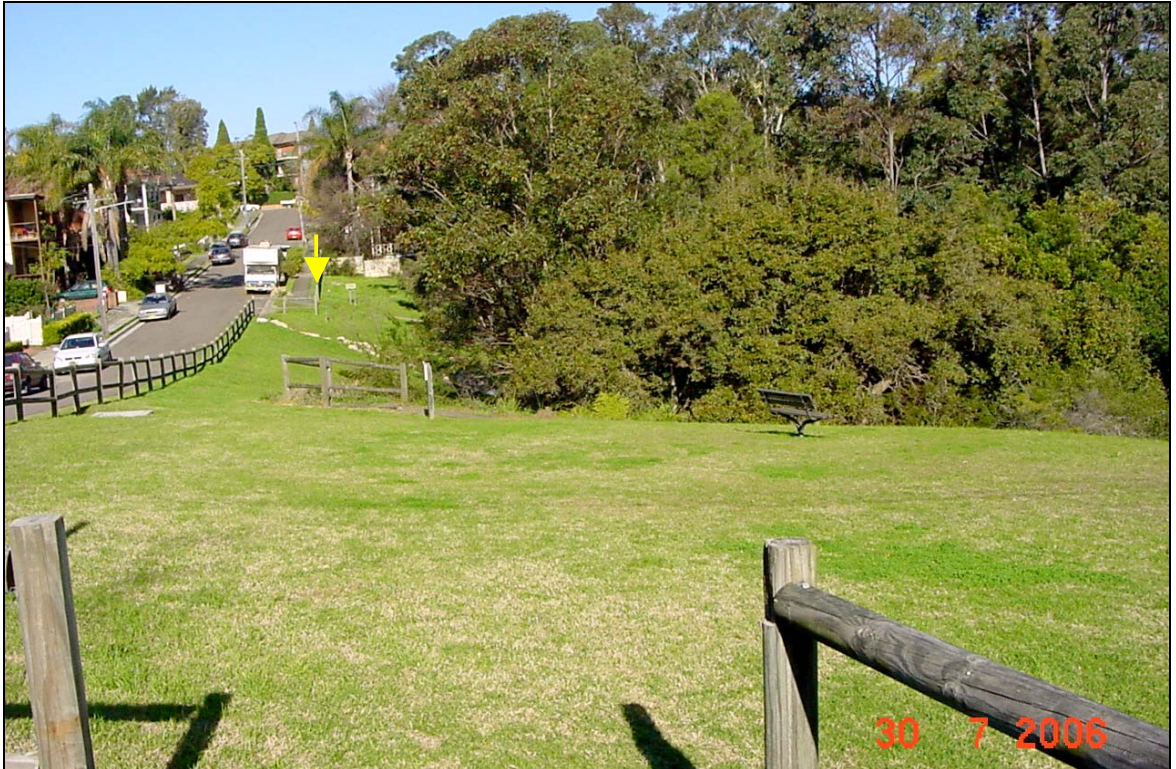
Figure 26 GLADES BAY PARK

- 3.7.3 The proposed path avoids the watercourse and vegetation shown in Figure 26. The land falls steeply to the southwest, (other side of vegetation in photograph), so the proposed path meets up with the existing path that begins where the yellow arrow indicates.
- 3.7.4 There is an existing concrete path through the park which meets Delmar Parade to the south (Figure 27). Some sections have been recently repaired or are undergoing repairs. The damage does not appear to be tree root related, as existing trees are generally well set back from the path.

Any widening of the path in the future would need to ensure that works within proximity to mature trees should be initially subject to review by an arboriculturist.

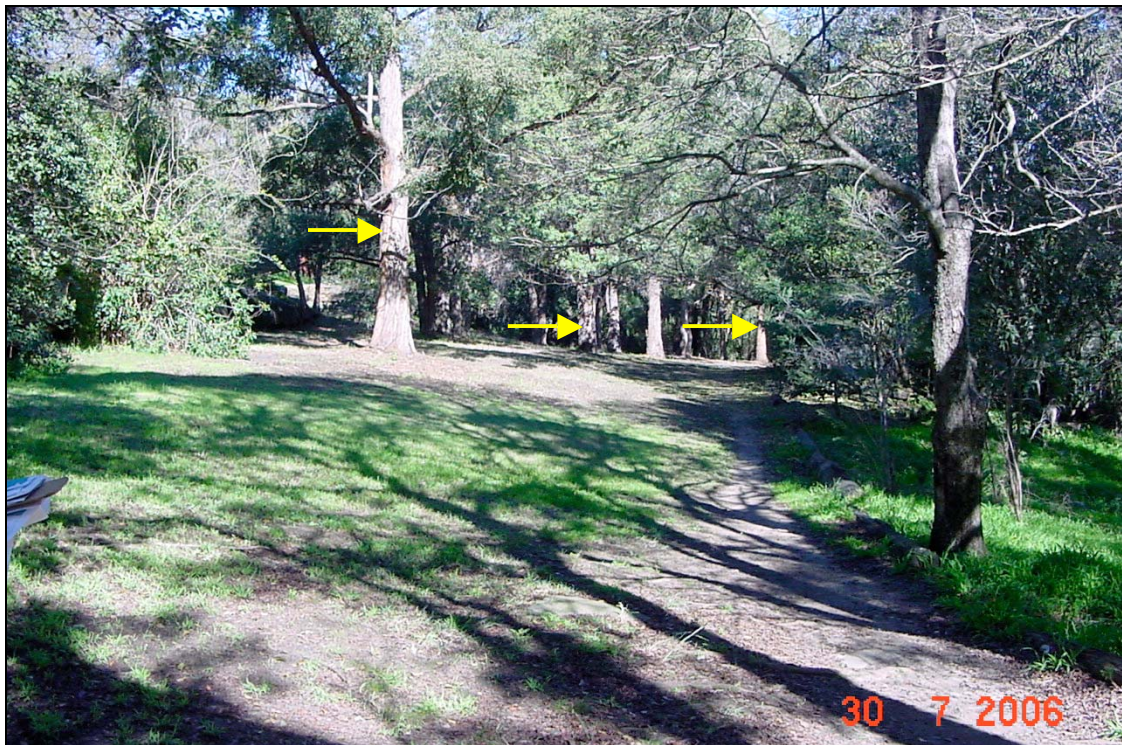
Figure 29 LOOKING GLASS BAY PARK

Looking southwest. Tallowwoods (some arrowed) are growing on the east side of the track.

- 3.7.5 A significant, scattered grouping of *Eucalyptus microcorys* (Tallowwood) is located on the east side of the track, opposite a long rock bench (Figure 29). The sandstone benching and trees are located outside the boundaries of the adjacent private properties abutting the park. Where this group of trees begins, I noted the existing dirt track is over unstable, rocky ground. Several large woody roots belonging to Tallowwoods were noted in this area. Some roots have been damaged by past foot and bike traffic.

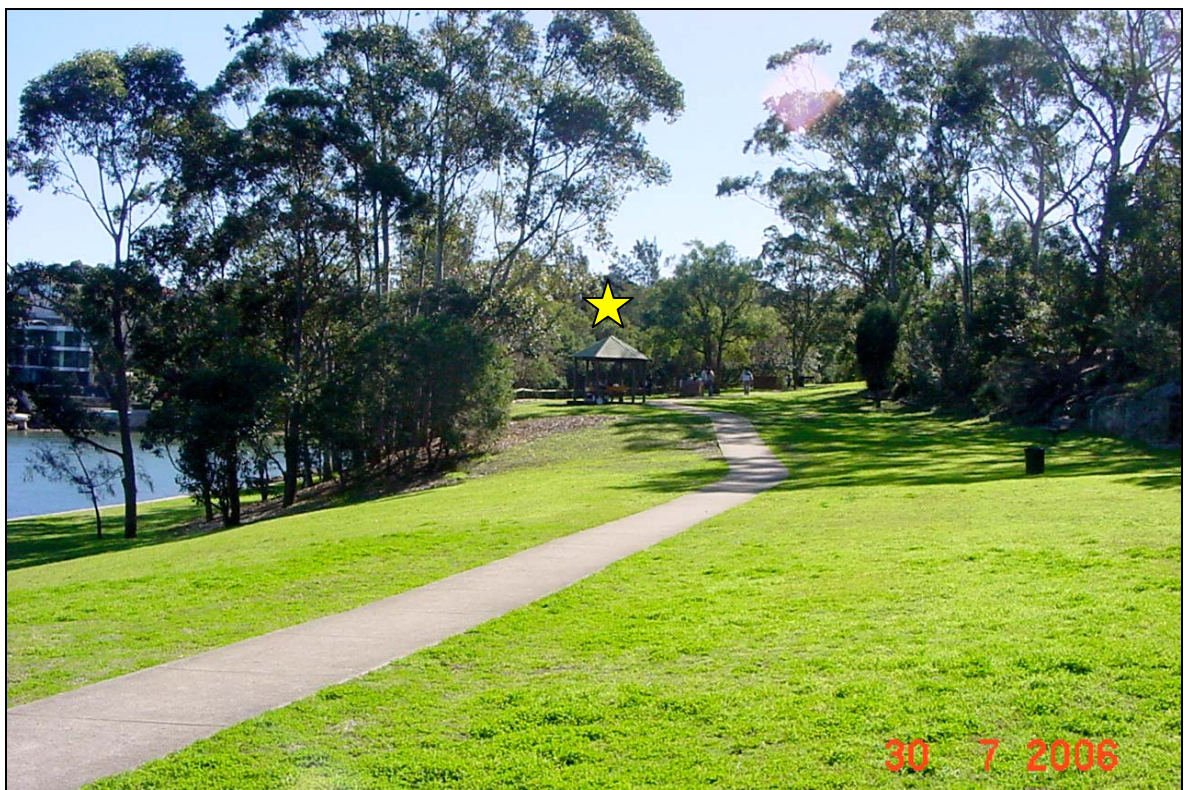
Figure 33 BANJO PATERSON PARK

The existing path is in good condition. Widening of this path in this area will not impact on trees. The yellow star identifies the location of the picnic shelter.

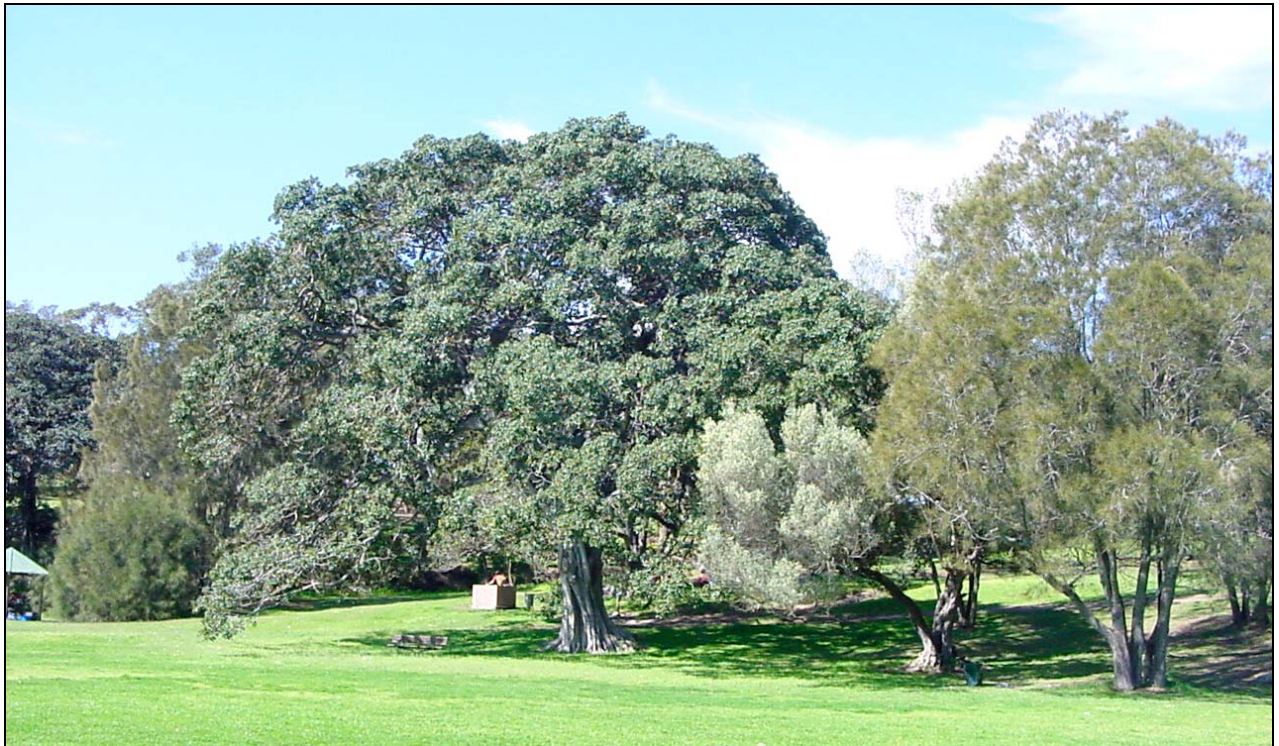
Figure 34 PUTNEY PARK

A significant and visually dominant Fig tree. One of several very large, mature trees in the park.
