# TOP RYDE CENTRE AND NORTH RYDE SMALL CENTRES PEDESTRIAN ACCESS AND MOBILITY PLAN (PAMP)

P2320

CITY OF RYDE

16 March 2016

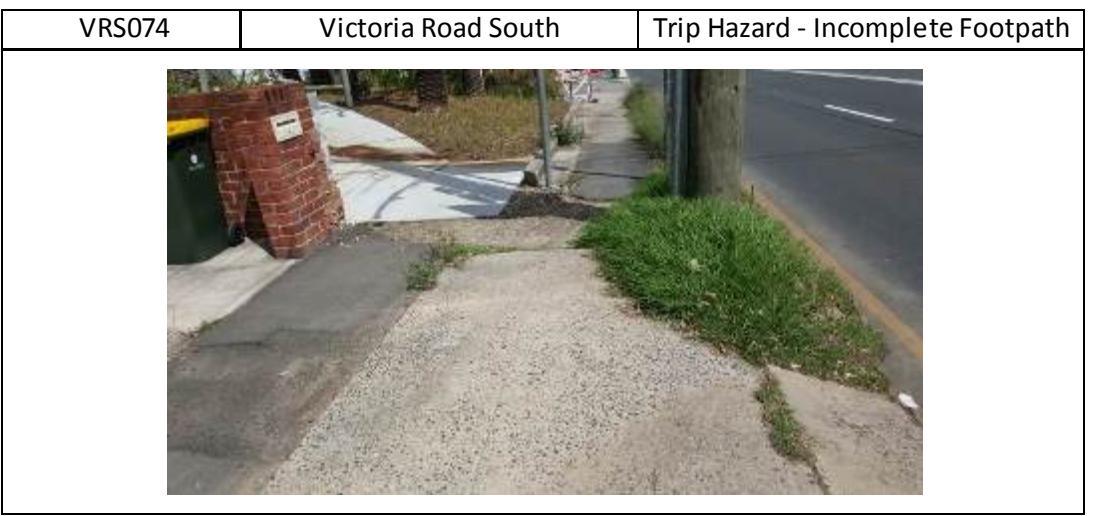
Incomplete footpaths;

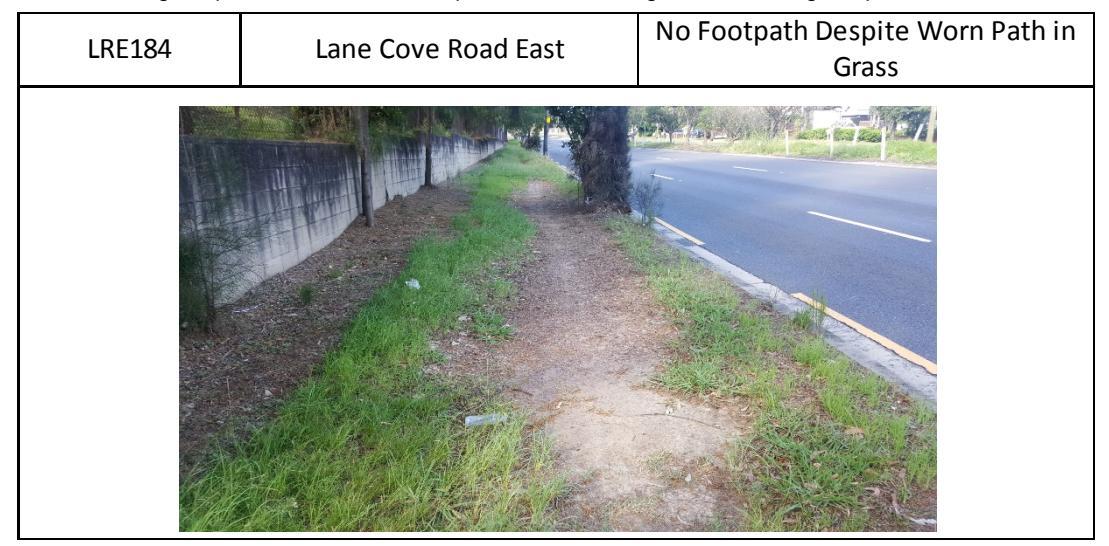
• Missing footpaths where there are paths worn in the grass due to regular pedestrian movements;

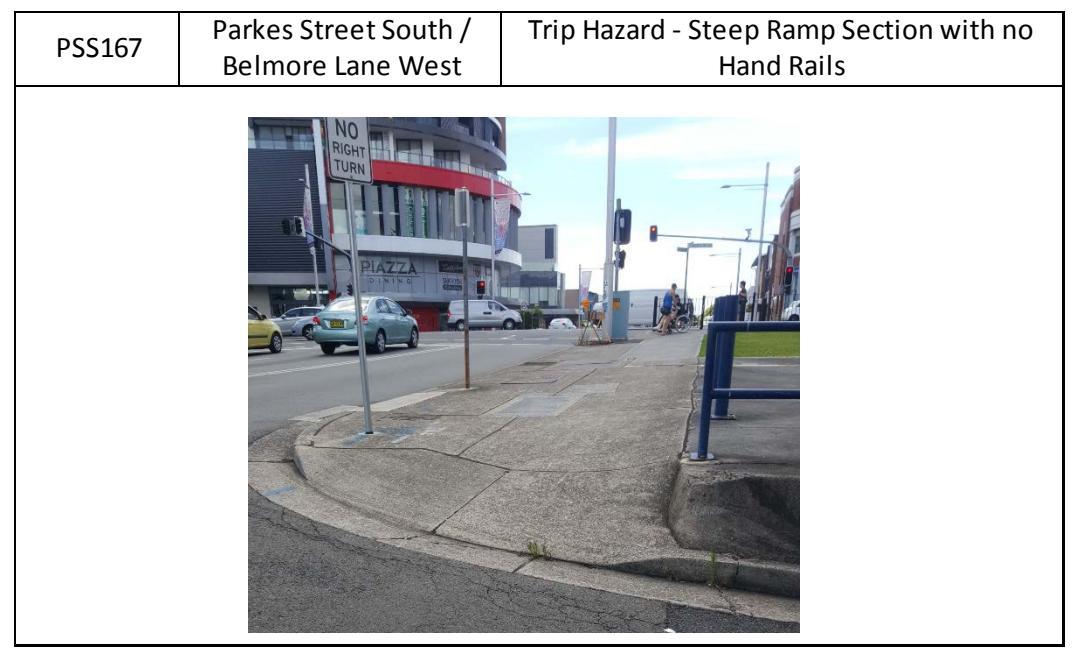
Steep kerb ramp

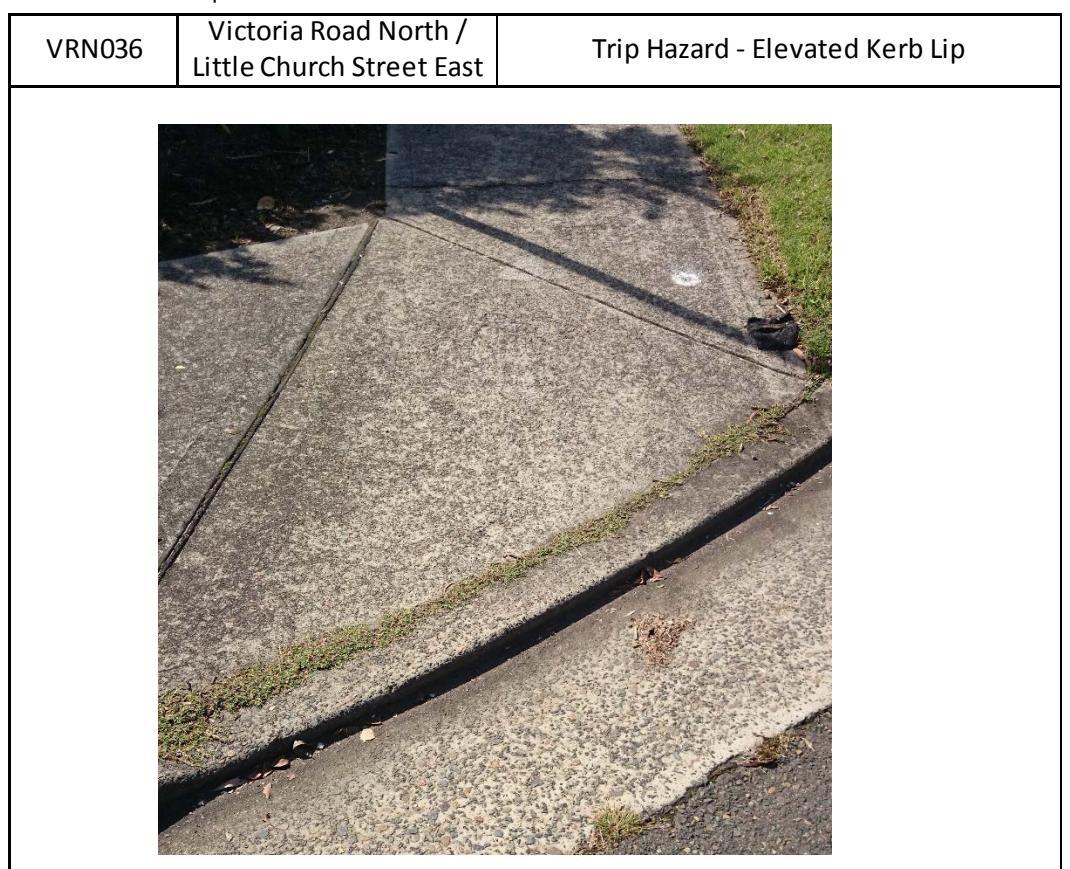
Raised kerb lip

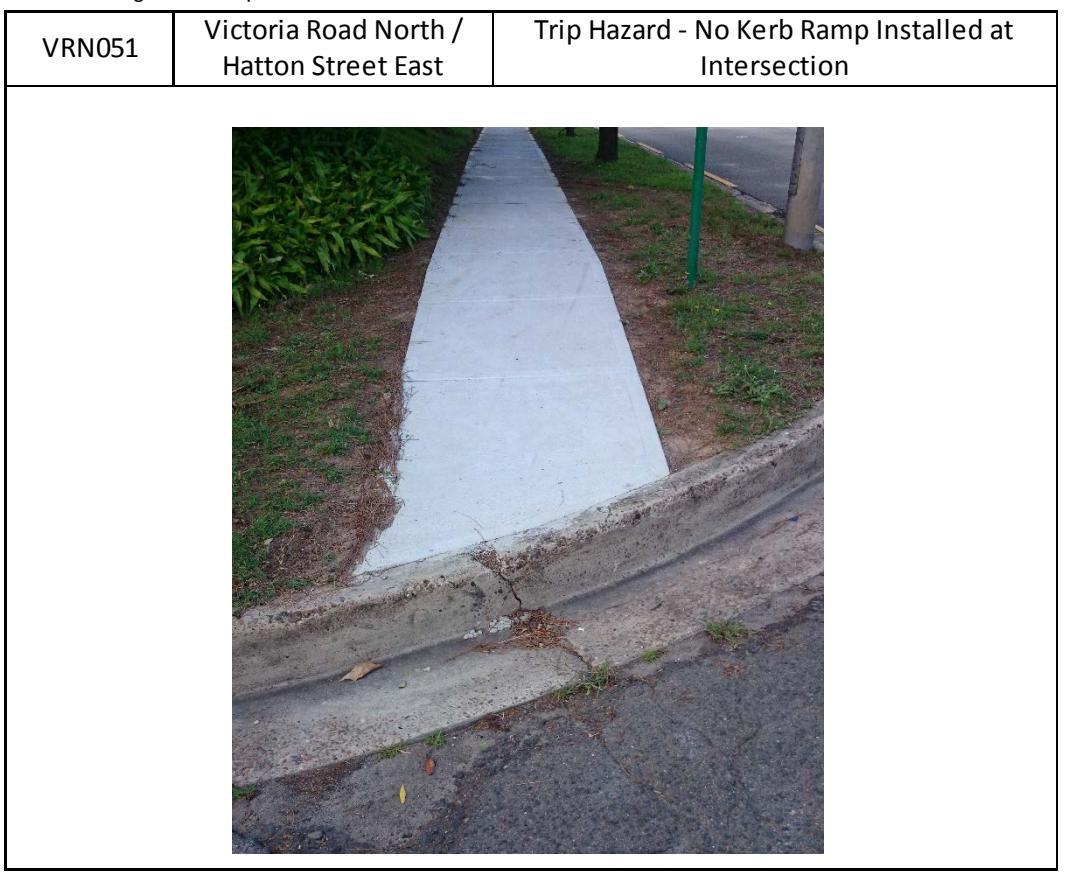
Missing kerb ramp

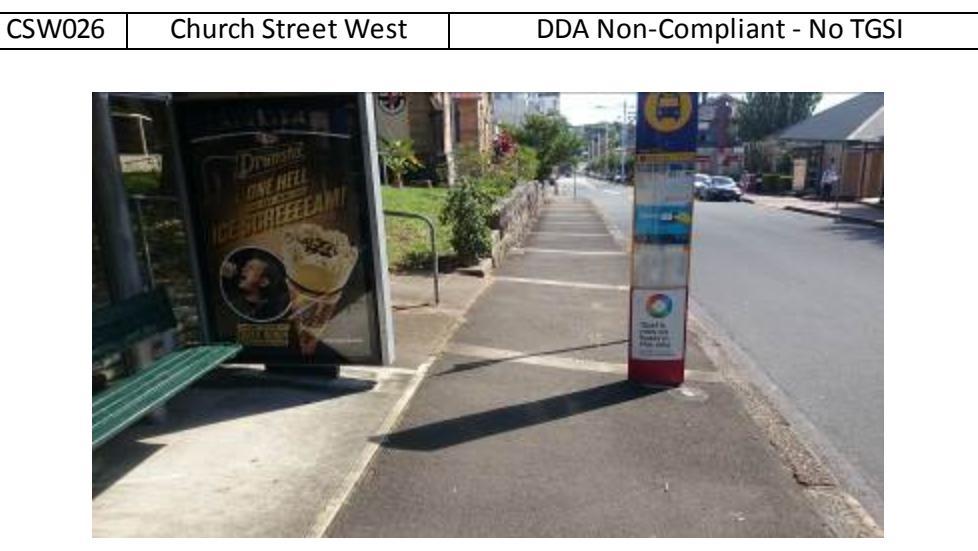
No Hard Stand

No TGSI

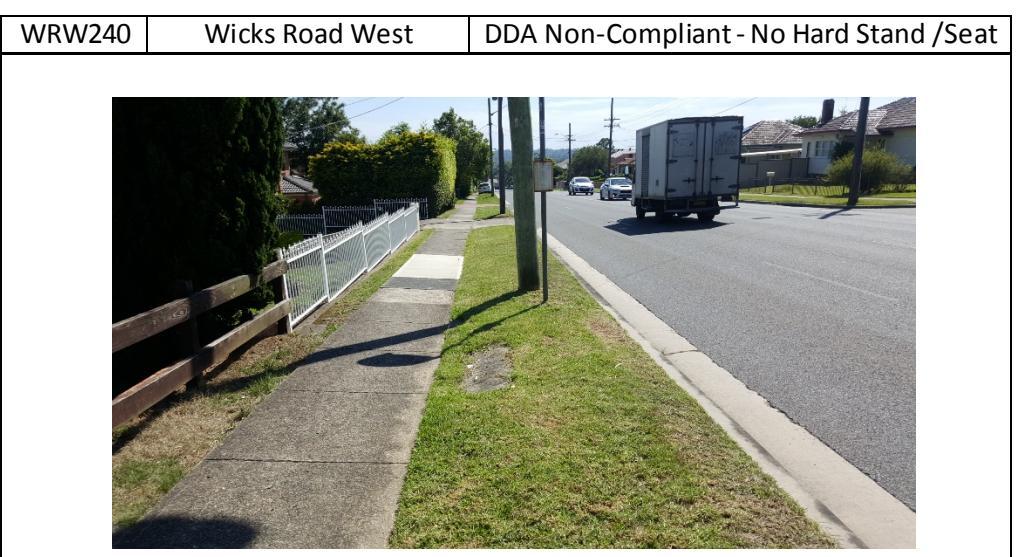
No Seat

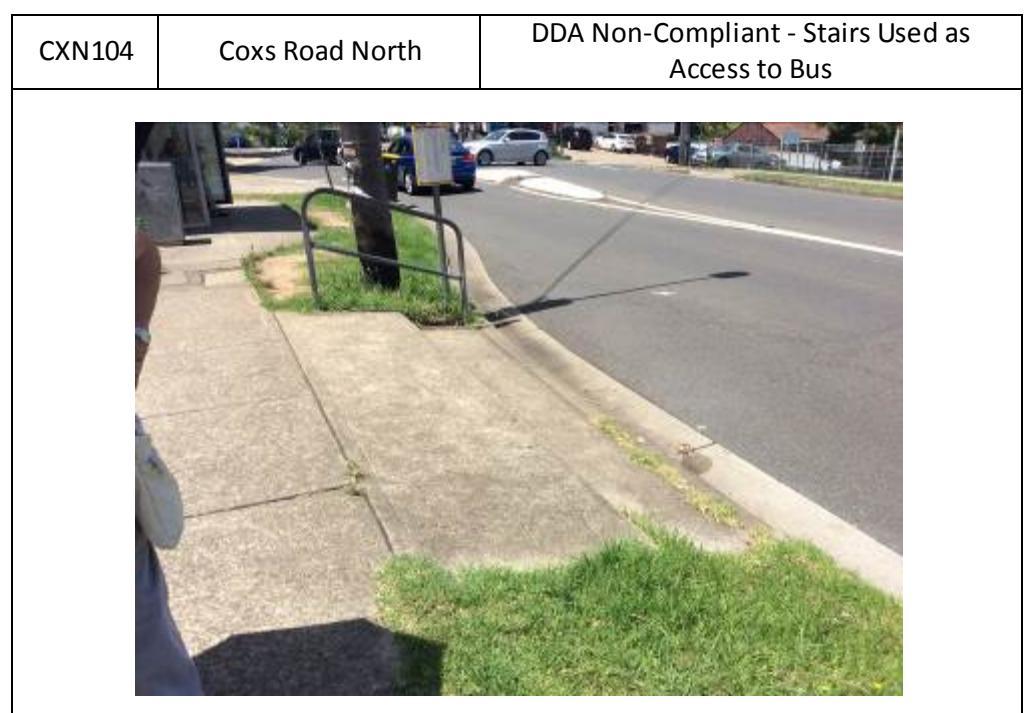
Unsafe Hardstand

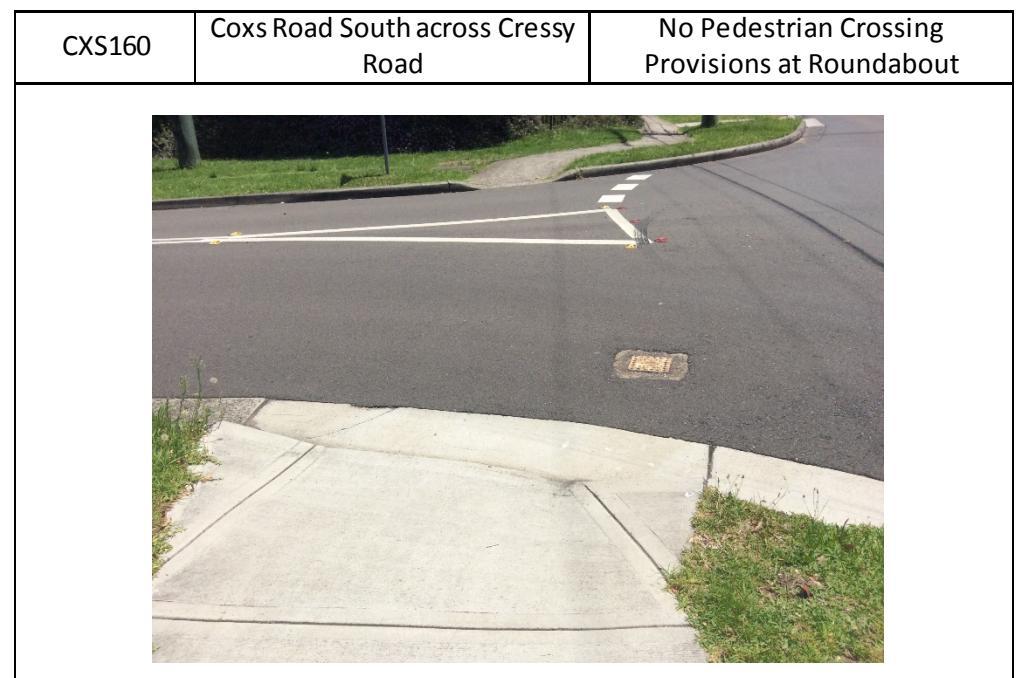
No crossing provisions

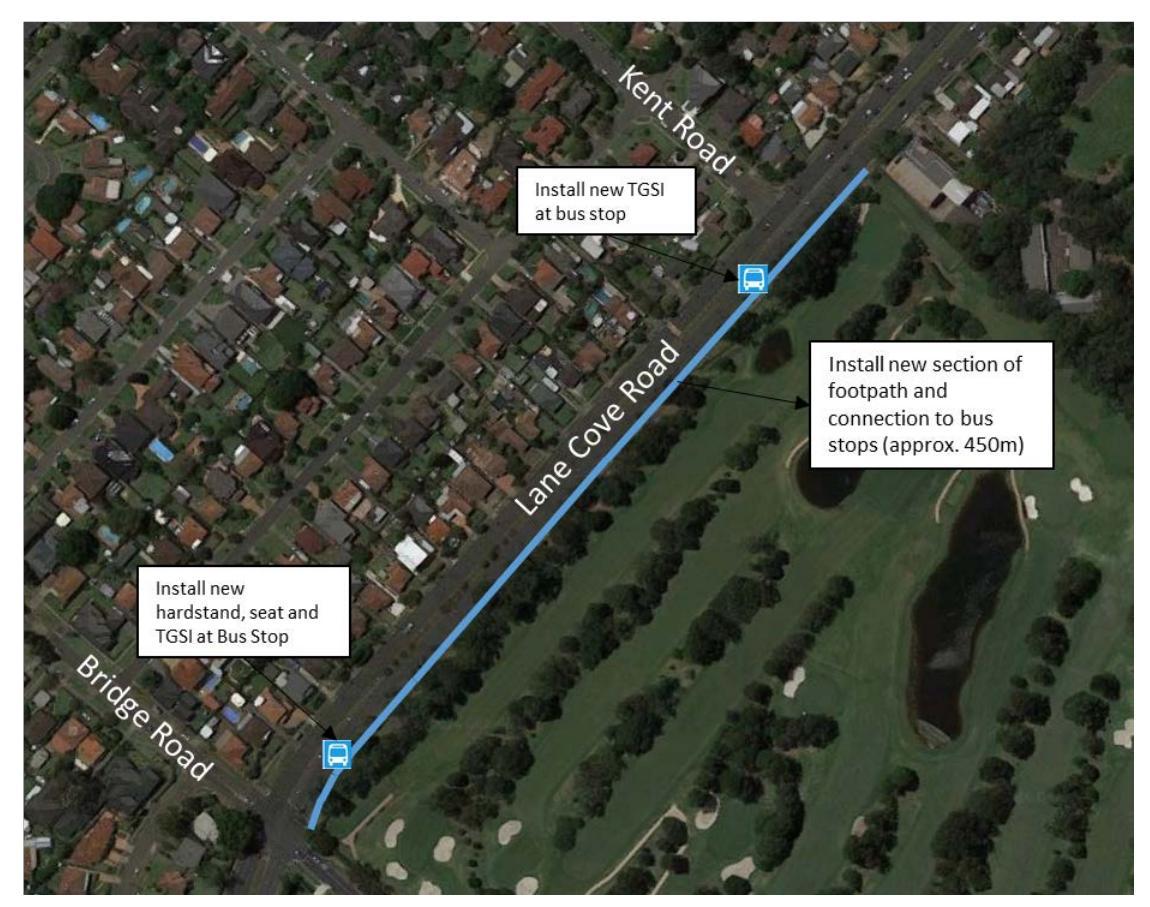
Figure 7.1: Lane Cove Road Footpath Upgrades

As identified in the site audit conducted on the 21<sup>st</sup> January 2016 a worn pedestrian path exists along the south eastern side of Lane Cove Road between Kent Road and T win Road. It is recommended that a footpath be installed that connects the existing footpath along Lane Cove Road to the intersection of Lane Cove Road with T win Road as shown in Figure 7.1. Additionally the two bus stops located along this stretch of road require upgrades.

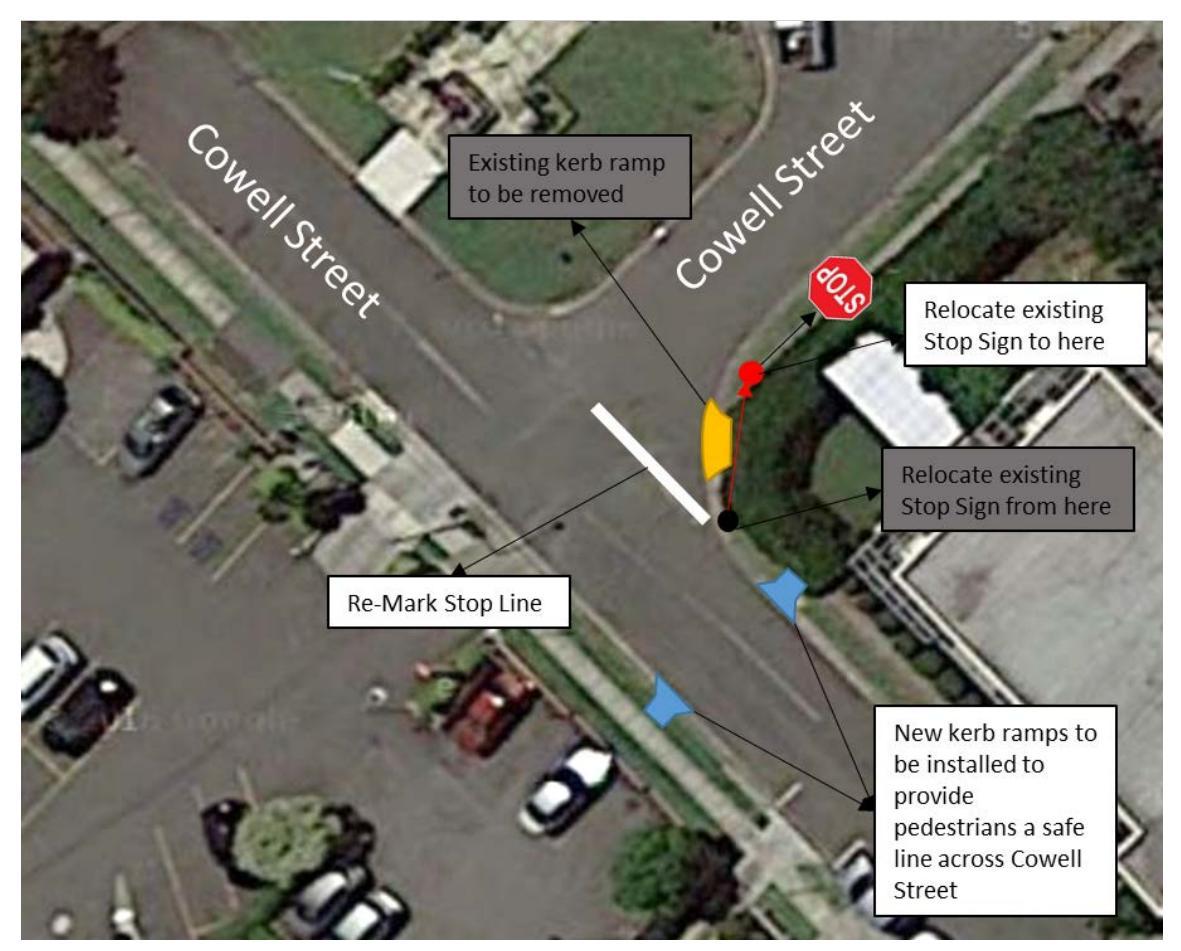
Figure 7.2: Cowell Street Intersection Pedestrian Facility Alterations

The intersection at Cowell Street near Victoria Road presents dangers to pedestrians in its existing layout. Pedestrians are directed through the middle of the intersection by a kerb ramp towards the entry and exit driveway laybacks to the Ryde X Club. The intersection also contains large potholes and even road pavement in the direct pedestrian desire line and the stop sign to the left of the northern approach is unsighted due to its current location. A reconfiguration of the intersection is shown in Figure 7.2.

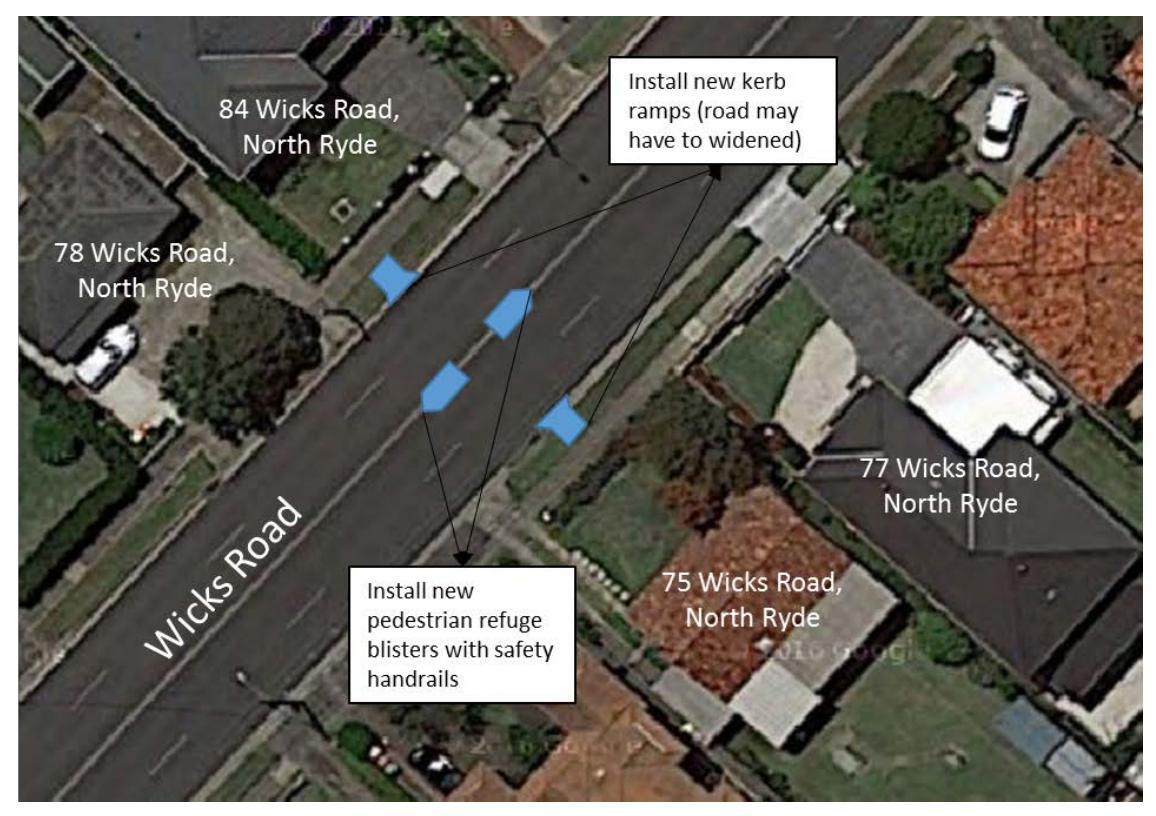
Figure 7.3: Wicks Road Potential Pedestrian Refuge Location

The section of Wicks Road between Coxs Road and Beatrice Street does not have any existing pedestrian crossing provisions over a span of just over 500m. This section of road was identified as being a priorityroute for pedestrians and contains a number of bus stops. It is proposed that an investigation is conducted into the feasibility of a pedestrian refuge across Wicks Road. An initial concept location is shown in Figure 7.3.
