Marsden High School

Aboriginal Cultural Heritage Assessment Report

13th MAY **2021**

Report to: Department of Education, School Infrastructure NSW

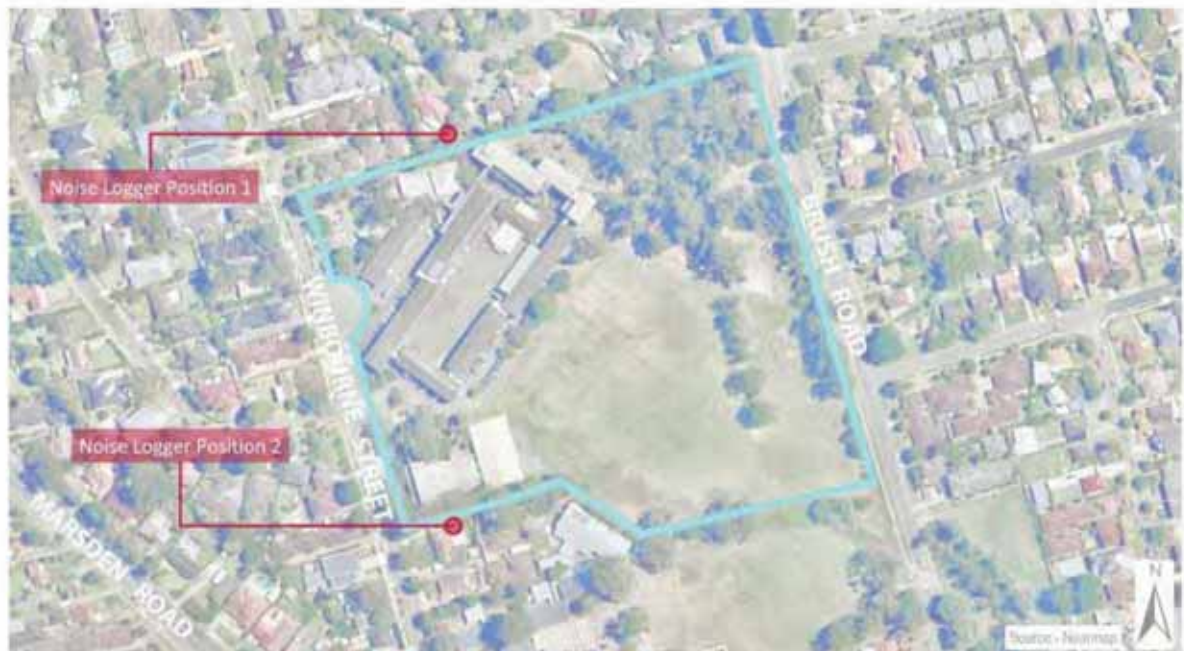
Figure 4: Unattended noise logger locations

Both loggers continuously measured background levels with post-processing resampling noise levels into 15 minute intervals following methodologies provided in the NSW EPA's Noise Policy for Industry (NPfI).

Logger background noise data was then analysed and edited, removing data sets affected by poor weather conditions and data exclusion guidelines also set out in the NPfI. Data for 24 and 25 February 2021 was not available for the logger at Position 1 due to an equipment storage failure. In order to provide comparable survey periods, data for Position 2 was excluded for the same period.

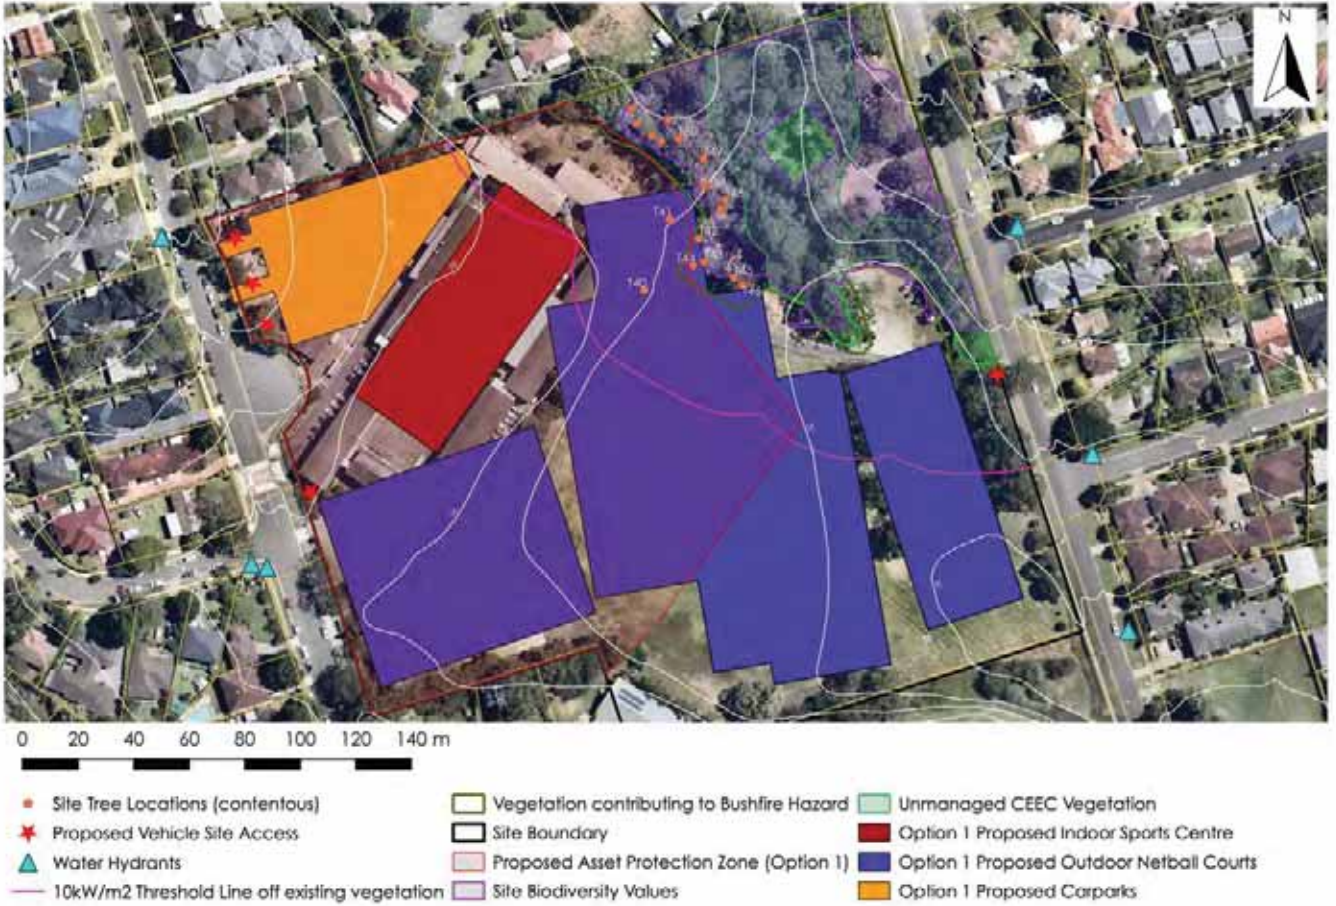
Figure 10. Bushfire assessment of proposed Option 1.

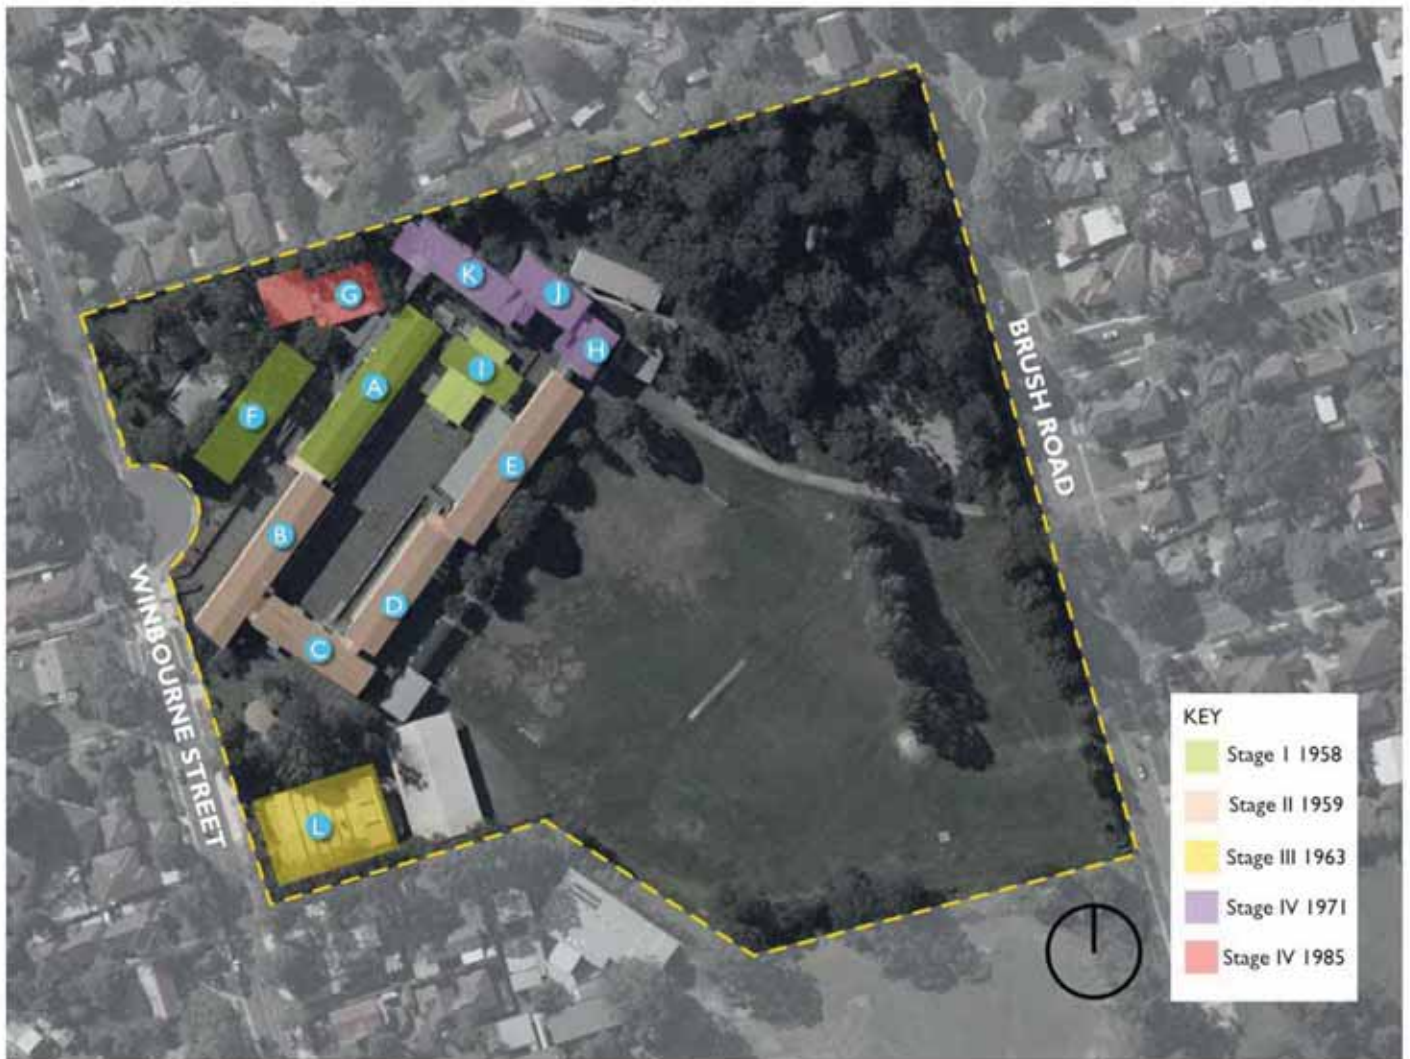
- Stage I was occupied in January 1959;
- Stage II was completed in 1959 and occupied by February 1960;
- Stage III included the Assembly Hall completed in 1963;
- Stage IV included buildings K, J, and H completed in 1971;
- Stage V included the Library, lift, and covered ramps between the library, and buildings A and K in 1985

Marsden High School Development Stages future boundary dashed in yellow. (Source: SIXMaps modified by Purcell, boundary information supplied by SINSW).

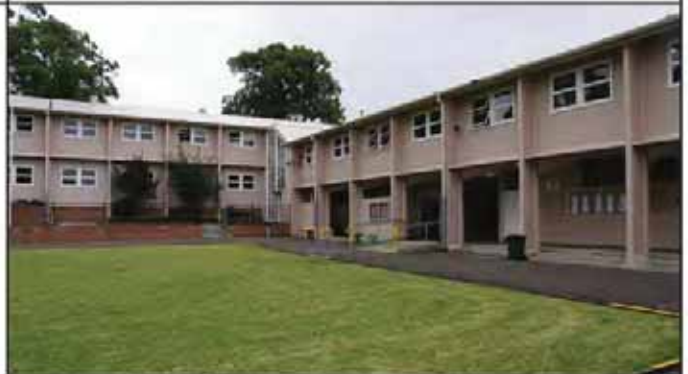
Typical classroom blocks looking north west across the courtyard. Note the original tiled roof was recently replaced with a sheet metal roof. (Source: Purcell)

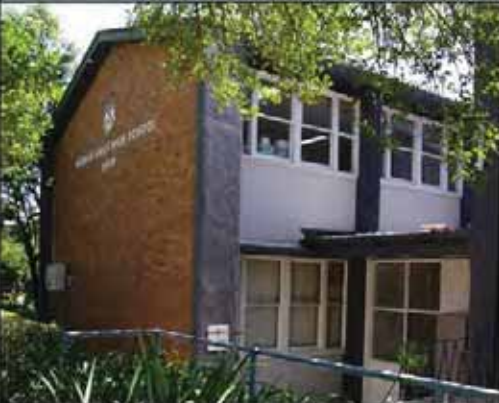
School signage is installed on the gable end, similar to Marsden HS. Note the entrance to the admin block has no awning (right). (Source: Purcell)

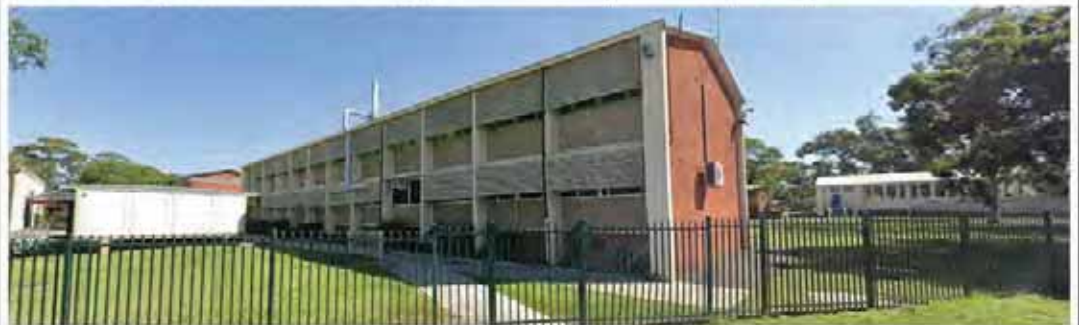
The roof material was unable to be ascertained from Google Street View, although the green colour of the roof on plan view is suggestive of its replacement with a coloured, profiled sheet metal roof. (Source: Google Street View October 2020)

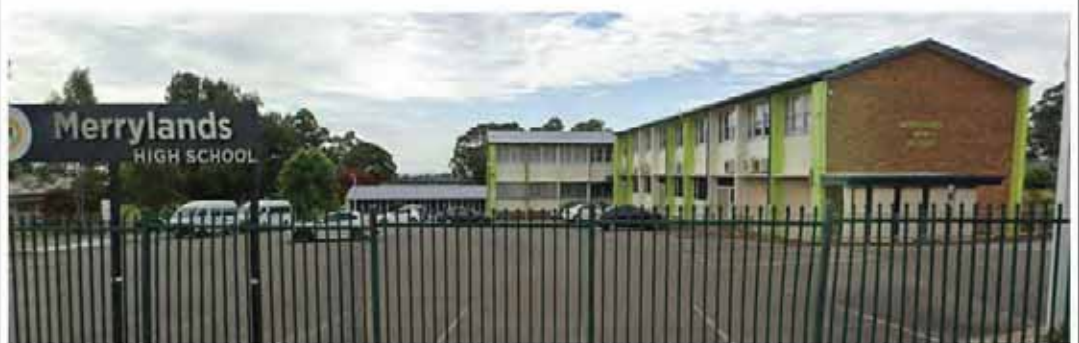
The roof has been replaced with profiled metal sheeting since 2018. (Source: Google Street View, October 2020)

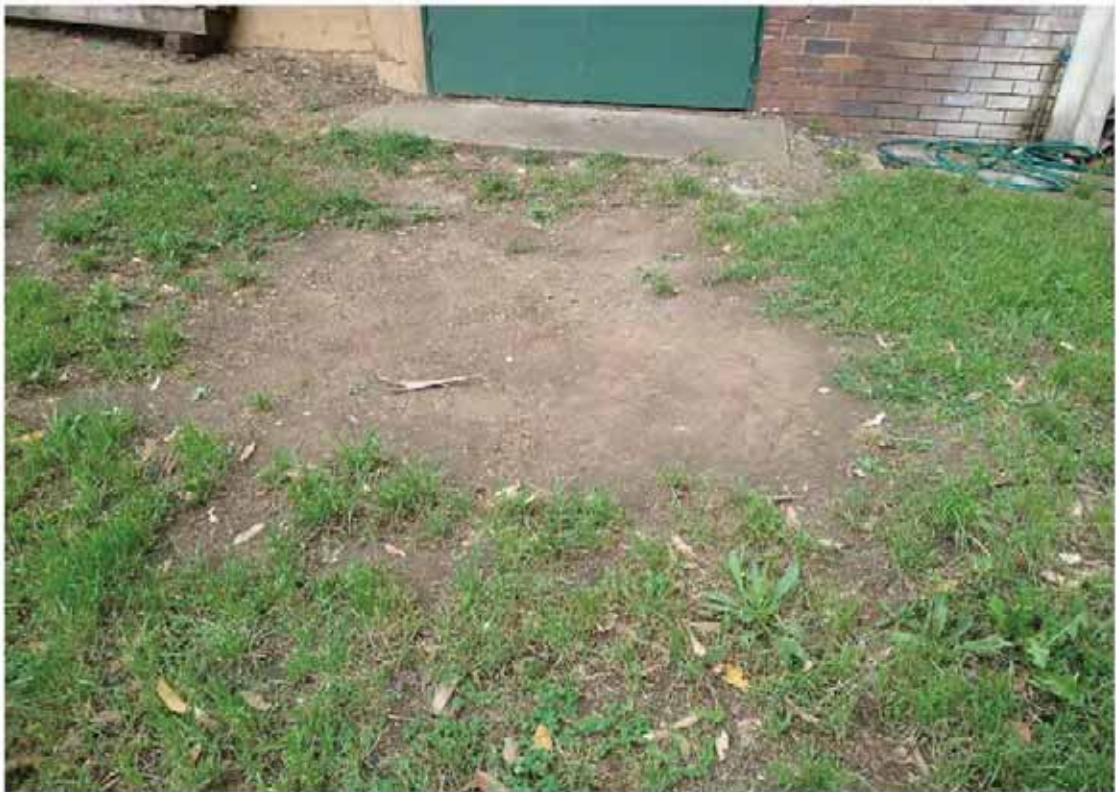
Photo 8: Bare patch of exposed fill soils similarly observed across the site

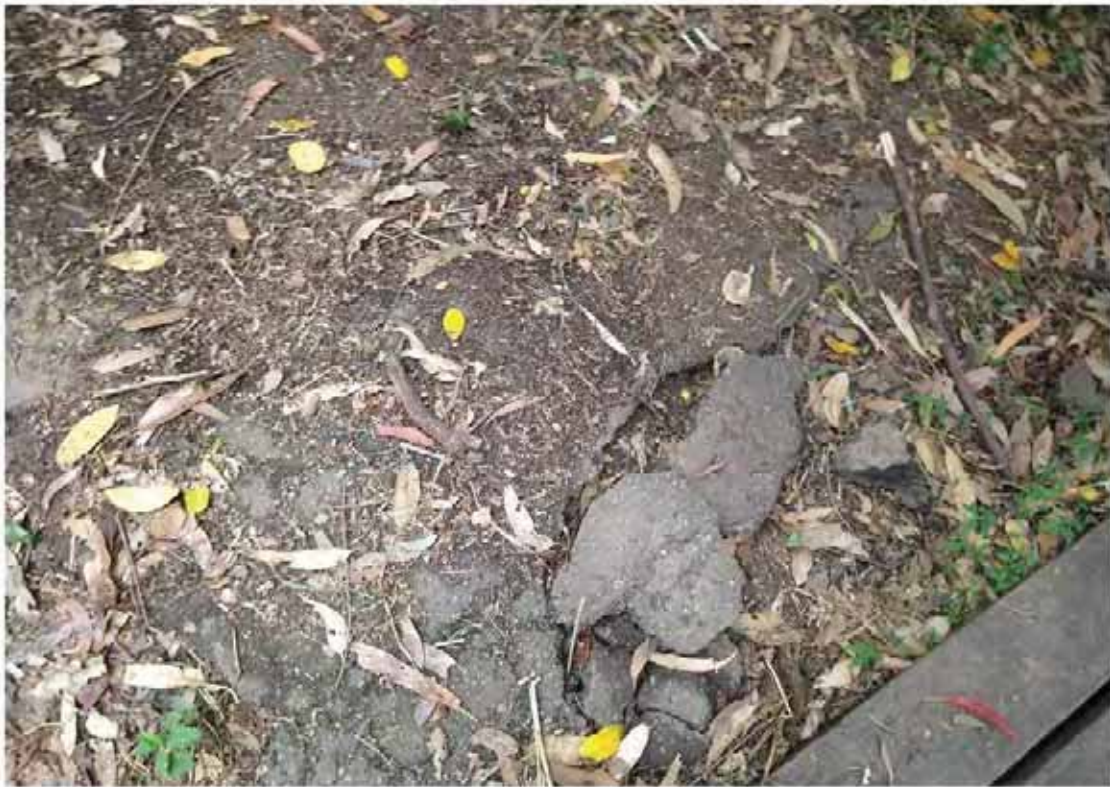
Photo 12: - Aged asphalt observed around footpath that bisects the bushland

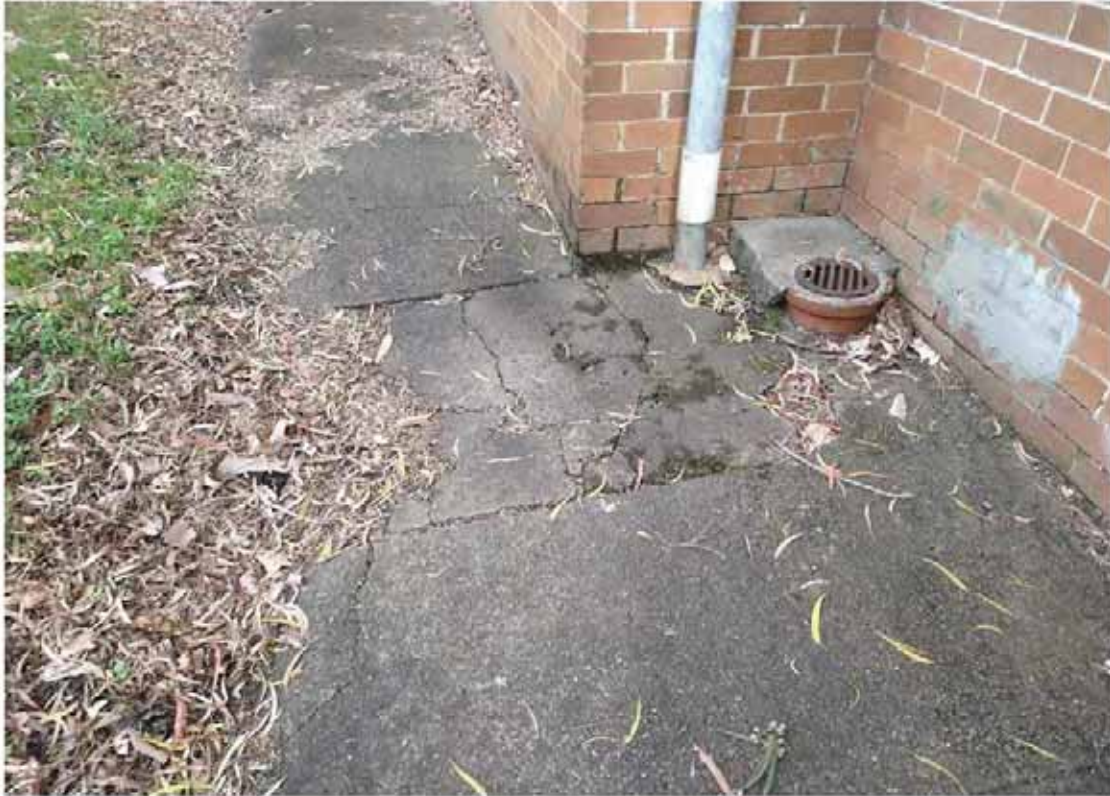
Photo 17: - Cracked concrete pavement similarly observed across the site

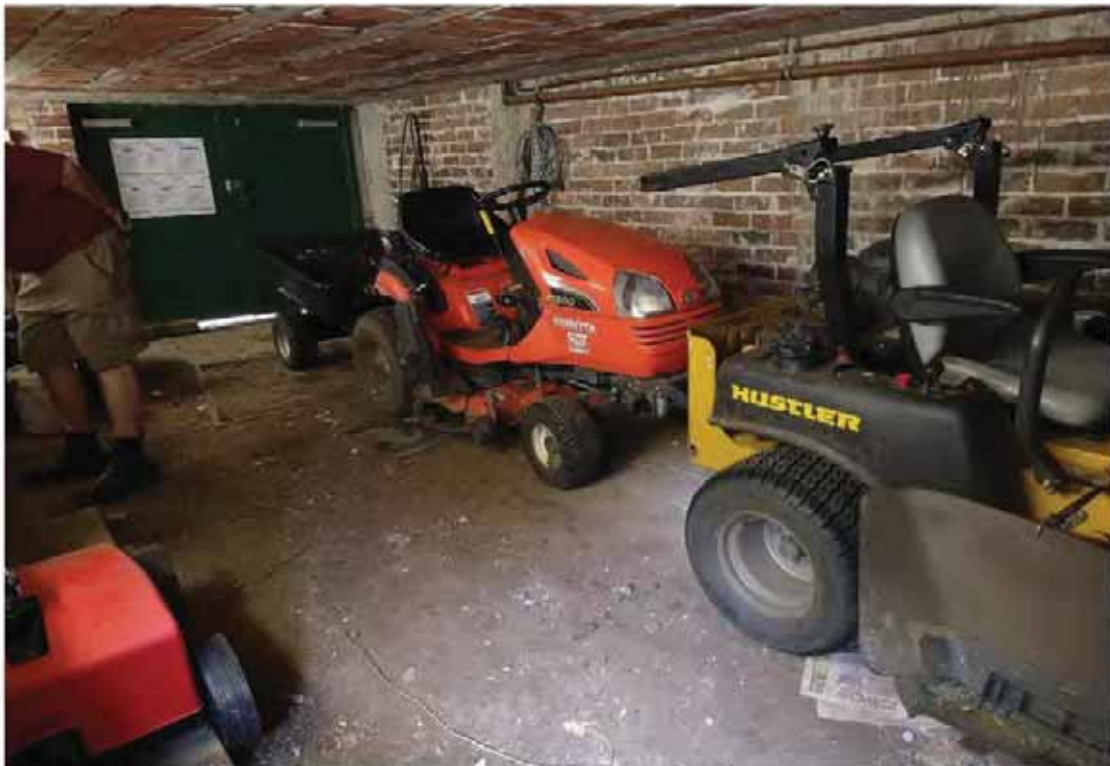
Photo 18: - Loosely sealed pavement within groundskeeping storage alcove with lawnmowers

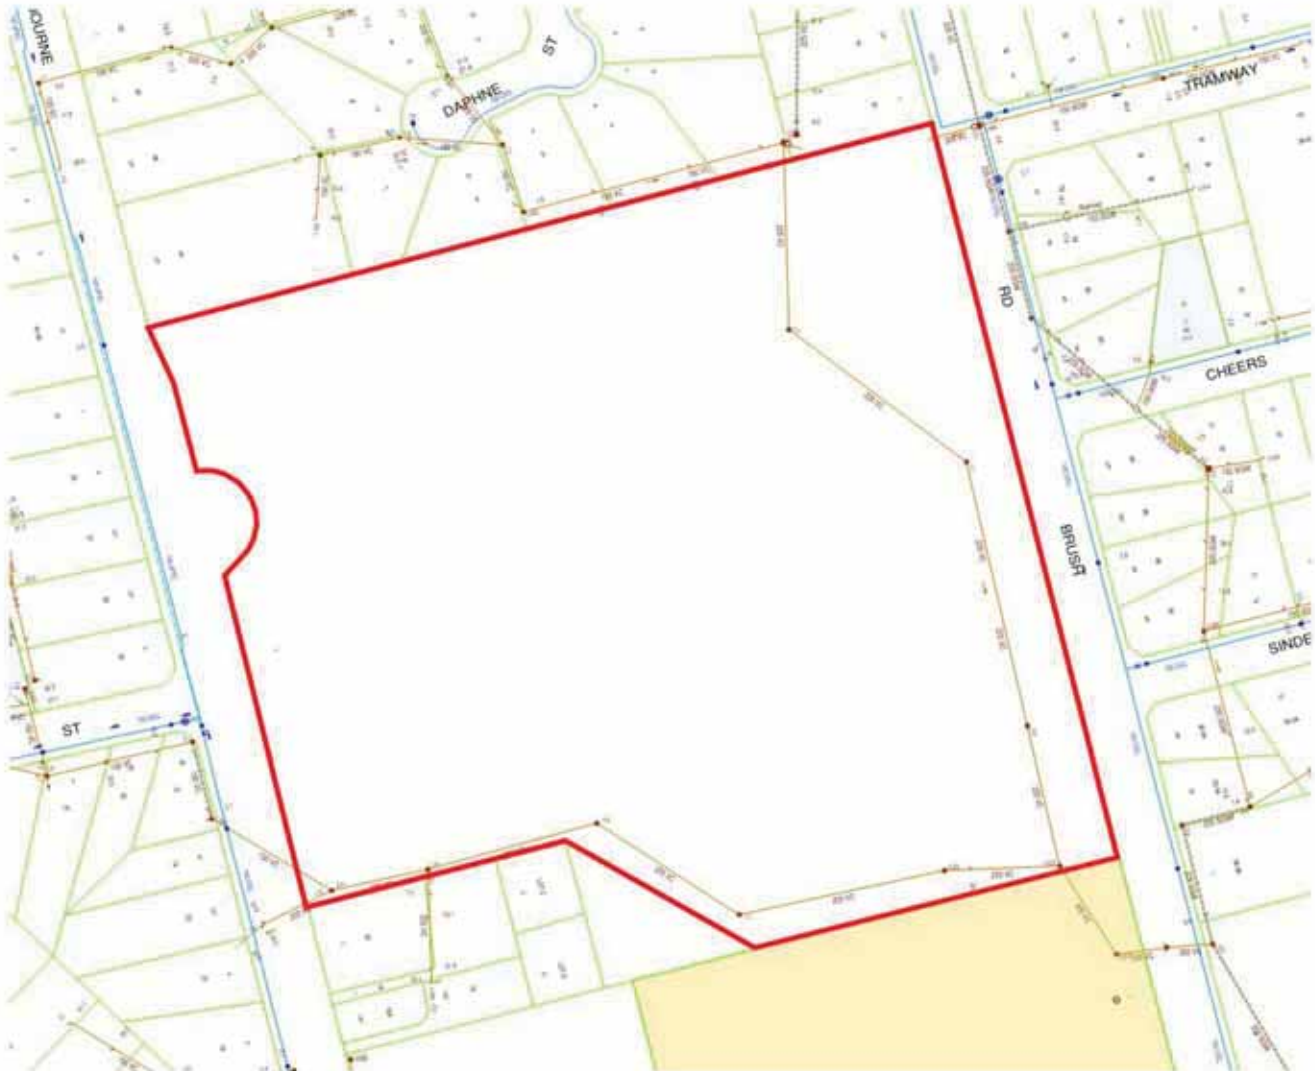
Figure 5: Sydney Water Dial Before You Dig Plan Showing Sewer and Water Networks within vicinity of redevelopment site

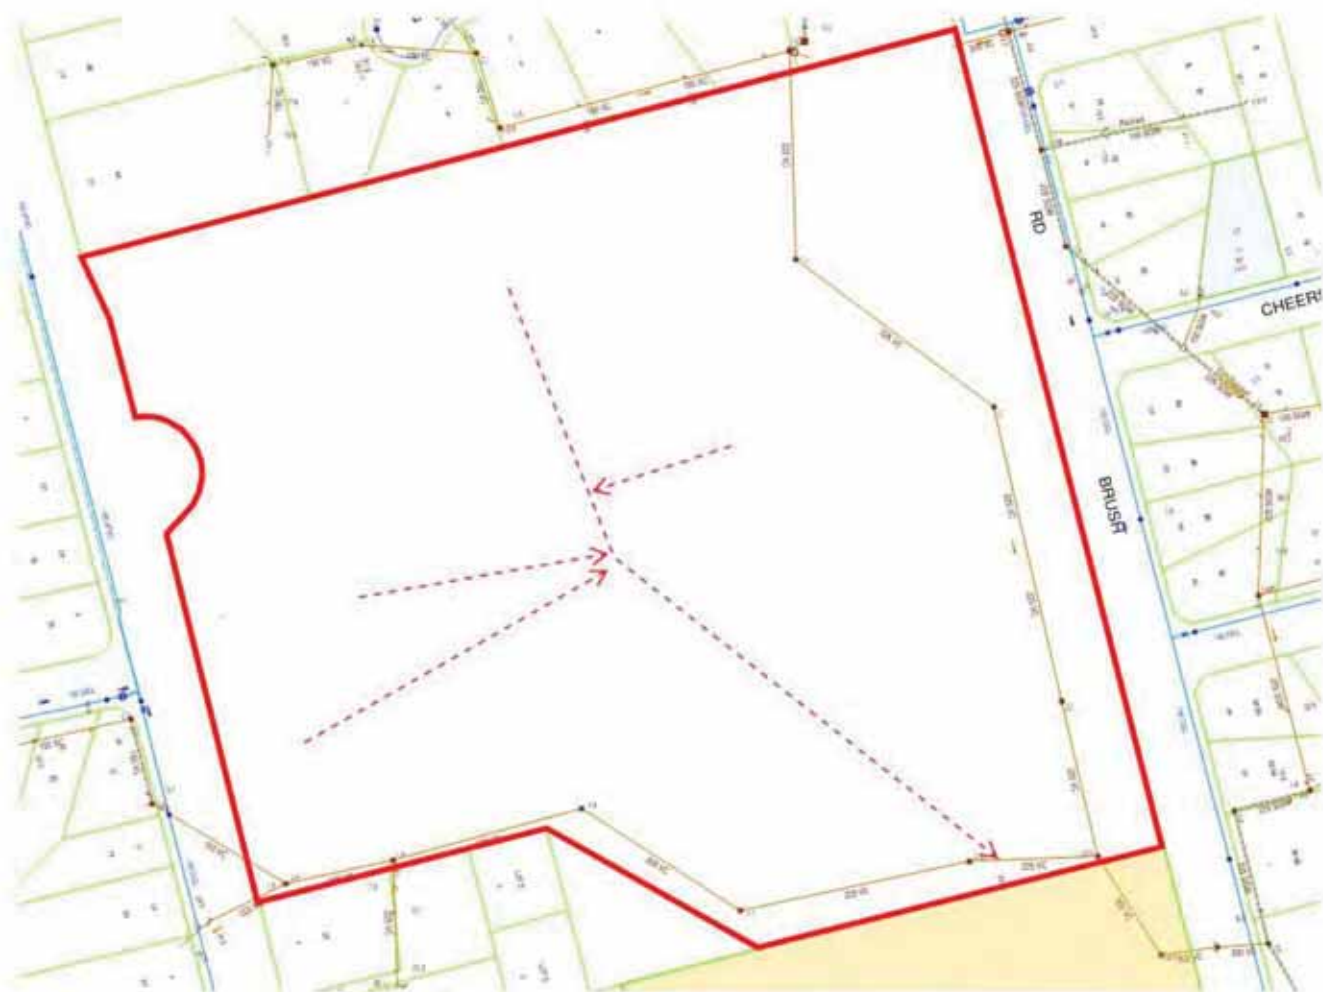
- The Site is encumbered by the following assets:
 - Eastern boundary – 225mm VC sewer main falling towards the south along the watercourse alignment
 - Southern Boundary – 225mm VC sewer main falling from west to east along the existing embankment.
- The South-Eastern corner of the site would be the proposed position of connection.

Figure 8: Sydney Water Sewer map extract
