Preliminary Geotechnical Assessment: 63 – 71 Waterloo Road, Macquarie Park, NSW

P1806577JR02V03
April 2020

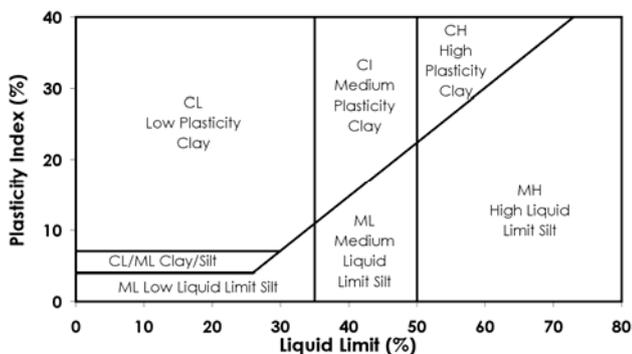
Plasticity Properties

Plasticity properties of cohesive soils can be assessed in the field by tactile properties or by laboratory procedures.
