City of Ryde

Water Quality Monitoring Report Autumn 2022

Report Name: City of Ryde Water Quality Monitoring Report

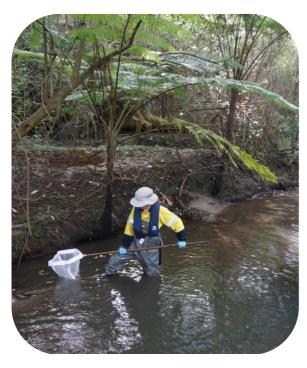
Figure 2 Collecting macroinvertebrates from Buffalo Creek (Autumn 2019)

They are collected from the core sites following a standard method detailed in previous reports. This involves using a fine mesh net to upwell the water and dislodge the animals.

They are picked from the debris and preserved for lab-based identification and enumeration.

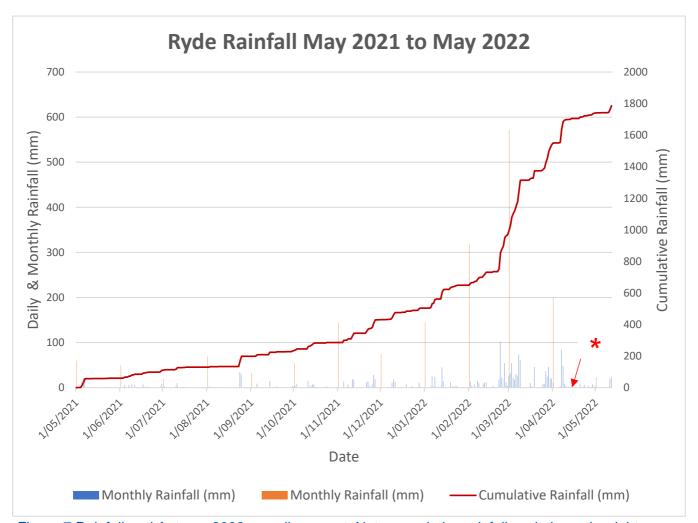
Figure 7 Rainfall and Autumn 2022 sampling event. Note cumulative rainfall scale is on the right.

March 2022 had the highest cumulative monthly rainfall of 572 mm.

Macroinvertebrate collection and physicochemical water quality testing were conducted on the 13th of April 2022. The cumulative rainfall during the month of April was 199 mm. Rainfall during this month was highly variable with a range between 0 – 84 mm for the duration of the month.

Daily, monthly, and cumulative rainfall for the sampling period is summarised in Figure 7.

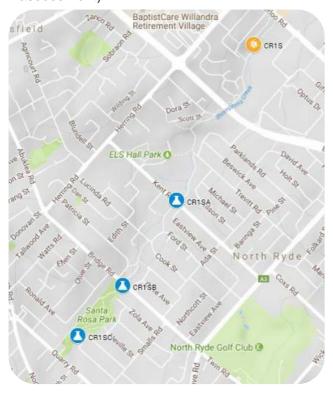
Figure 8 Shrimpton Creek Catchment Area

The Shrimptons Creek catchment contains three water quality sites and one core site (macroinvertebrate, water quality and riparian assessment).

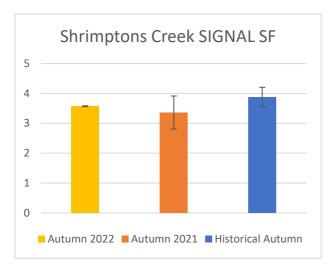
Figure 14 SIGNAL SF results for Shrimptons Creek

The average SIGNAL score for Autumn 2022 (3.6, Figure 14) was slightly higher than that of the previous season (3.4, Autumn 2021) and comparable to the historical average (3.9).

SIGNAL SF result for Autumn 2022 was slightly higher than Autumn 2021 and was consistent with the historical average

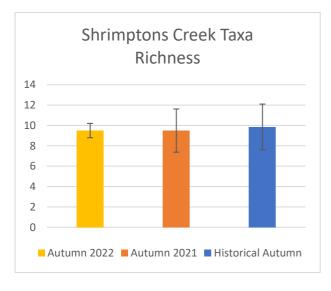
Figure 15 Taxa Richness results for Shrimptons Creek

The taxa richness result for Autumn 2022 was the same as that for Autumn 2021 (9.5, Figure 15). Both were only slightly lower than the historical average for this site (9.9). Shrimptons Creek core site was dominated by Aquatic snails. Other prominent macroinvertebrate families included Dragonflies, Aquatic Annelids and Flatworms.

Taxa Richness results were consistent between recent seasons and when compared to historical data

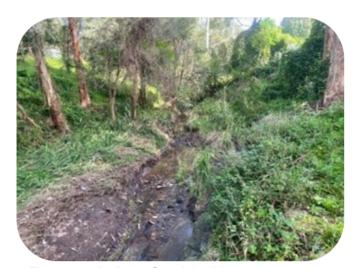
Figure 18 Archers Creek looking upstream

This site is located in Maze Park, West Ryde and is upstream of the Victoria Rd crossing (Figure 17). The upstream surrounding land use is residential and a golf course is present downstream. The bank was relined in the past with sandstone blocks. The creek bed is mostly bedrock with banks of sediment (sand, silt and organic matter, Figure 18). The vegetation within and around the creek is a mix of native and introduced species.

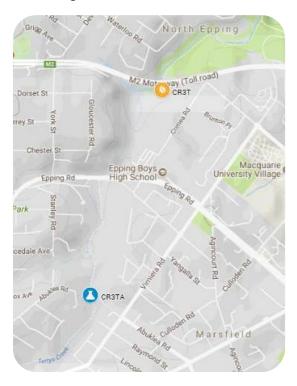
Figure 21 Terrys Creek Catchment Area

This site is located within Somerset Park under the M2 overpass in the suburb of Epping (Figure 21). The surrounding land use is residential, and the creek flows through a bushland corridor. The surrounding riparian area and bank edge is a mix of native and exotic plant species. The creek bed is predominately bedrock, gravel, and sand.

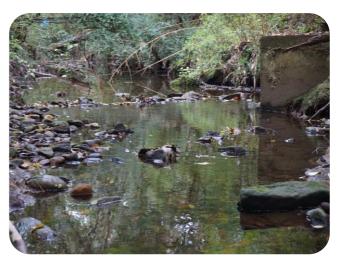
Figure 24 Terrys Creek at Foresters Park facing upstream

This site is located downstream of Terrys Creek Waterfall, which is an area surrounded by bushland. Dense vegetation covers both banks and consists of a mixture of native and introduced species. The bank is comprised of sediment (mostly sand and silt) and river rocks, which create areas of broken water.

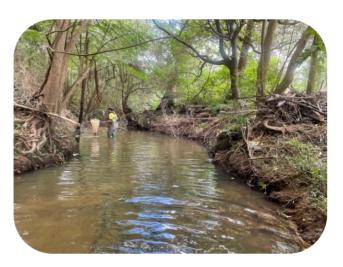
Figure 28 Buffalo Creek core site looking downstream

The Buffalo Creek core sampling site is in a bush corridor in the suburb of Gladesville and is accessed through private property. The surrounding land use is a mix of residential, light industry/commercial and reserves. The surrounding vegetation is a mix of native and exotic species, with exotic species dominating. The southern bank is mostly residential lawns.

The creek bed has a mix of sand, silt and gravel. There is usually some macrophyte growth, *Egeria* and *Potamogeton*, and little algal growth has been observed. Sedimentation has occurred periodically, along with a significant amount of organic debris and domestic rubbish

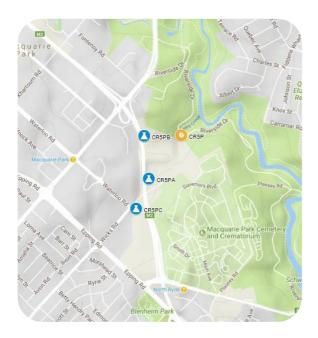
Figure 34 Porters Creek Catchment Area

There is one core site and three water quality only sites within the Porters Creek Catchment.
