City of Ryde

# Water Quality Monitoring Report

Spring 2018- Autumn 2019

Report Name: City of Ryde Water Quality Monitoring Report  
Spring 2018 & Autumn 2019

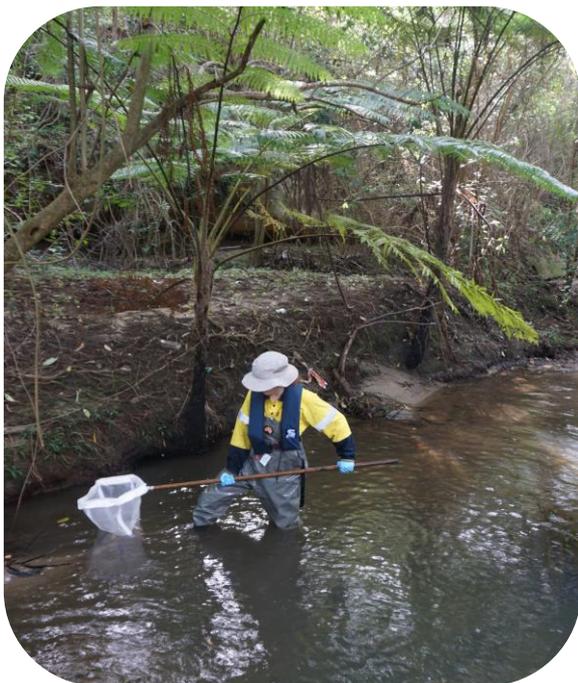
Figure 2 Collecting macroinvertebrates from Buffalo Creek (Autumn 2019)

They are collected from the core sites following a standard method detailed in previous reports. This involves using a fine mesh net to upwell the water and dislodge the animals. They are picked from the debris and preserved for lab based identification and enumeration.

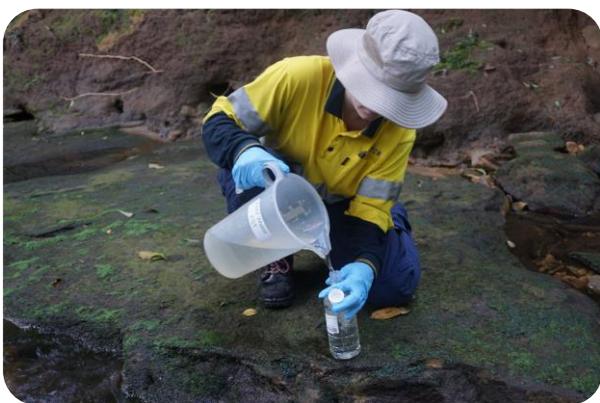
Figure 6 Collecting water samples for analysis

Water quality samples were collected at the same time as the macroinvertebrates to ensure the data was accurate for comparison. These are the *dry weather* sampling events and occur when <10mm of rainfall has fallen in the catchments.

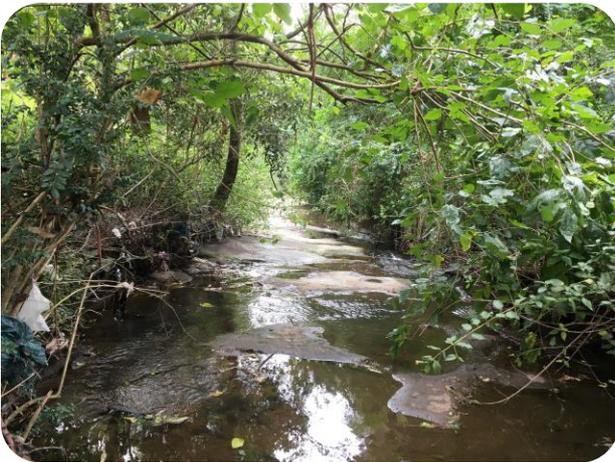
Figure 8 Shrimptons Creek core site, high level of riparian vegetation

The riparian zone is the area where a body of water or stream, meets the land. The Rapid Riparian Assessment provides information on and assessment of the features of the stream and the vegetation community surrounding the stream.

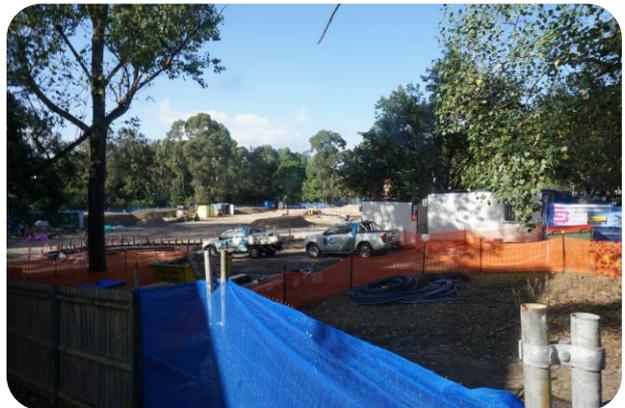
Figure 11 Council works on Wilga Park, uphill of Shrimptons Creek core site

During autumn 2019, there was a large degree of development on both banks of the creek. This includes the Wilga Park upgrade.

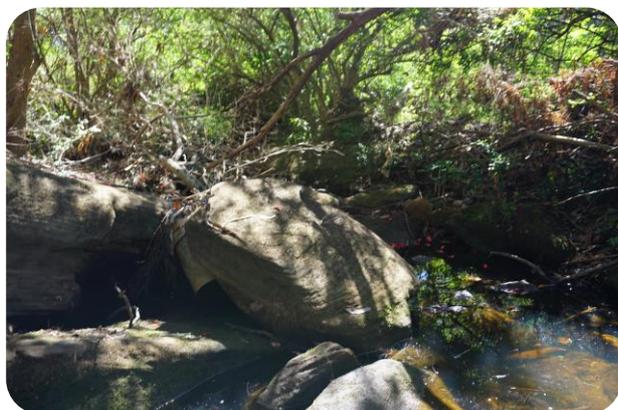
Figure 13 Shrimptons Creek @ Kent Road facing downstream

There is a gross pollutant trap located within the site which was cleaned out regularly in the last 12 months. In Spring 2017 & Autumn 2018 there was moderate to high rubbish observed at the site. In Autumn 2018 a slight odour and low flow were observed during sampling.

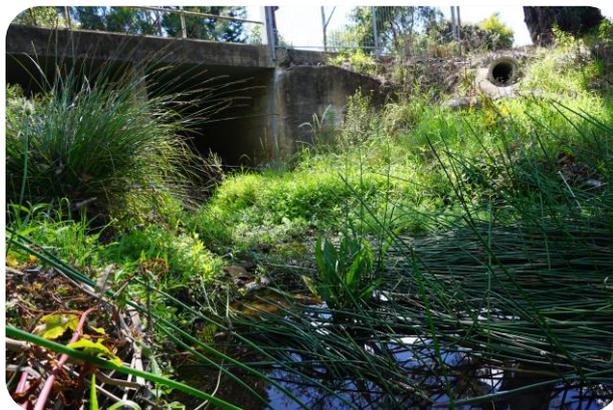
Figure 14 Shrimptons Creek @ Bridge Street facing downstream

This site is located at the downstream section of Burrows Park, just before it flows under Bridge St and is surrounded by residential areas. The revegetation of the riparian area is now established adding to bank stabilisation, physical buffer and filtration. Low flow, low rubbish and high density of aquatic plants were observed in Autumn 2018.

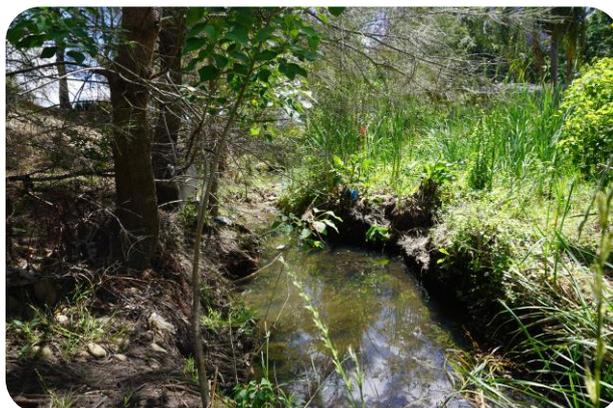
Figure 15 Shrimptons Creek @ Quarry Road facing downstream

Odour, oil and scum was observed on the water surface in Spring 2017, Autumn 2018 and historically.

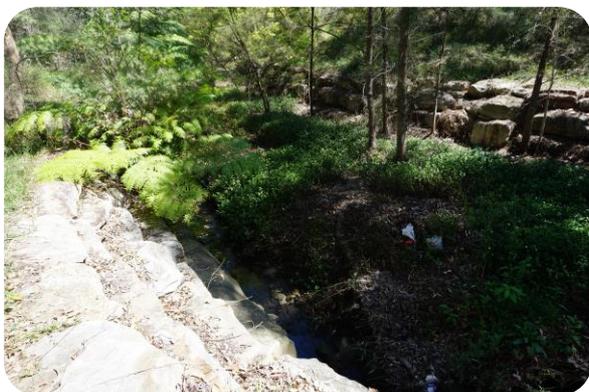
Figure 20 Archers Creek Core Site facing downstream

This site is located in Maze Park, West Ryde and is upstream of the Victoria Rd crossing. The upstream surrounding land use is residential and a golf course is present downstream. The bank was relined in the past with sandstone blocks. The creek bed is mostly bedrock with banks of sediment (sand, silt and organic matter). The vegetation within and around the creek is a mix of native and introduced species.

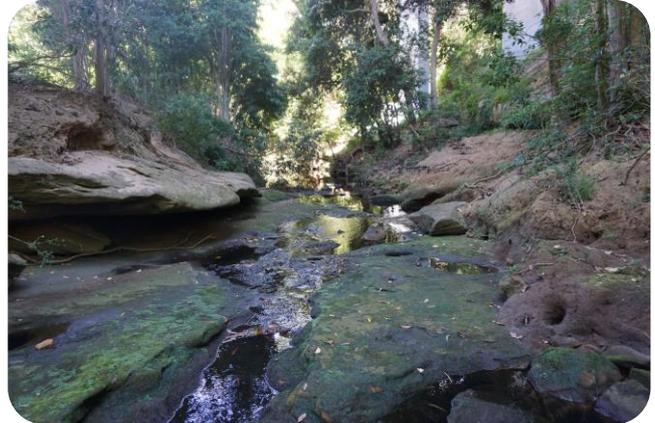
Figure 24 Terrys Creek Core Site facing downstream

This site is located within Somerset Park under the M2 overpass in the suburb of Epping. The surrounding land use is residential, and the creek flows through a bushland corridor. The surrounding riparian area and bank edge is a mix of native and exotic plant species. The creek bed is predominately bedrock, gravel and sand.

There were no observations that differed from standard conditions for this site in 2017/18.

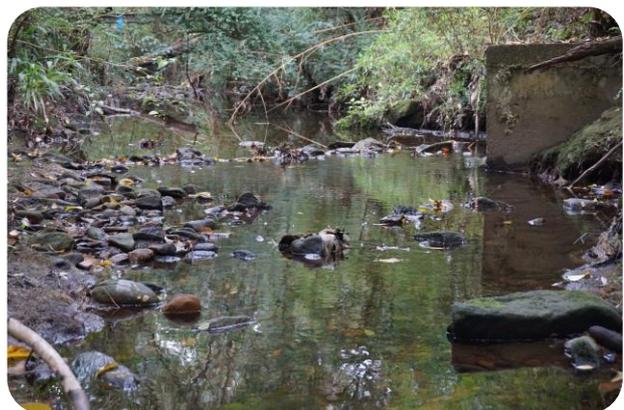
Figure 23 Terrys Creek @ Foresters Park facing upstream

This site is located downstream of Terrys Creek Waterfall, which is an area surrounded by bushland. Dense vegetation covers both banks and consists of a mixture of native and introduced species. The bank is comprised of sediment (mostly sand and silt) and river rocks, which create areas of broken water.

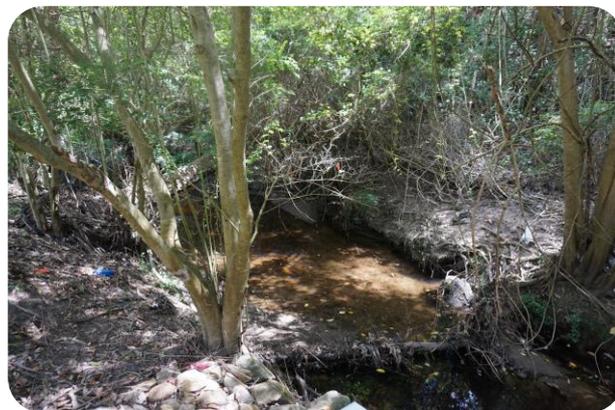
Figure 28 Buffalo Creek Core Site facing upstream

The creek bed has a mix of sand, silt and gravel. There is usually some macrophyte growth, *Egeria* and *Potamogeton*, and little algal growth has been observed.

Sedimentation has occurred periodically, along with a significant amount of organic debris and domestic rubbish

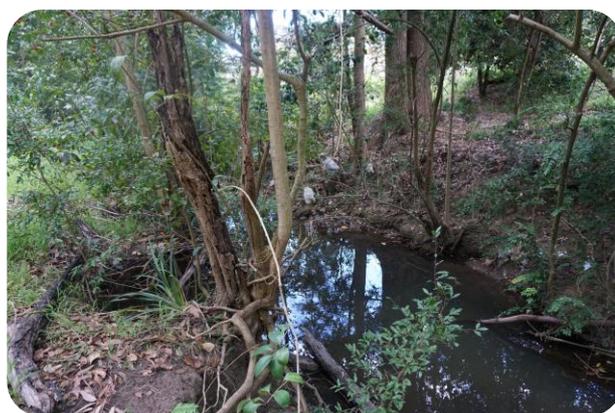
Figure 29 Buffalo Creek Downstream of Burrows Park facing upstream

The downstream Burrows Park site is accessed off Buffalo Rd and is positioned just before the creek flows under the road. The surrounding land use is residential and Burrows Park consists mostly of a bush corridor. There are usually obvious signs of bird activity around this site, including extensive bird droppings.

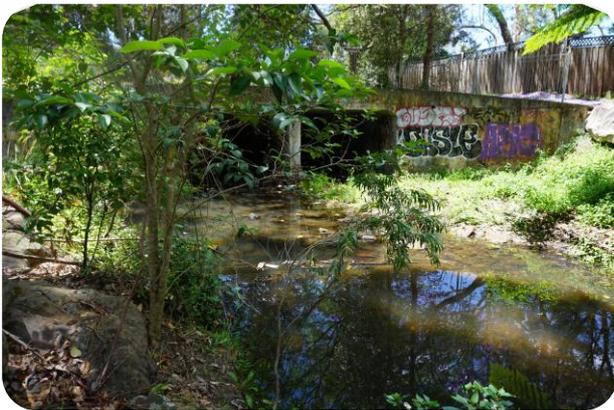
Figure 30 Buffalo Creek Upstream of Burrows Park facing upstream

The upstream Burrows Park site is about 300 metres upstream of Buffalo Rd, and lies in the middle of a bush corridor. The site is surrounded by vegetation that completely shades the creek. The creek is shallow at this point and has little flow. The site is positioned just downstream from a stormwater tributary/pipe. There has been little observable physical change at this site throughout the survey periods.

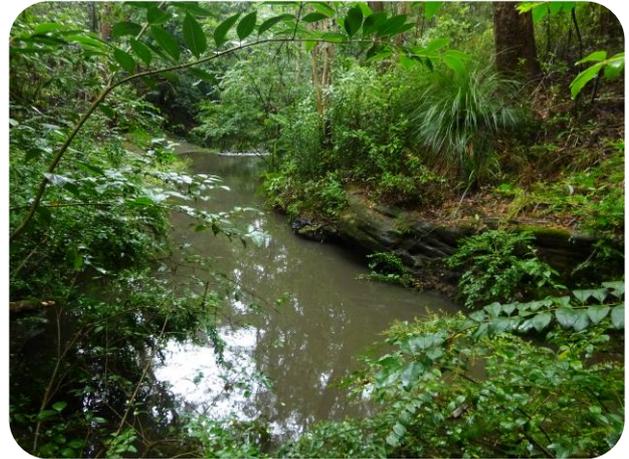
Figure 34 Porters Creek Core Site facing downstream

some cobble, boulder and sand. No macrophyte growth has been observed at the site however there has been varying levels of algal growth present.

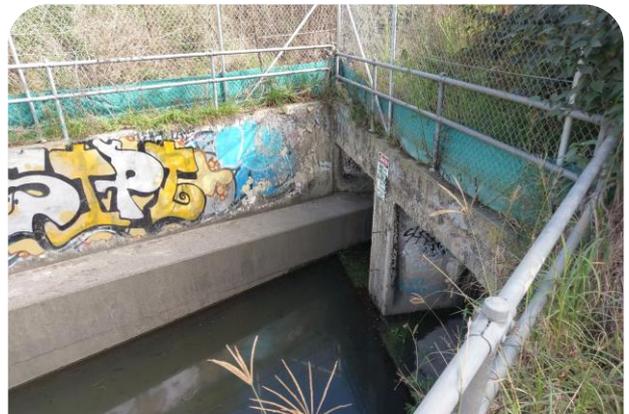
Figure 35 Porters Creek @ Main Branch facing downstream

This site is located on the western boundary of the centre and consists of an open concrete channel. Samples are collected from the retention basin at the end of the channel. Extensive algal growth and scum was observed on the surface in both Spring 2017 and Autumn 2018. This is consistent with historical observations. Access prevented sampling in the past. This was resolved in Spring 2017.

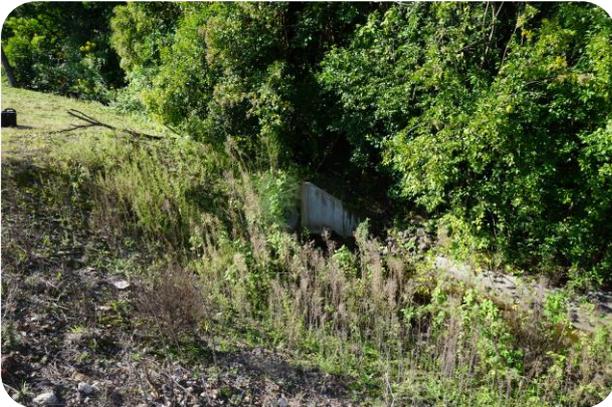
Figure 36 Porters Creek @ Spur Branch

This site is in the north-western corner of the centre in an underground drainage pit where several underground stormwater lines meet before joining and draining to the main Porters Creek line. The exact location has changed over the years due to access issues. Algae was present in Spring 2017 and less algae in Autumn 2018.

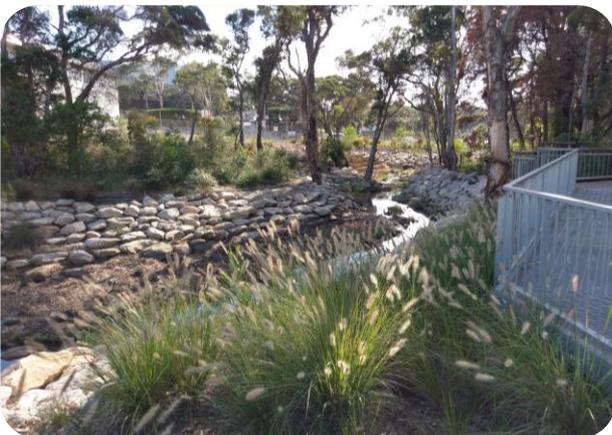
Figure 37 Porters Creek @ Wicks Road facing downstream

This site is the first point that Porters Creek drains from the underground stormwater system. The site is surrounded by commercial and industrial land uses. The banks have been re-lined with sandstone and surrounding area vegetated with native plants.
