City of Ryde

Water Quality Monitoring Report

Spring 2017- Autumn 2018

Report Name: City of Ryde Water Quality Monitoring Report
Spring 2017 & Autumn 2018

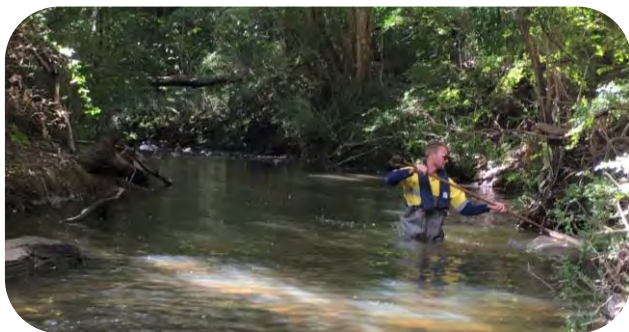
Figure 2 Collecting macroinvertebrates from Terrys Creek

They are collected from the core sites following a standard method detailed in previous reports. This involves using a fine mesh net to upwell the water and dislodge the animals. They are picked from the debris and preserved for lab based identification and enumeration.

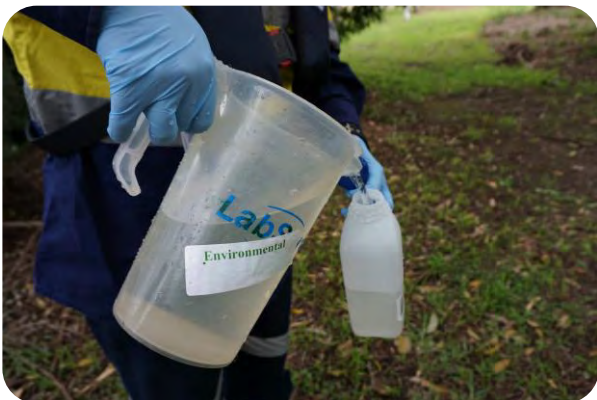
Figure 5 Collecting water samples for analysis

Water quality samples are collected at all 15 sites. Several analyses are conducted in the field and additional water is collected for lab analysis. The lab analysis is performed at the Sydney Water Laboratory located in West Ryde.

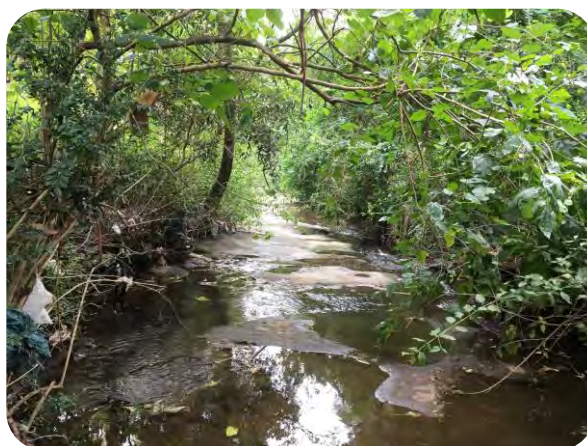
Figure 6 Shrimptons Creek core site surrounded by riparian vegetation

The riparian zone is the area where a body of water or stream, meets the land. The Rapid Riparian Assessment provides information on and assessment of the features of the stream and the vegetation community surrounding the stream.

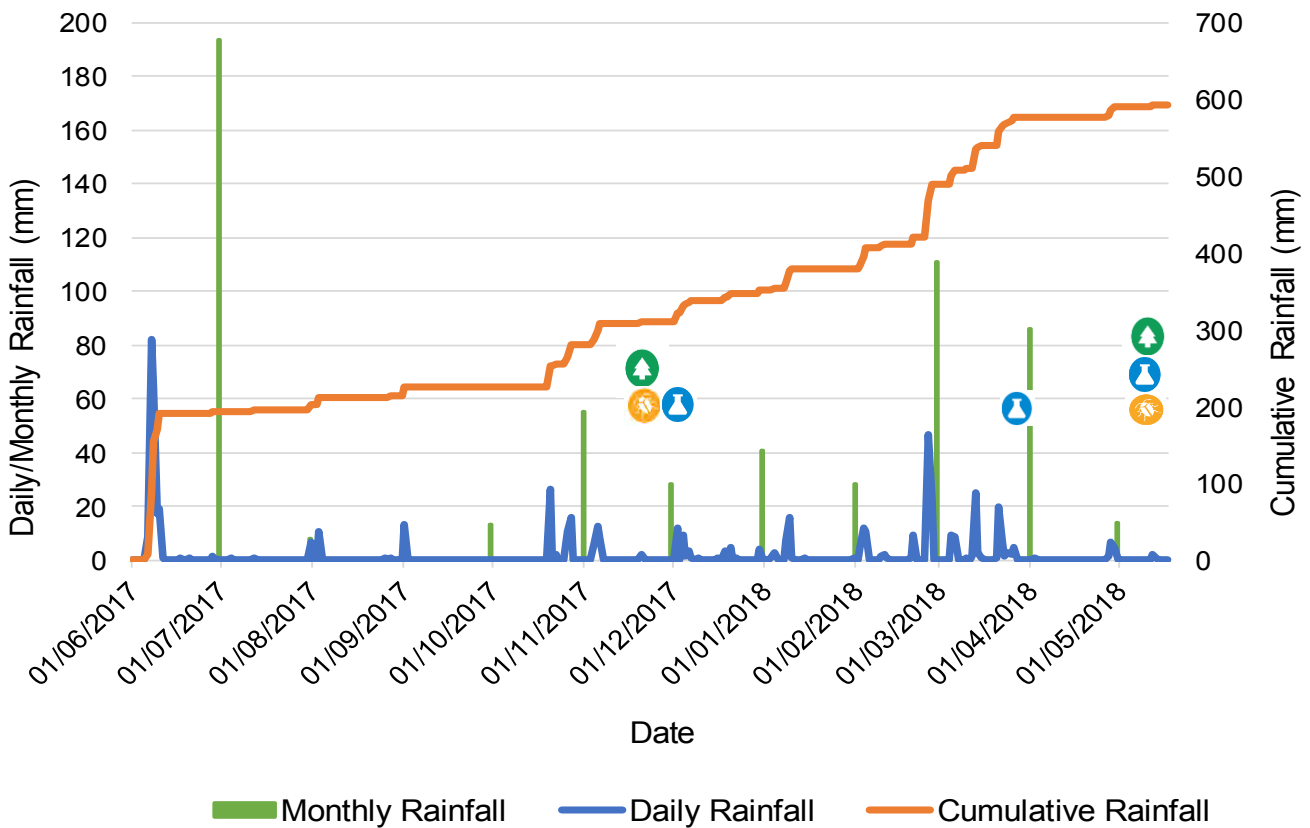
Figure 8 Rainfall and sampling events for Spring 2017 and Autumn 2018. Note cumulative rainfall scale is on the right.

Autumn sampling 2018 occurred on May 10th, which included macroinvertebrate, Rapid Riparian Assessments and water quality sampling. There was very low rainfall leading up to this sampling event.

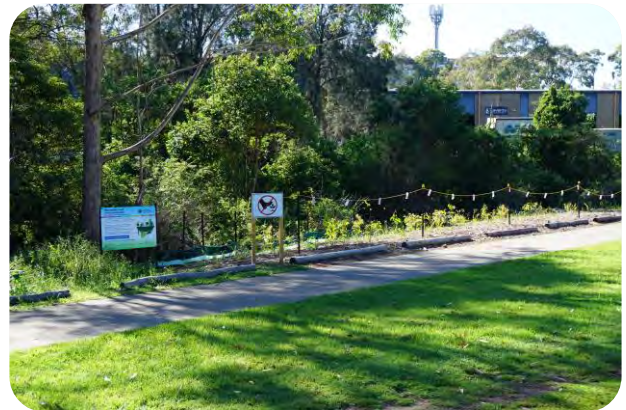
The creek flows through a thin riparian corridor, which is a mix of native and exotic species. The creek bed is predominately bedrock and sand/silt.

Figure 10 Revegetation and bank works

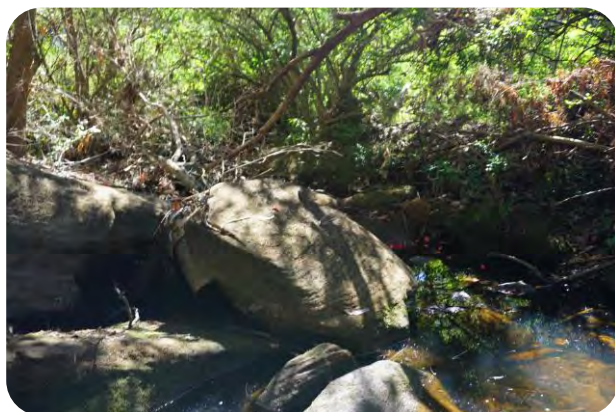
Figure 12 Shrimptons Creek @ Kent Road facing downstream

There is a gross pollutant trap located within the site which was cleaned out regularly in the last 12 months. In Spring 2017 & Autumn 2018 there was moderate to high rubbish observed at the site. In Autumn 2018 a slight odour and low flow were observed during sampling.

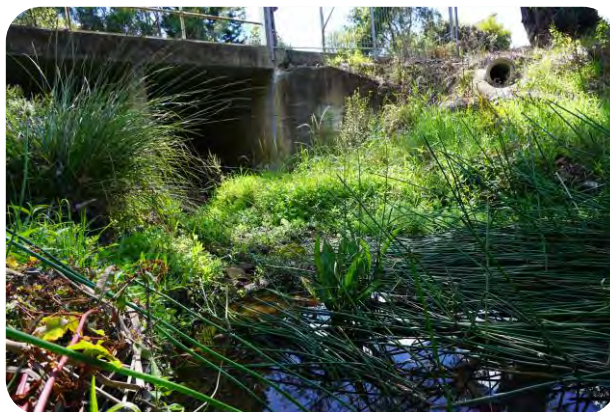
Figure 13 Shrimptons Creek @ Bridge Street facing downstream

This site is located at the downstream section of Burrows Park, just before it flows under Bridge St and is surrounded by residential areas. The revegetation of the riparian area is now established adding to bank stabilisation, physical buffer and filtration. Low flow, low rubbish and high density of aquatic plants were observed in Autumn 2018.

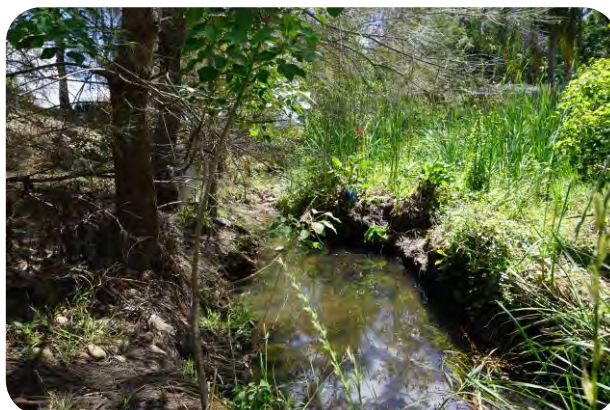
Figure 14 Shrimptons Creek @ Quarry Road facing downstream

Odour, oil and scum was observed on the water surface in Spring 2017, Autumn 2018 and historically.

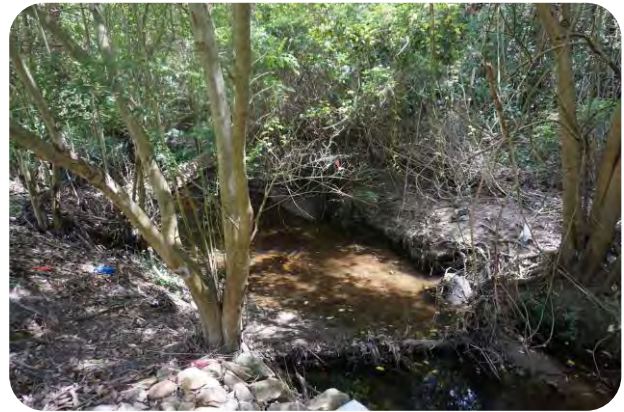
Figure 27 Buffalo Creek Core Site facing upstream

The creek bed has a mix of sand, silt and gravel. There is usually some macrophyte growth, *Egeria* and *Potamogeton*, and little algal growth has been observed.

Sedimentation has occurred periodically, along with a significant amount of organic debris and domestic rubbish

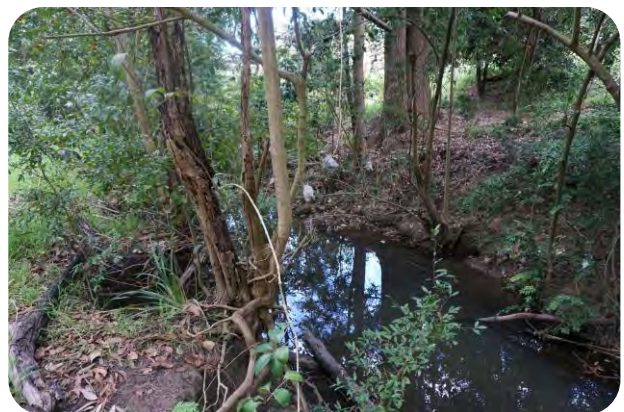
Figure 28 Buffalo Creek Downstream of Burrows Park Facing upstream

The downstream Burrows Park site is accessed off Buffalo Rd and is positioned just before the creek flows under the road. The surrounding land use is residential and Burrows Park consists mostly of a bush corridor. There are usually obvious signs of bird activity around this site, including extensive bird droppings.

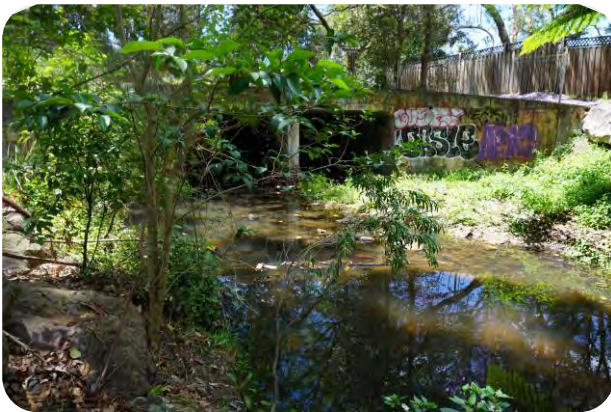
Figure 29 Buffalo Creek Upstream of Burrows Park facing upstream

The upstream Burrows Park site is about 300 metres upstream of Buffalo Rd, and lies in the middle of a bush corridor. The site is surrounded by vegetation that completely shades the creek. The creek is shallow at this point and has little flow. The site is positioned just downstream from a stormwater tributary/pipe. There has been little observable change at this site throughout the survey periods.

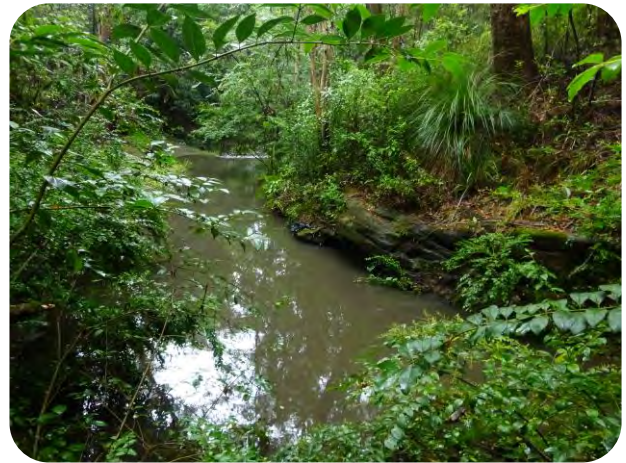
Figure 33 Porters Creek Core Site facing downstream

some cobble, boulder and sand. No macrophyte growth has been observed at the site however there has been varying levels of algal growth present.

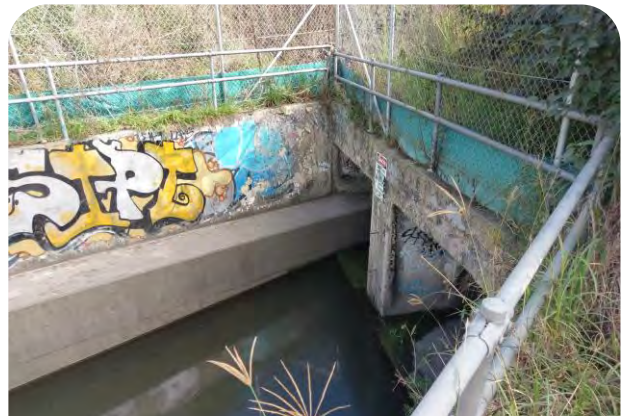
Figure 34 Porters Creek @ Main Branch facing downstream

This site is located on the western boundary of the centre and consists of an open concrete channel. Samples are collected from the retention basin at the end of the channel. Extensive algal growth and scum was observed on the surface in both Spring 2017 and Autumn 2018. This is consistent with historical observations. Access prevented sampling in the past. This was resolved in Spring 2017.

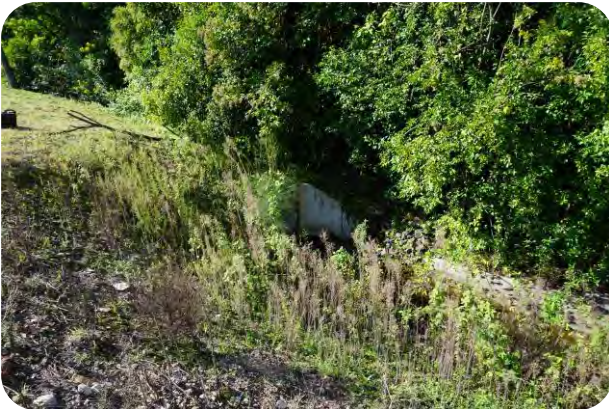
Figure 35 Porters Creek @ Spur Branch

This site is in the north-western corner of the centre in an underground drainage pit where several underground stormwater lines meet before joining and draining to the main Porters Creek line. The exact location has changed over the years due to access issues. Algae was present in Spring 2017 and less algae in Autumn 2018.

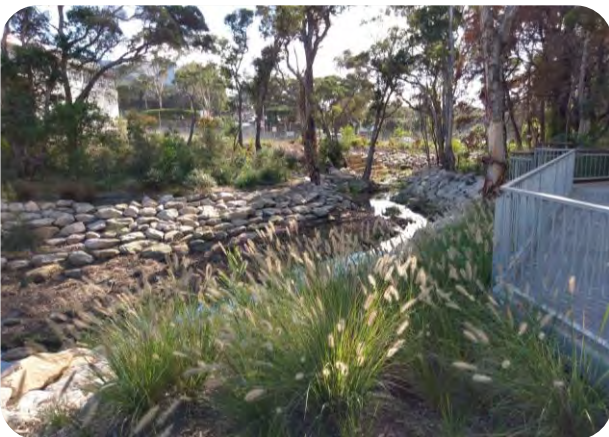
Figure 36 Porters Creek @ Wicks Road facing downstream

This site is the first point that Porters Creek drains from the underground stormwater system. The site is surrounded by commercial and industrial land uses. The banks have been re-lined with sandstone and surrounding area vegetated with native plants.
