City of Ryde

Water Quality Monitoring Report
Spring 2020 – Autumn 2021

Report Name: City of Ryde Water Quality Monitoring Report
Spring 2020 & Autumn 2021

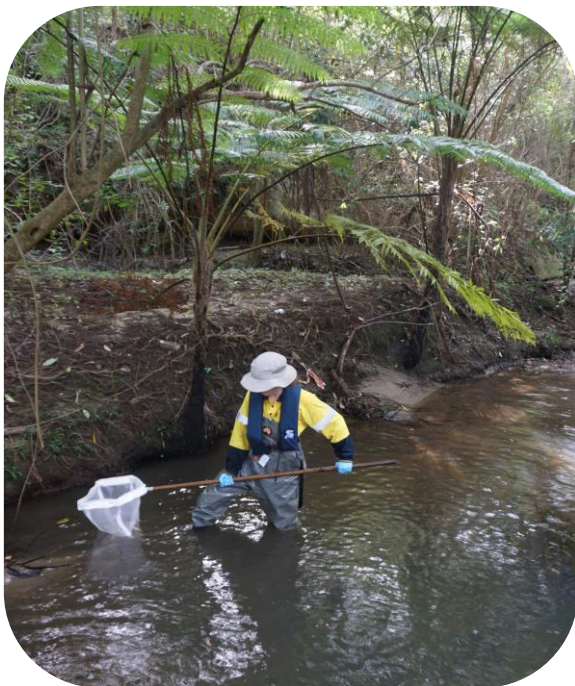
Figure 2 Collecting macroinvertebrates from Buffalo Creek (Autumn 2019)

They are collected from the core sites following a standard method detailed in previous reports. This involves using a fine mesh net to upwell the water and dislodge the animals. They are

picked from the debris and preserved for lab-based identification and enumeration.

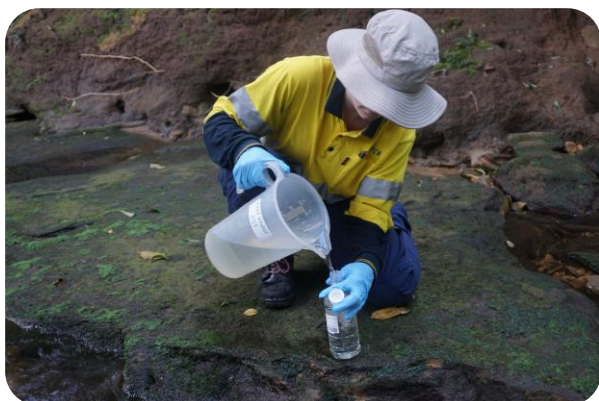
Figure 5 Collecting water samples for analysis

Water quality samples were collected at the same time as the macroinvertebrates to ensure the data was accurate for comparison.

Water quality samples are collected at all 14 sites. Several analyses are conducted in the field and additional water is collected for lab analysis. The lab analysis is performed at the Sydney Water Laboratory located in West Ryde.

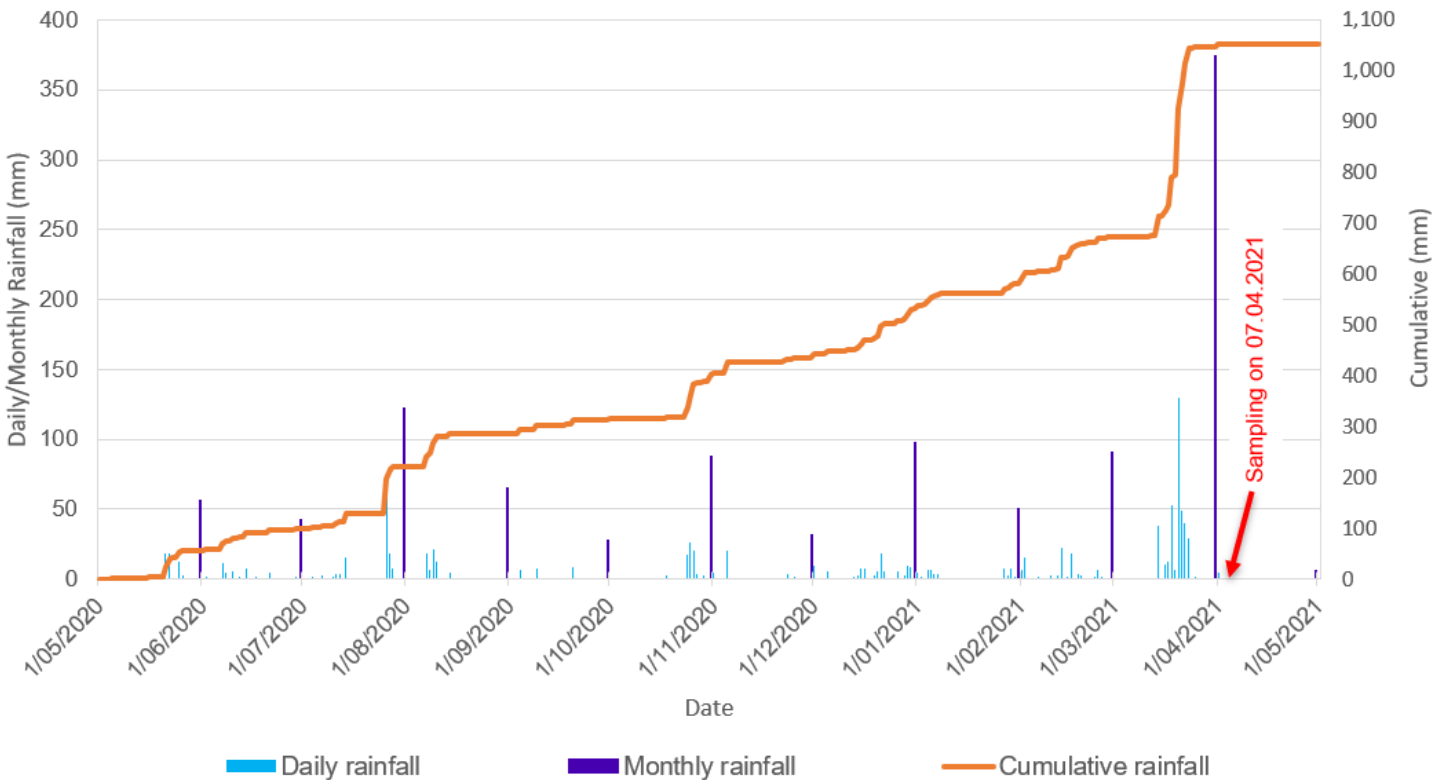
Figure 8 Rainfall and sampling events for Spring 2020 and Autumn 2021. Note cumulative rainfall scale is on the right.

In the weeks preceding the sampling period significant rainfall and severe weather impacted the Sydney region with localised flooding of the Parramatta River. The region of North Ryde experienced days of significant rain. On March 20th, 2021 a volume of 130 mm fell in the Ryde region. Daily, monthly, and cumulative rainfall for the sampling period is summarised in Figure 8.

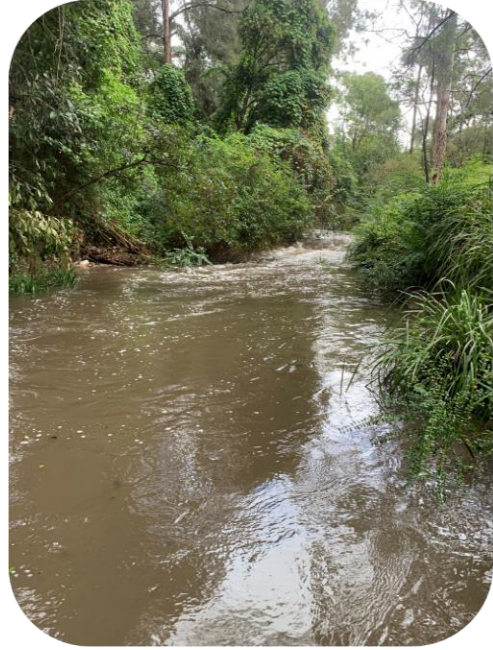
During Autumn 2021 sampling, the area was impacted by localised flooding which significantly impacted the volume and flow of water in the channel (Figures 10 and 11).

Figure 10 Flooding at Shrimptons Creek, view from upstream

Figure 11 Flooding at Shrimptons Creek, view from downstream

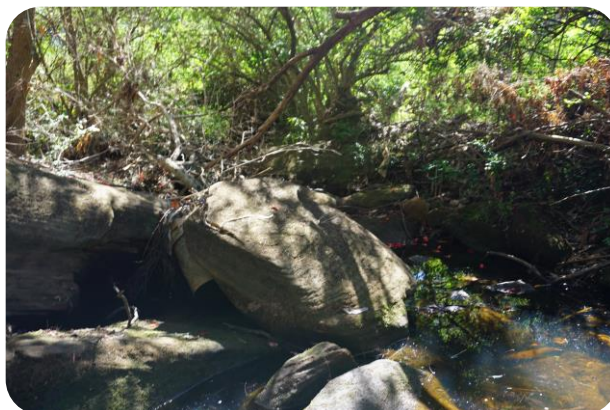
Figure 12 Shrimptons Creek at Kent Rd facing downstream

The Kent Road site is situated amongst a residential area and is lined by a thin section of riparian vegetation that completely shades the creek and comprises a mix of native and exotic species.

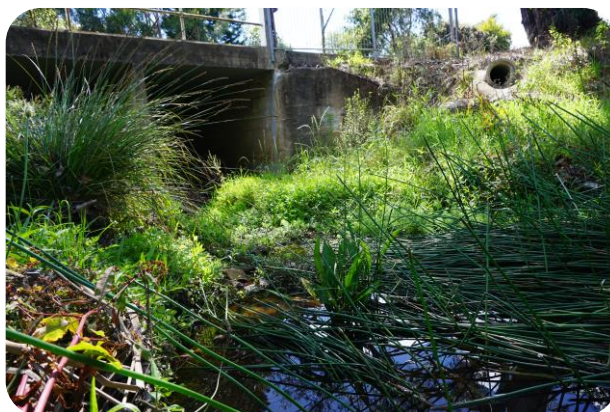
Figure 13 Shrimptons Creek at Bridge St facing downstream

This site is located at the downstream section of Burrows Park, just before it flows under Bridge St and is surrounded by residential areas. The revegetation of the riparian area is now established adding to bank stabilisation, physical buffer and filtration.

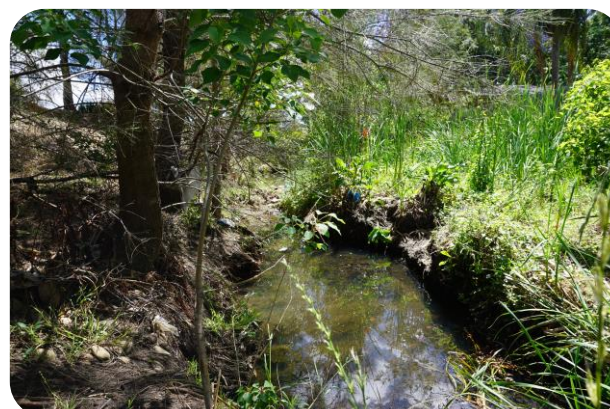
Figure 14 Shrimptons Creek at Quarry Rd facing downstream

The Quarry Road site is located at the upstream section of Burrows Park, at the point where Shrimptons Creek emerges from the underground stormwater system. This site has sandstone blocks around the drain for bank stabilisation.

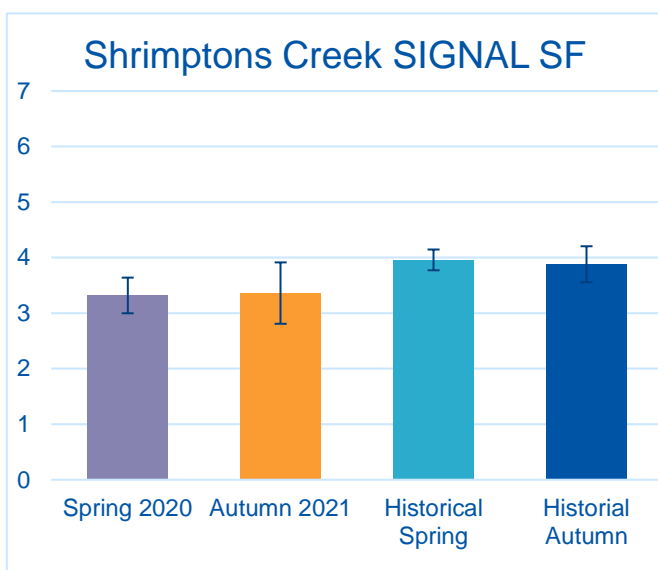
Figure 15 SIGNAL SF results for Shrimptons Creek

The SIGNAL SF results for Autumn 2021 were consistent with values recorded historically (Figure 15). However, the result for Spring 2020 was observed to be slightly lower than the historical average.

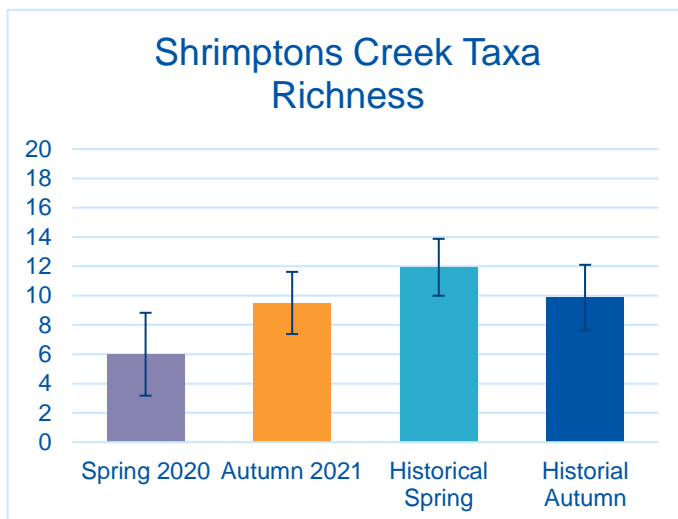
Figure 16 Taxa Richness results for Shrimptons Creek

The taxa richness result for Autumn 2021 was comparable to the historical average for the season (Figure 16). This contrasts with the observations for Spring sampling where Taxa Richness for Spring 2020 was lower than the historical average. This result was consistent with the previous sampling period (Spring 2018) which was also lower than the historical average for this season.

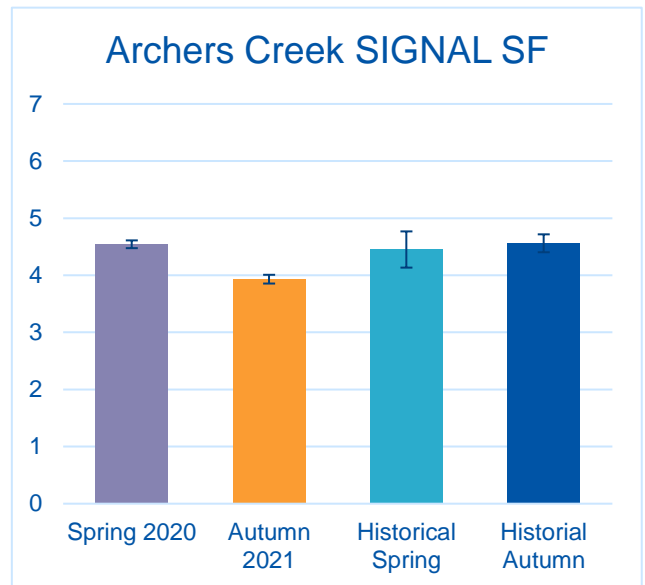
Figure 18 Archers Creek SIGNAL SF

The SIGNAL SF score for Archers Creek in Autumn 2021 was lower than the historical average (Figure 19). SIGNAL SF results for Spring 2020 were consistent with previous years.

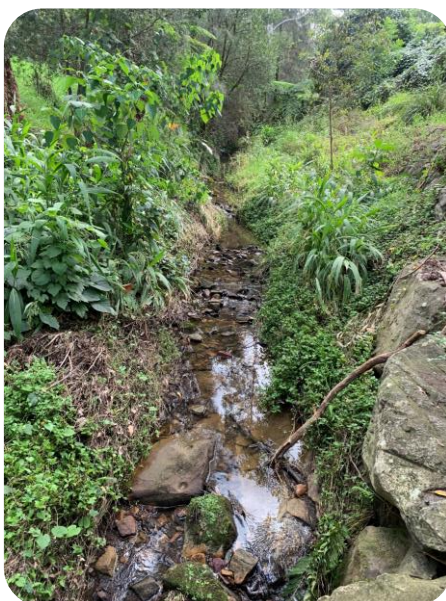
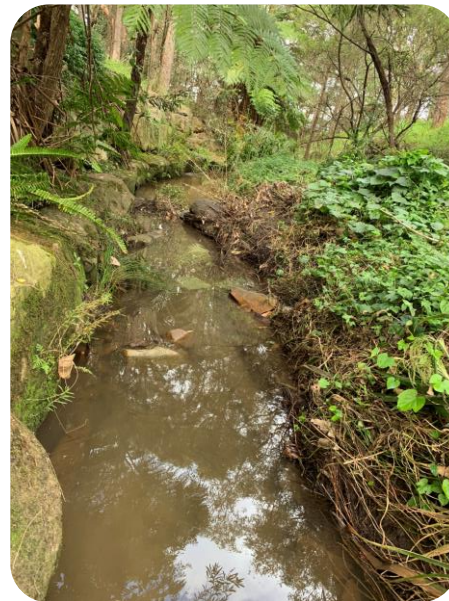
Figure 18 Archers Creek Site upstream (left) and downstream (right)

This site is located in Maze Park, West Ryde and is upstream of the Victoria Rd crossing (Figure 17). The upstream surrounding land use is residential and a golf course is present downstream. The bank was relined in the past with sandstone blocks. The creek bed is mostly bedrock with banks of sediment (sand, silt and organic matter, Figure 18). The vegetation within and around the creek is a mix of native and introduced species.

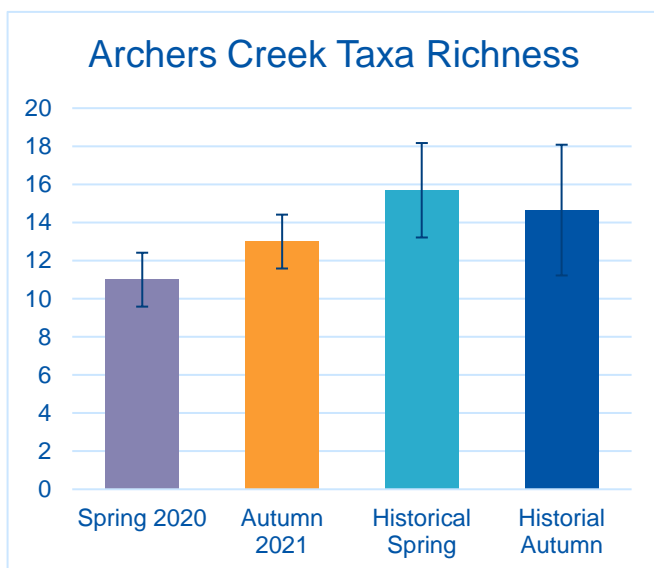
Figure 19 Archers Creek Taxa Richness

Autumn 2021 taxa richness result was within a similar range to previous values (Figure 20). Spring 2020 results were lower than the historical average.

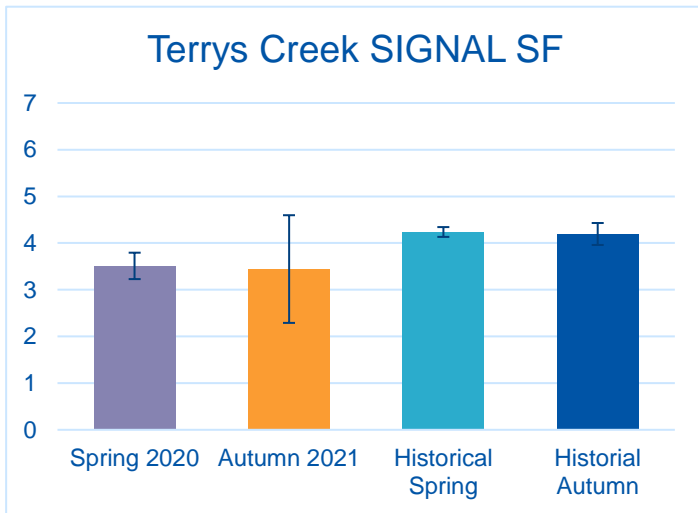
Figure 24 Terrys Creek SIGNAL SF

SIGNAL SF results for Terrys Creek were observed to be consistent with historical averages for both Spring and Autumn sampling seasons (Figure 24).

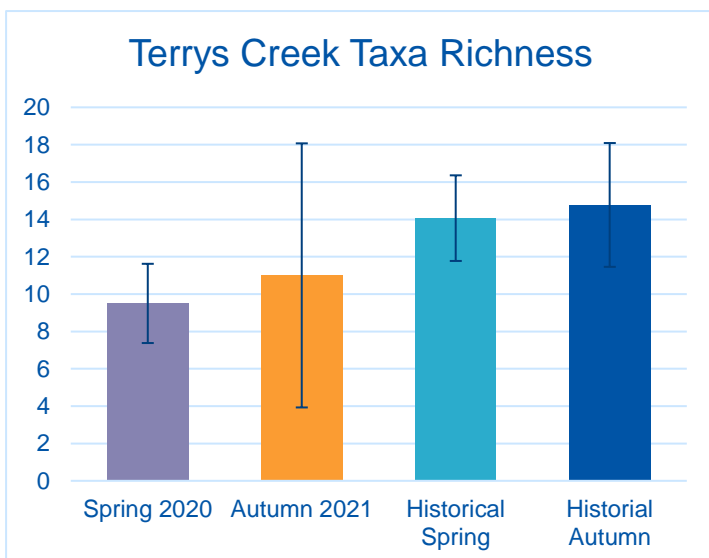
Figure 25 Terrys Creek Taxa Richness

Current Spring and Autumn season results were slightly lower than historical averages (Figure 25). The richness score for Spring 2020 was 9.5 which declined from the previous season (Spring 2018, 14).

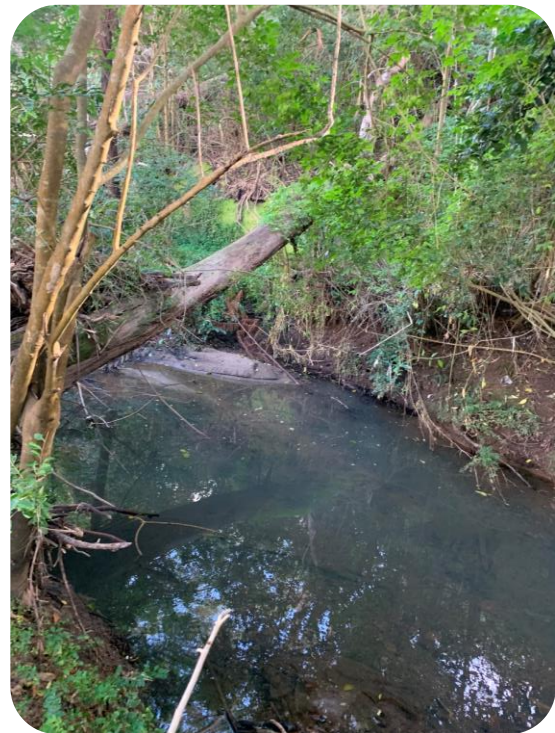
Figure 24 Buffalo Creek core site (CR4B) upstream

The Buffalo Creek core sampling site is in a bush corridor in the suburb of Gladesville and is accessed through private property. The surrounding land use is a mix of residential, light industry/commercial and reserves. The surrounding vegetation is a mix of native and exotic species, with exotic species dominating. The southern bank is mostly residential lawns.

The creek bed has a mix of sand, silt and gravel. There is usually some macrophyte growth, *Egeria* and *Potamogeton*, and little algal growth has been observed. Sedimentation has occurred periodically, along with a significant amount of organic debris and domestic rubbish.

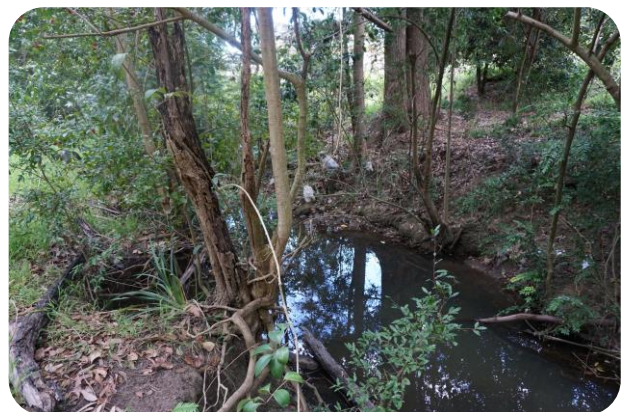
Figure 25 Figure 28 Buffalo Creek Downstream of Burrows Park facing upstream

The downstream Burrows Park site is accessed off Buffalo Rd and is positioned just before the creek flows under the road. The surrounding land use is residential and Burrows Park consists mostly of a bush corridor. There are usually obvious signs of bird activity around this site, including extensive bird droppings.

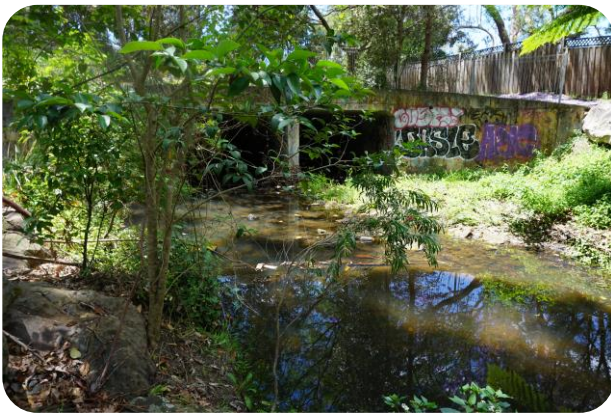
Figure 26 Buffalo Creek Upstream of Burrows Park

The upstream Burrows Park site is about 300 metres upstream of Buffalo Rd, and lies in the middle of a bush corridor. The site is surrounded by vegetation that completely shades the creek. The creek is shallow at this point and has little flow. The site is positioned just downstream from a stormwater tributary/pipe.

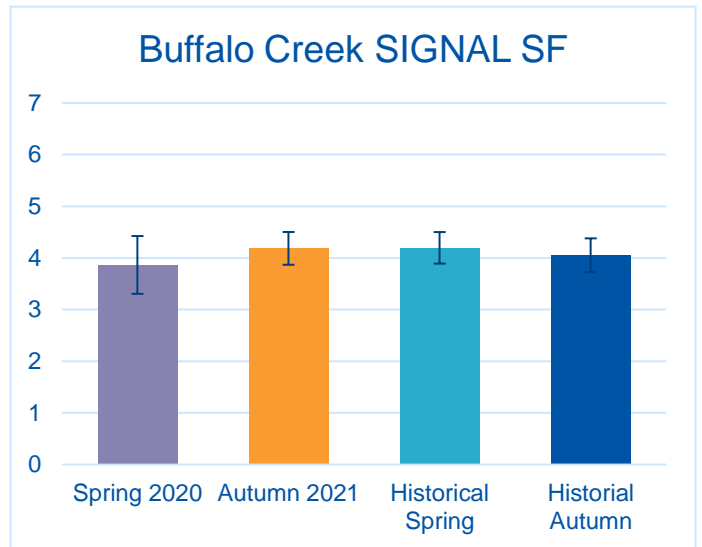
Figure 27 Buffalo Creek SIGNAL SF

Buffalo Creek SIGNAL SF results for Spring 2020 and Autumn 2021 were consistent between seasons and with historical averages (Figure 27)

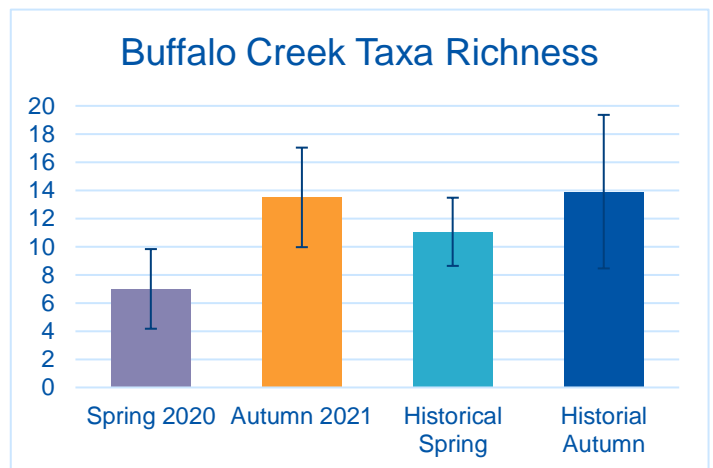
Figure 28 Buffalo Creek Taxa Richness

The taxa richness value for Spring 2020 was lower than the historical average for this season. The taxa richness result for Autumn 2021 was only slightly lower than the historical average.

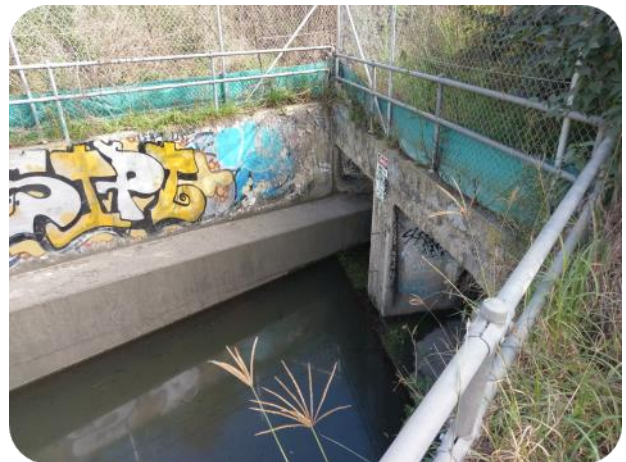
Figure 31 Porters Creek @ Main Branch facing downstream

This site is located on the western boundary of the centre and consists of an open concrete channel. Samples are collected from the retention basin at the end of the channel.

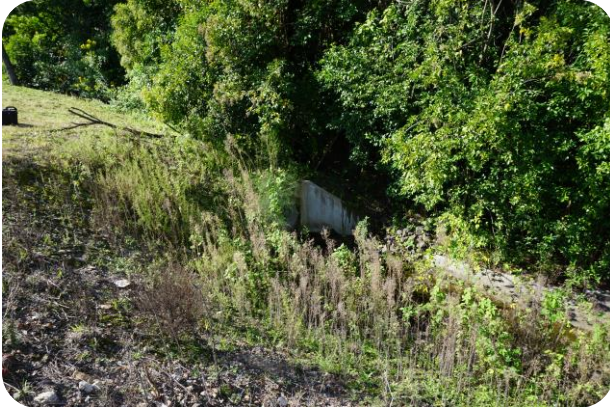
Figure 32 Porters Creek @ Spur Branch

This site is in the north-western corner of the centre in an underground drainage pit where several underground stormwater lines meet before joining and draining to the main Porters Creek line. The exact location has changed over the years due to access issues.

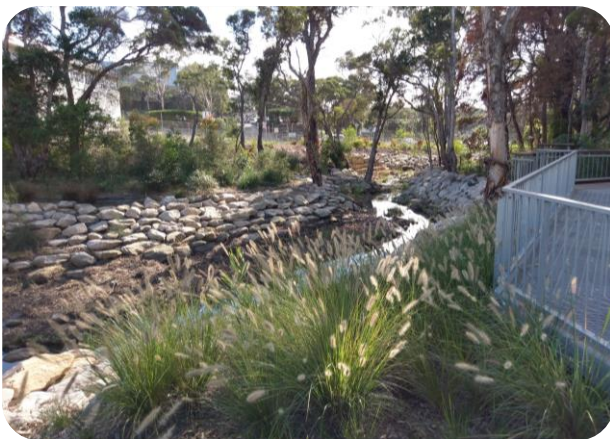
Figure 33 Porters Creek @ Wicks Road

This site is the first point that Porters Creek drains from the underground stormwater system. The site is surrounded by commercial and industrial land uses. The banks have been re-lined with sandstone and surrounding area vegetated with native plants.

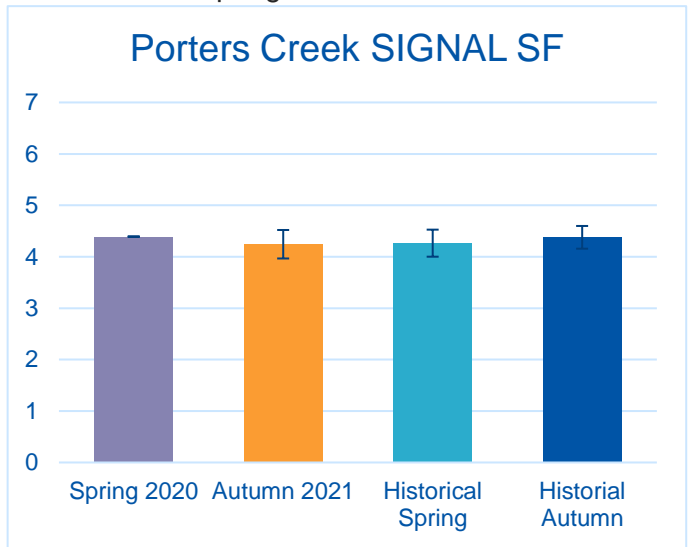
Figure 34 Porters Creek SIGNAL SF

Results were within thresholds of historical averages for both Spring 2020 and Autumn 2021 sampling seasons. This was consistent with results of Spring 2018 and Autumn 2019.

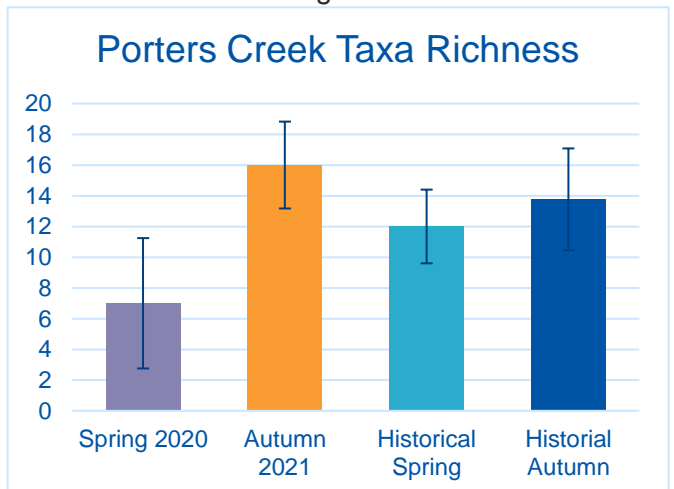
Figure 36 Porters Creek Taxa Richness

Spring 2020 had a taxa richness result beneath the Spring historical average. In contrast, Autumn 2021 taxa richness was higher than the Autumn historical average.
