City of Ryde Council

West Ryde Centre Pedestrian Access and Mobility Plan (PAMP)

09 October 2017

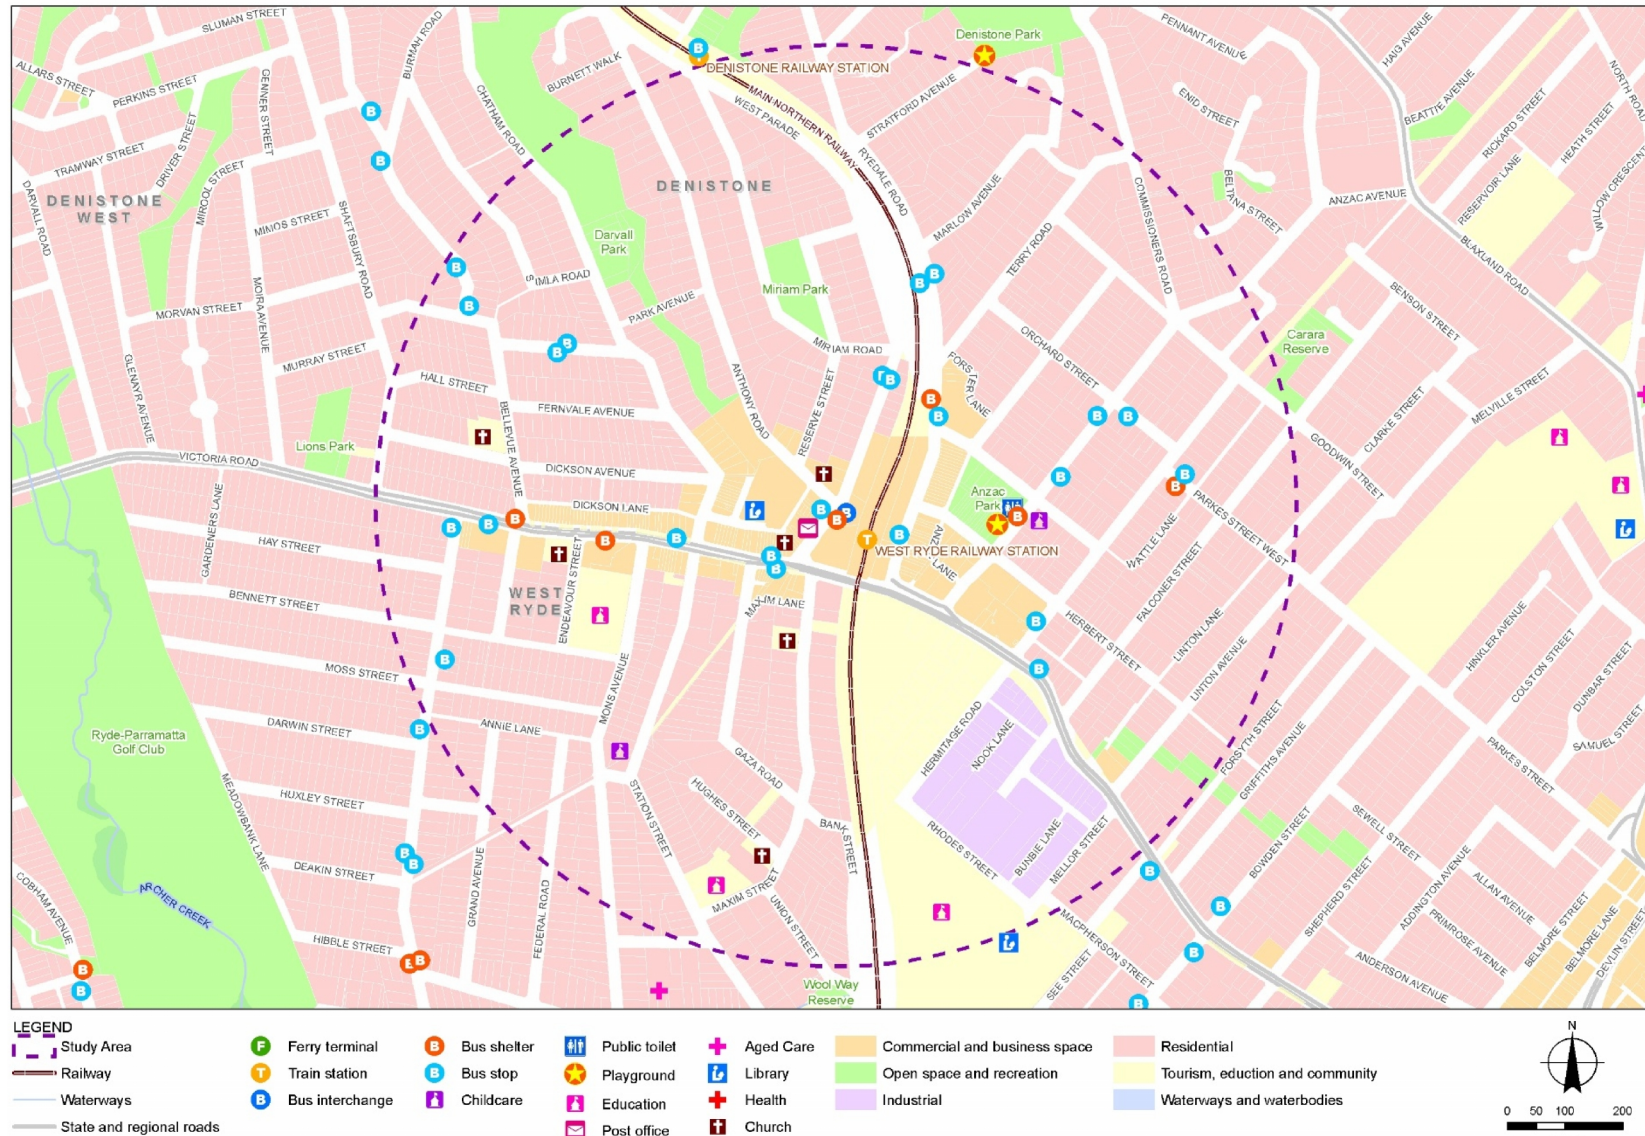
Figure 1-1 West Ryde Centre PAMP - Study Area

The study area for this *PAMP* includes an approximately 1 km walking catchment from West Ryde Station and town centre, including local businesses, schools and surrounding residential areas. The study area for this PAMP is illustrated in Figure 1-1.

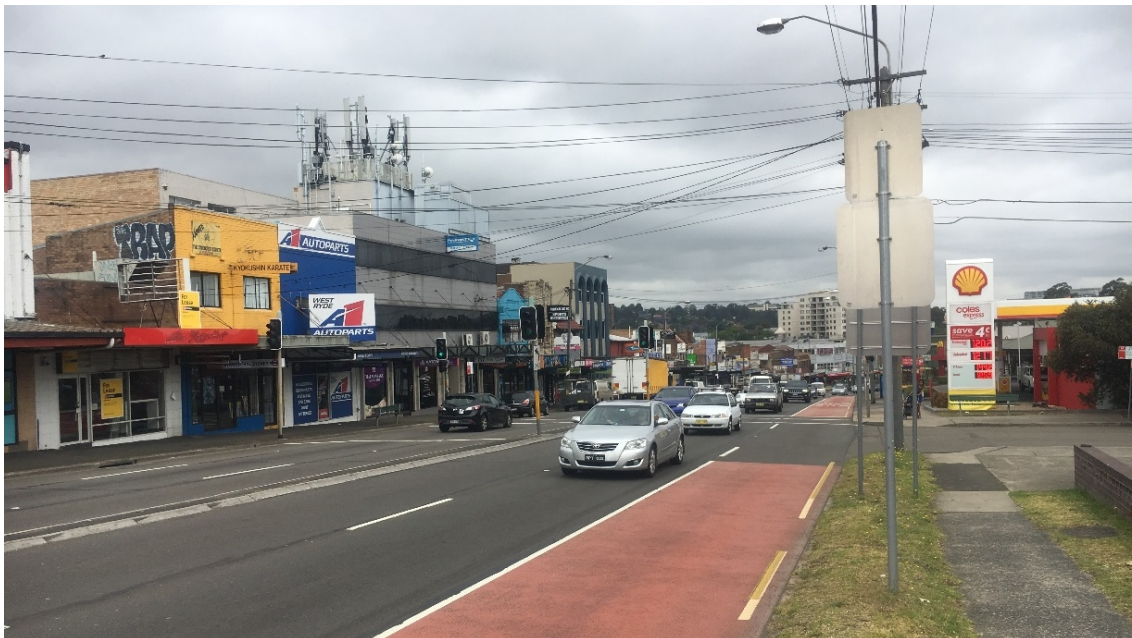
Figure 2-19 Victoria Road, looking east at Endeavour Street

Victoria Road is a State Road and major arterial road providing a link and key public transport (bus) corridor between Parramatta and Sydney CBD. Through the West Ryde Centre study area. Victoria Road has two general traffic lanes and a bus lane in the westbound direction, as illustrated in Figure 2-19.

Victoria Road currently has a sign posted speed of 60 km/h within the *West Ryde Centre PAMP* study area.

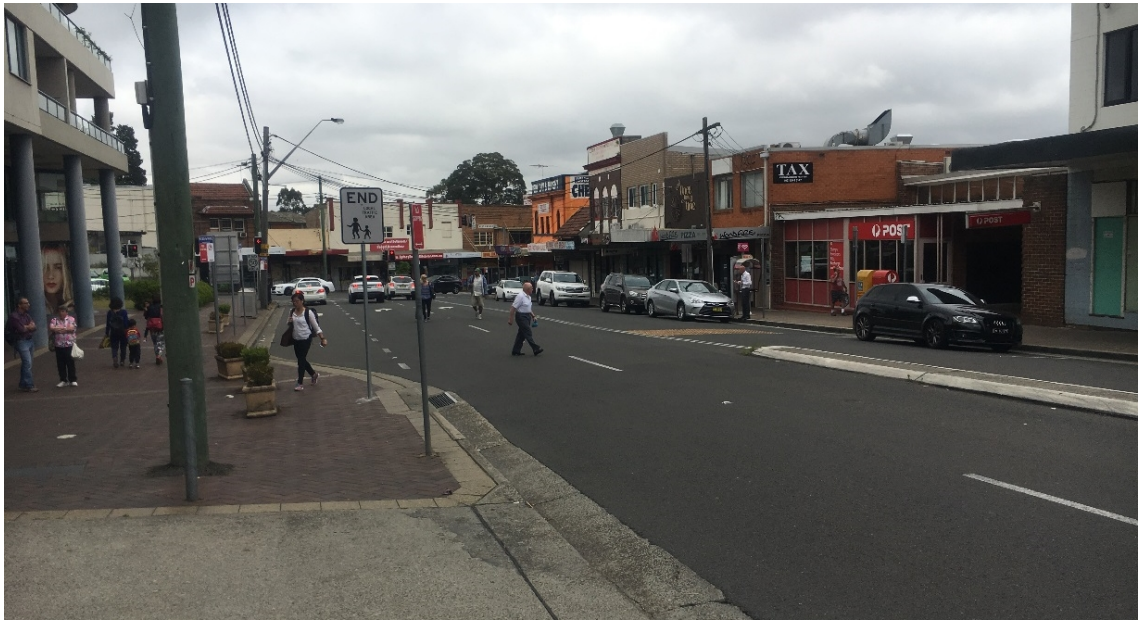
Figure 2-20 West Parade, looking south from West Ryde Station bus interchange

West Parade is a Regional Road functions as a collector road and provides generally one traffic lane in each direction, with provision of dedicated turning lanes at intersection approaches as illustrated in Figure 2-20.

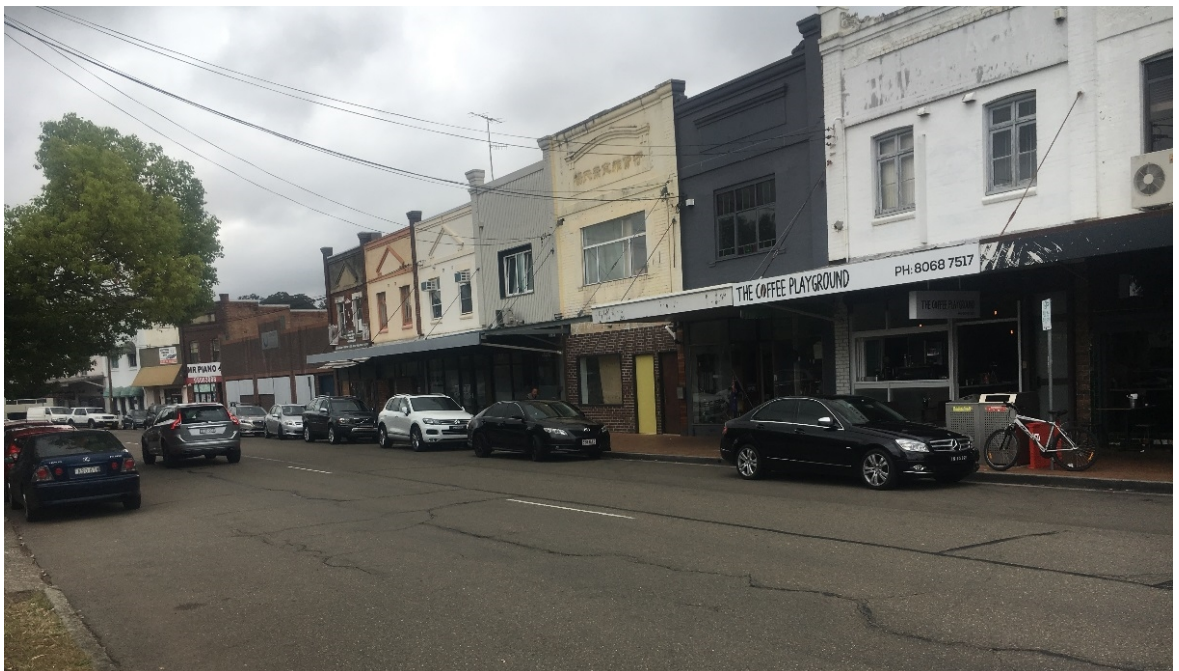
Figure 2-21 Ryedale Road, looking north from West Ryde Station entrance

Ryedale Road functions as a collector road and provides one traffic lane in each direction. On-street parallel parking spaces are available on both sides of the street, as illustrated in Figure 2-21.

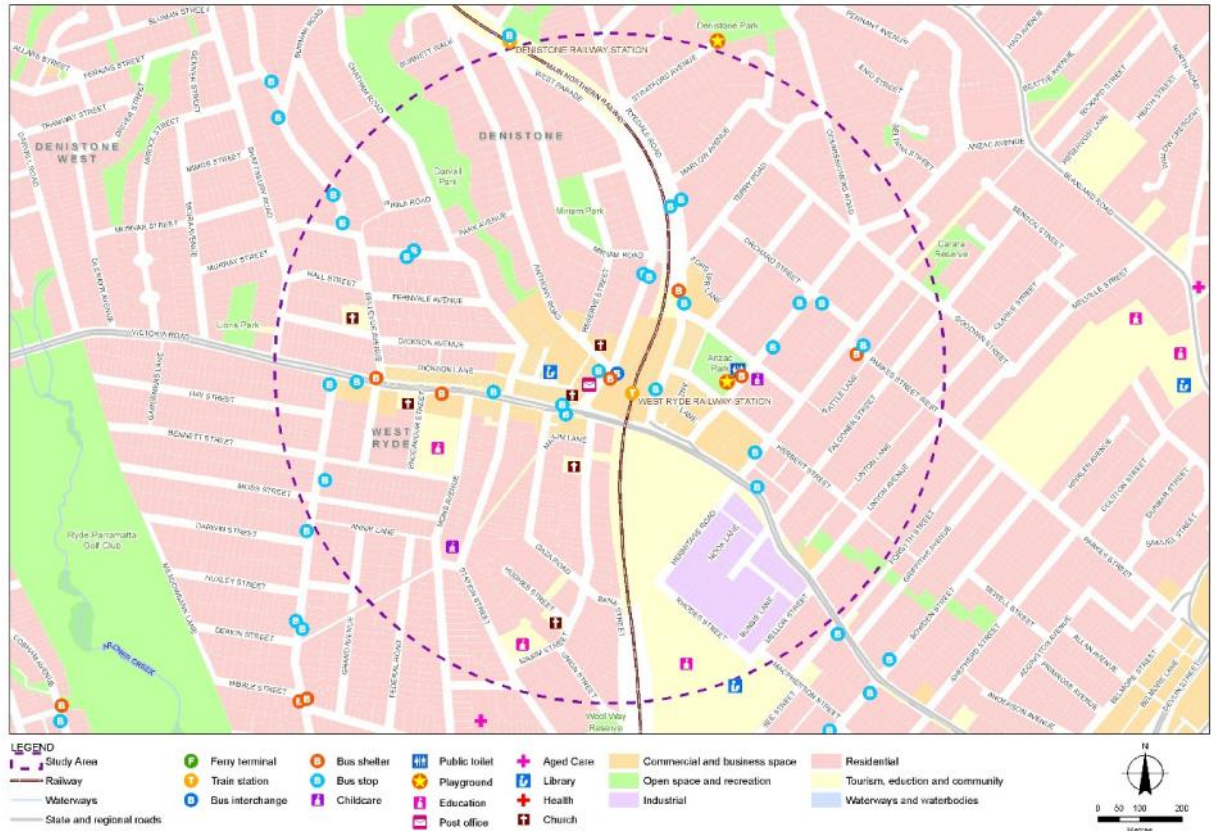
Figure 1-1 Study Area

The study area for the *PAMP* is shown in Figure 1-1.
