# **City of Ryde Council**

## Meadowbank Station West Pedestrian Access and Mobility Plan (PAMP)

5 December 2017

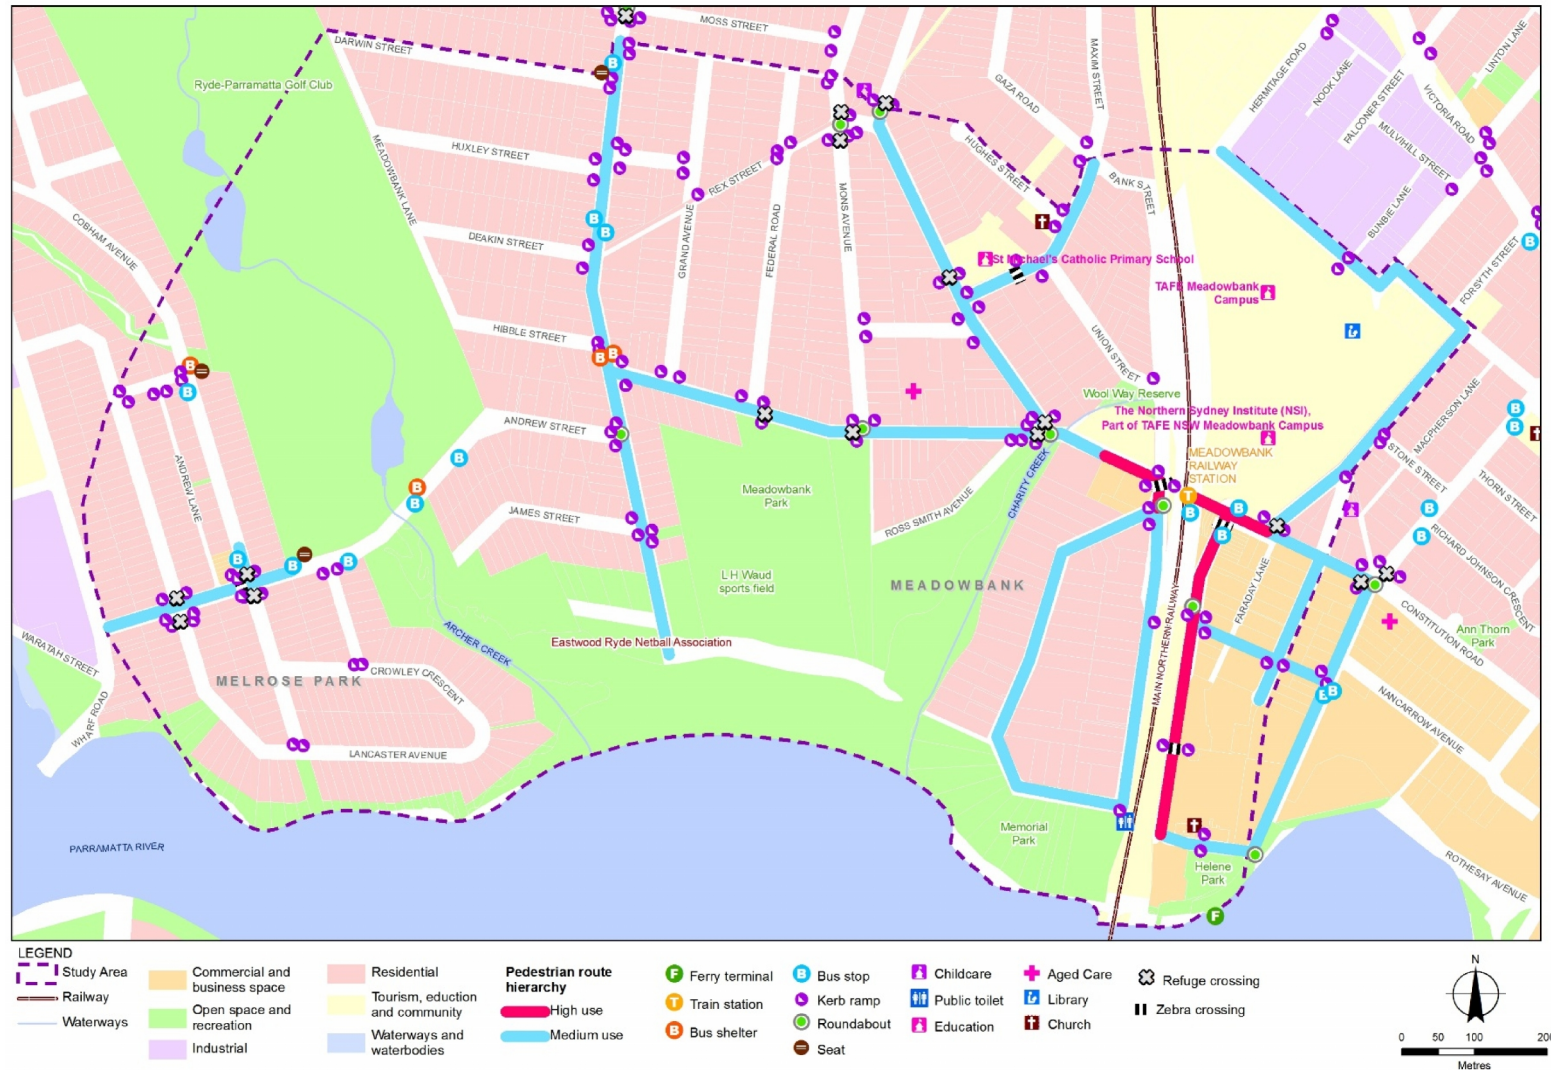
### Figure 6-1 Walking Route Hierarchy

A hierarchy of pedestrian routes has been established based on observed pedestrian demand and proximity to pedestrian attractors, such as the train station, commercial land uses, schools/TAFE, and key walking routes. This walking route hierarchy was used as part of the scoring method to determine the priority for proposed pedestrian infrastructure upgrades.
