Preliminary Site Investigation:
LOT 3 DP 707390
3-5 Vincentia Street, Marsfield, NSW

P1705856JR01V01
April 2017

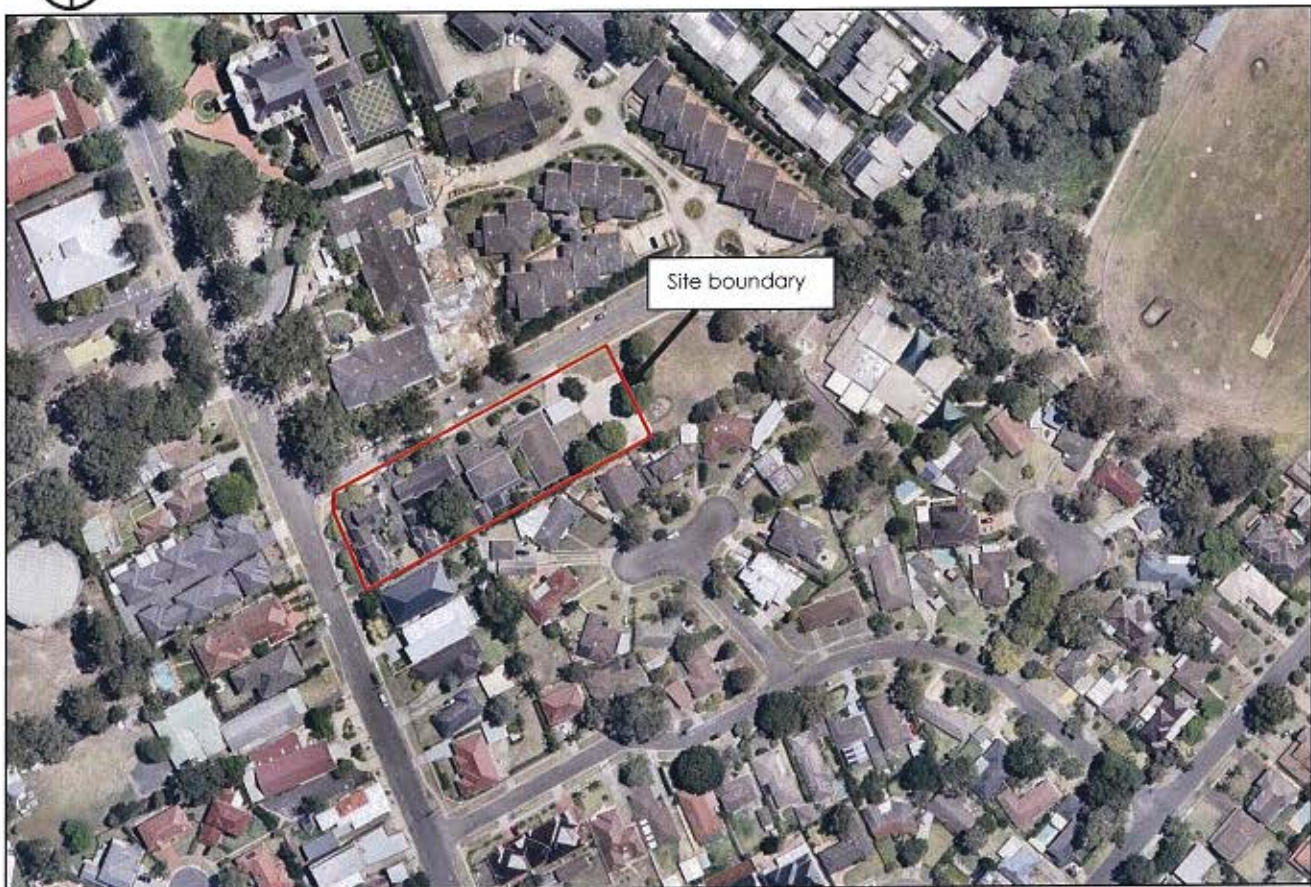
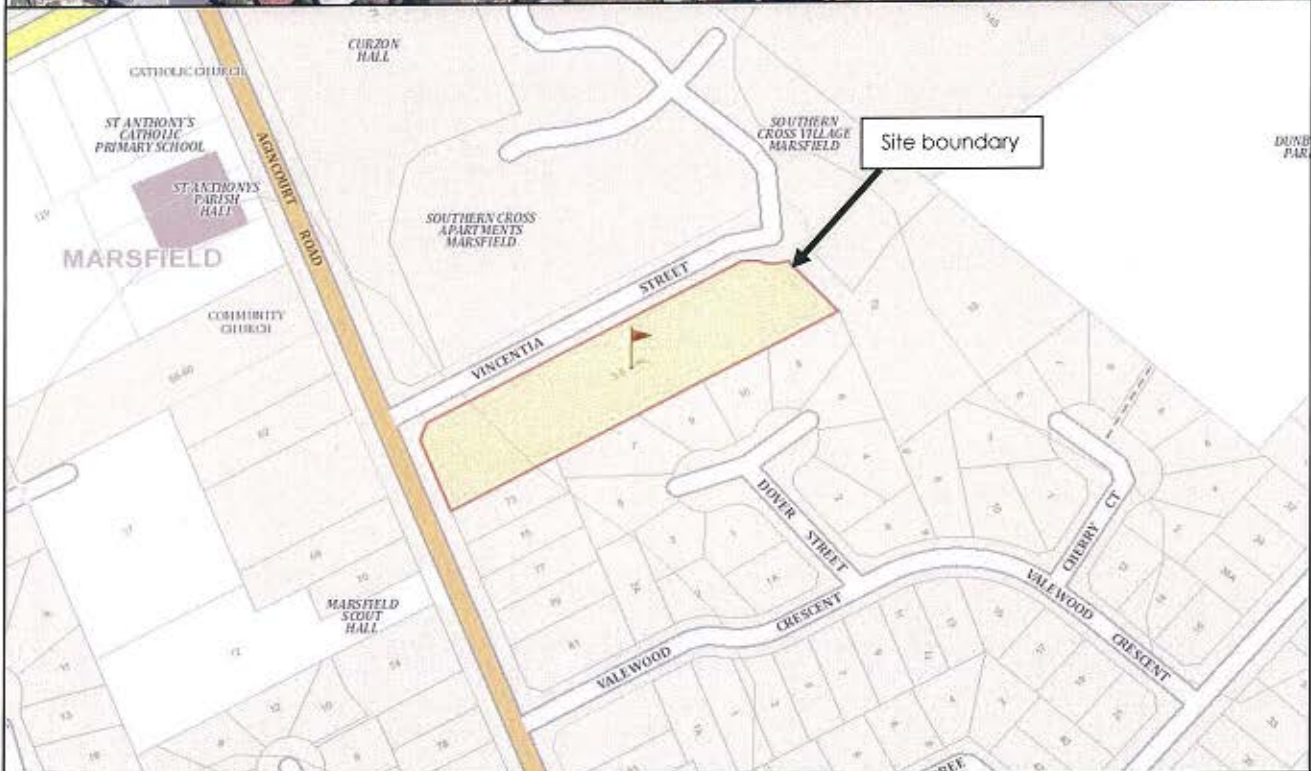
Site information is summarised in Table 1, and site location and general surrounds shown in Figure 1, Attachment A. A site survey is provided in Figure 2, Attachment A.

This report, prepared by Martens and Associates (MA), documents a preliminary site contamination investigation (PSI) completed to support a development application (DA) to the City of Ryde Council (CRC) to enable subdivision of the development at 3 – 5 Vincentia Street, Marsfield, NSW ('the site'). The subdivision aims to maintain the existing six dwellings on site with an addition of one single-dwelling lot. The site location is shown on Figure 1, Attachment A.
