# **City of Ryde Council**

## Meadowbank Station West Pedestrian Access and Mobility Plan (PAMP)

5 December 2017

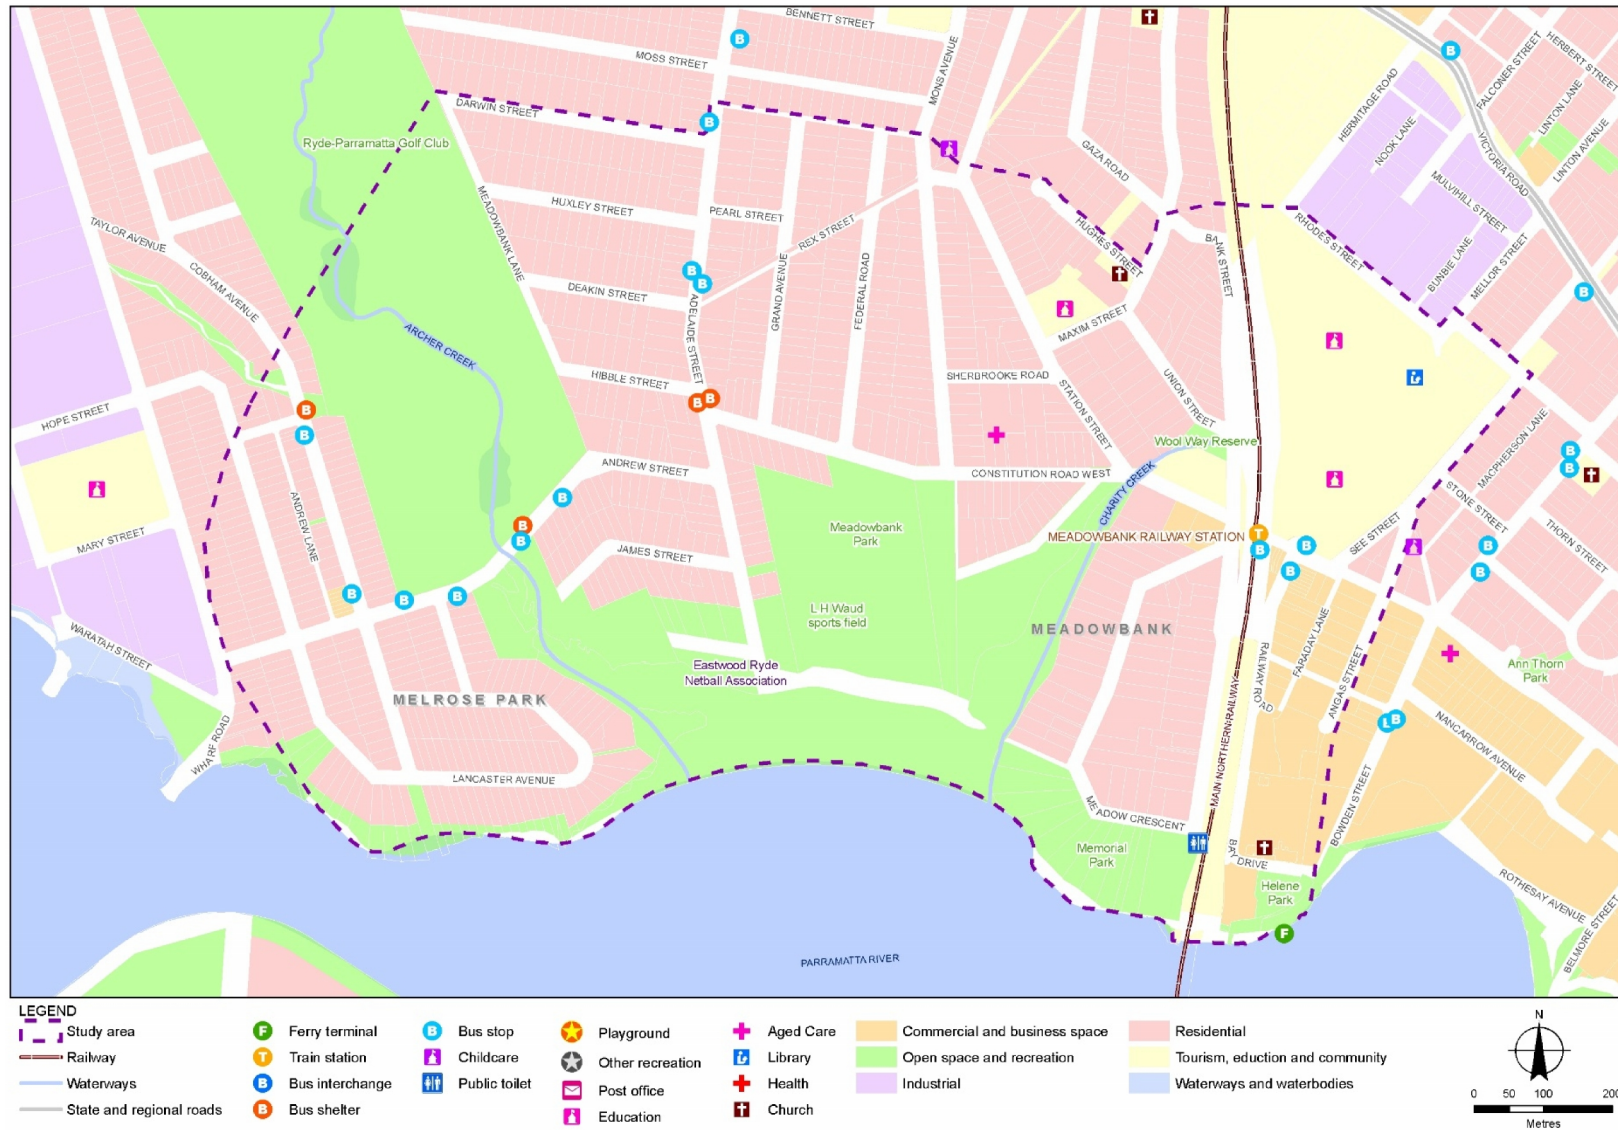
**Figure 1-1 Study Area**

The study area for this PAMP is shown at Figure 1-1, which includes:

The study mainly focuses on the pedestrian network located to the west of Meadowbank train station, due to the extensive urban renewal taking place on the eastern side of the station.

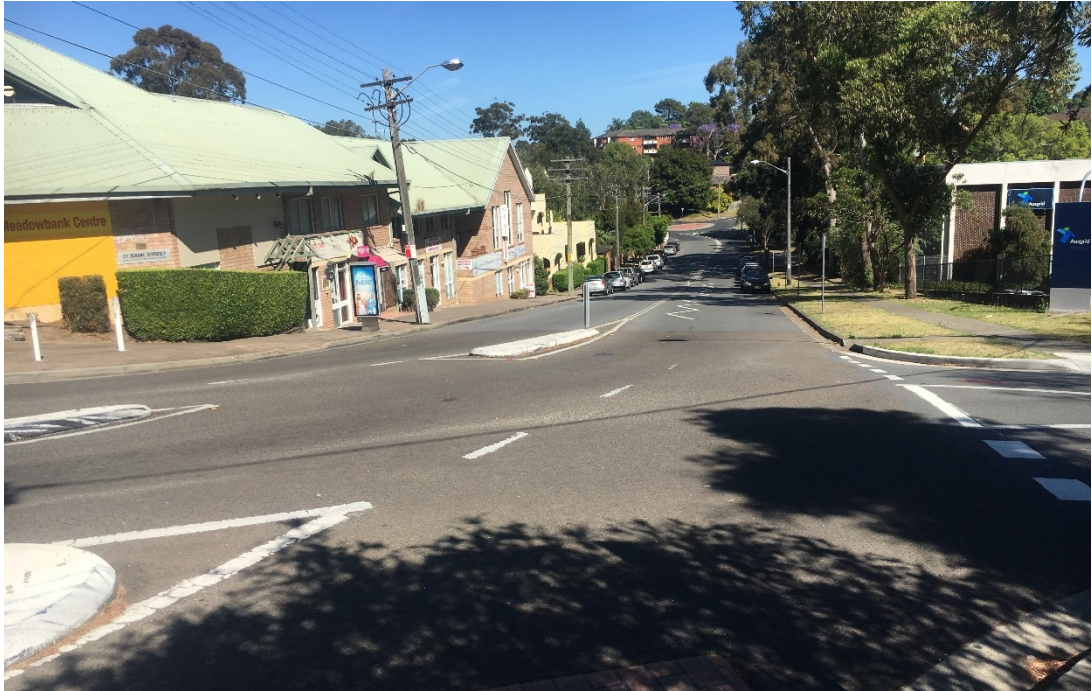
**Figure 2-19 Constitution Road West, viewed westwards**

Constitution Road is a regional road and functions as a collector road. It provides access to Meadowbank Station for pedestrians and motorists. It is made up of two sections and is separated by Meadowbank Station. The section west of the station is named Constitution Road West.

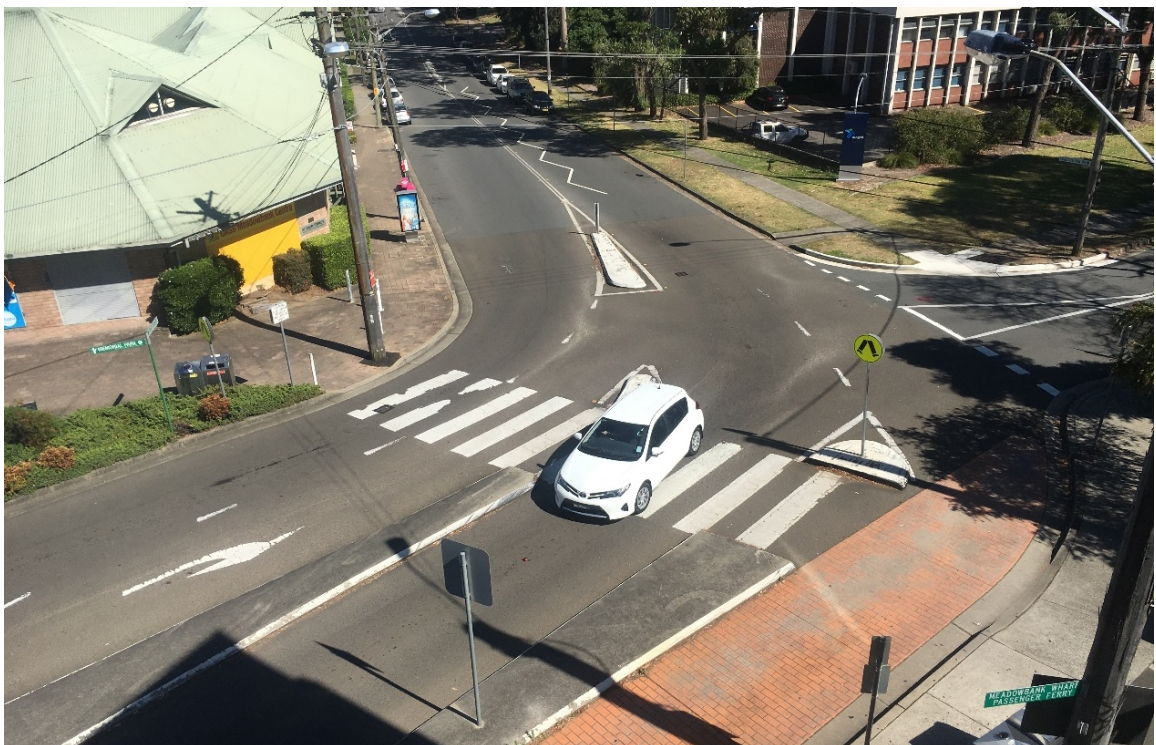
**Figure 2-22 Bank Street and Constitution Road West, Viewed Northwards from West Ryde Parade**

During the site audit, it was noted that there is pedestrian and vehicle conflict at the existing pedestrian crossing, as there were a large number of pedestrians crossing Bank Street when egressing trains at Meadowbank Station during the PM peak. This can cause long delays to traffic and result in impatient driver behaviour, which can be a risk to pedestrians.

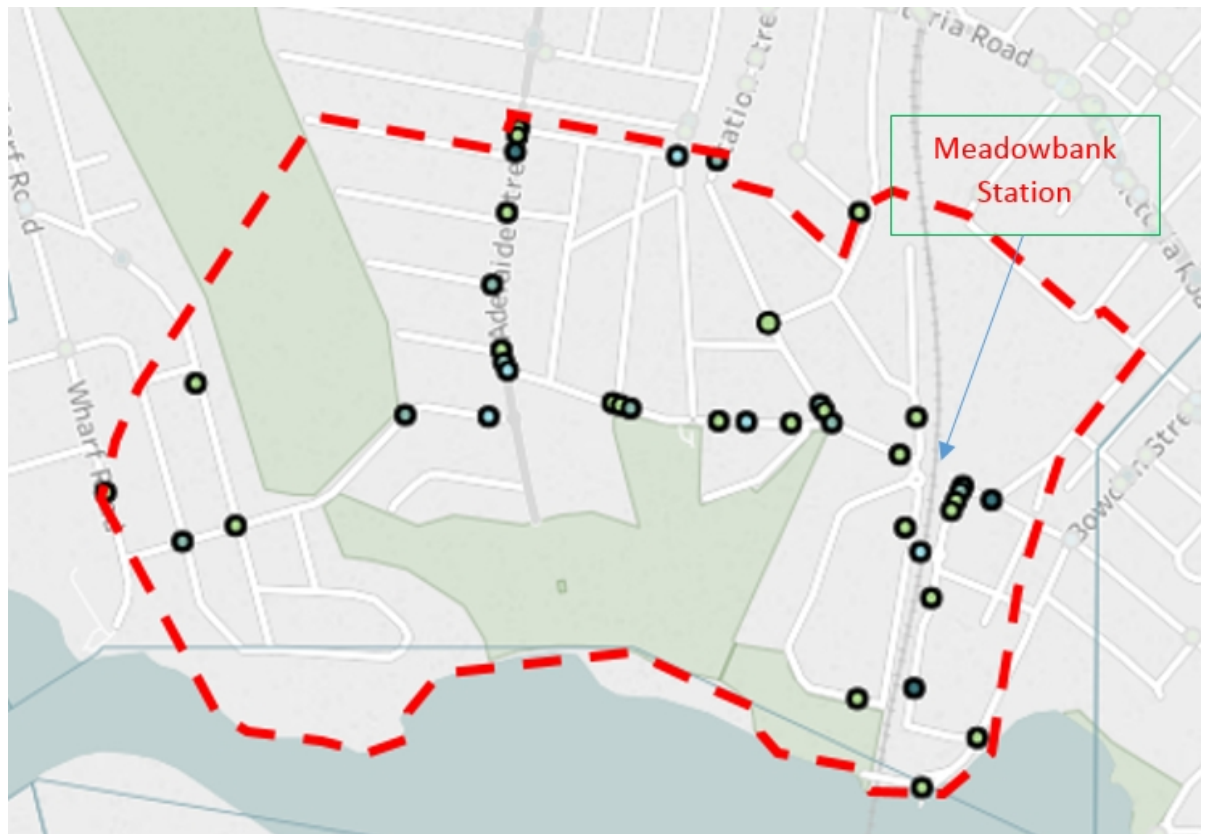
**Figure 2-23 Crashes Involving Vehicles Between 2011 - 2015**

Locations of crashes involving pedestrians is shown at Figure 2-23.

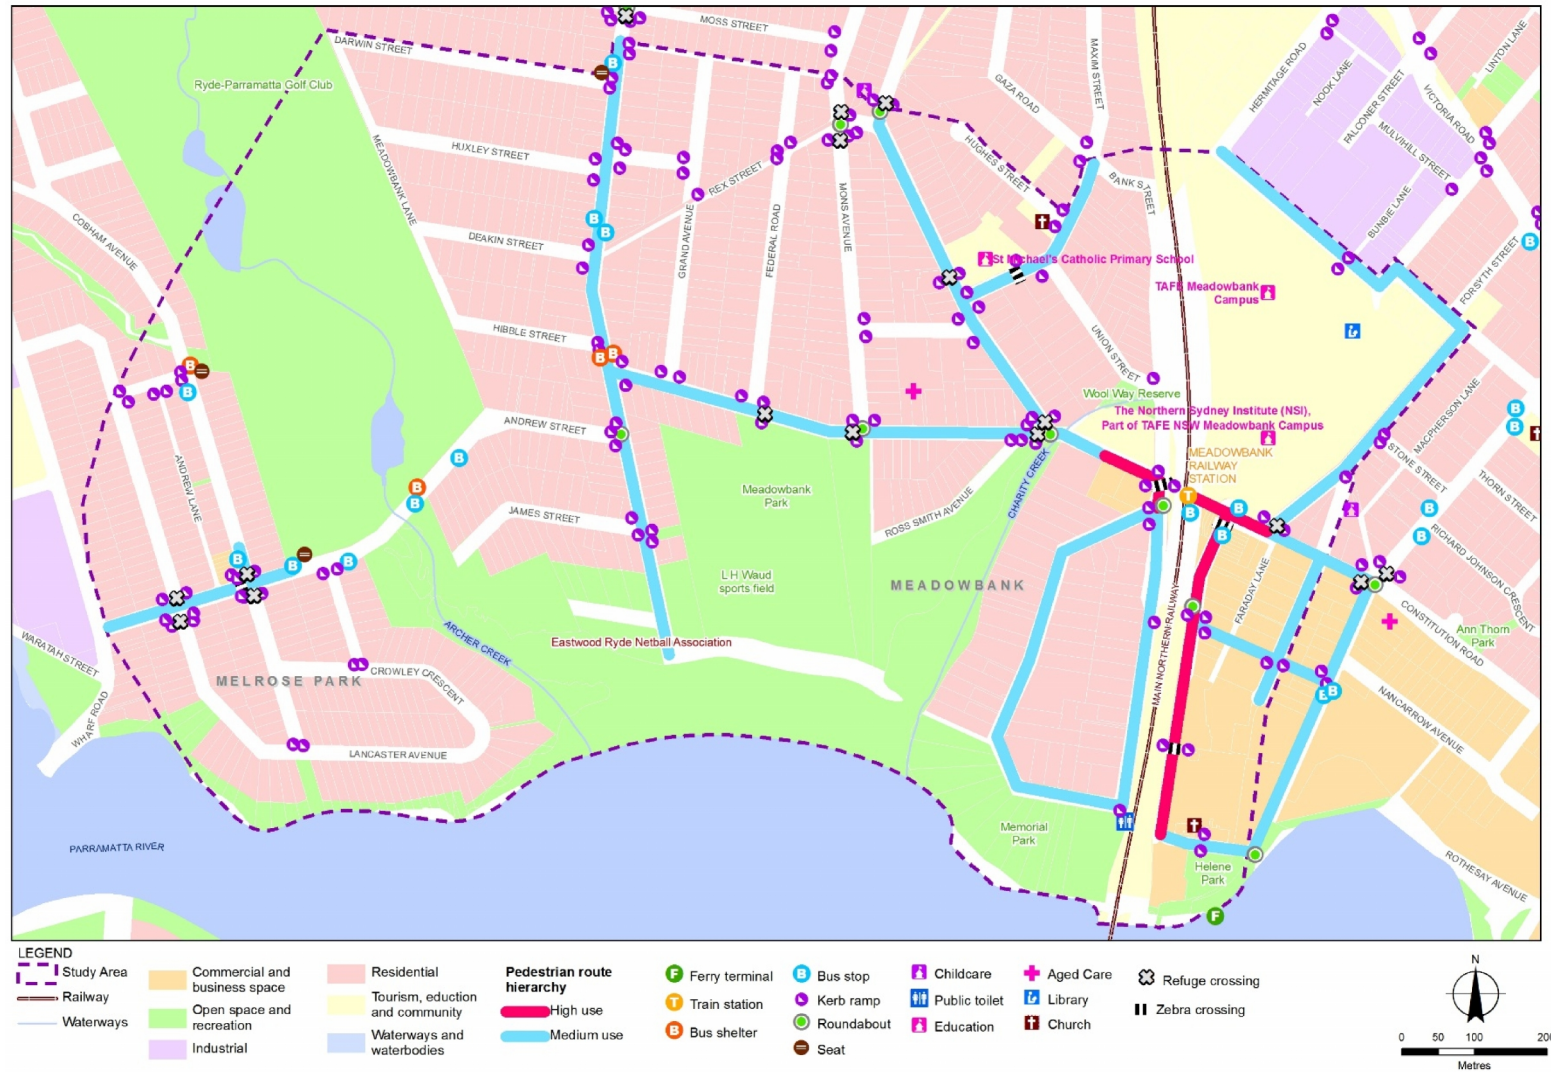
**Figure 6-1 Walking Route Hierarchy**

A hierarchy of pedestrian routes has been established based on observed pedestrian demand and proximity to pedestrian attractors, such as the train station, commercial land uses, schools/TAFE, and key walking routes. This walking route hierarchy was used as part of the scoring method to determine the priority for proposed pedestrian infrastructure upgrades.
