City of Ryde

Water Quality Monitoring Report

Spring 2022 & Autumn 2023

Report Name: City of Ryde Water Quality Monitoring Report
Autumn 2023

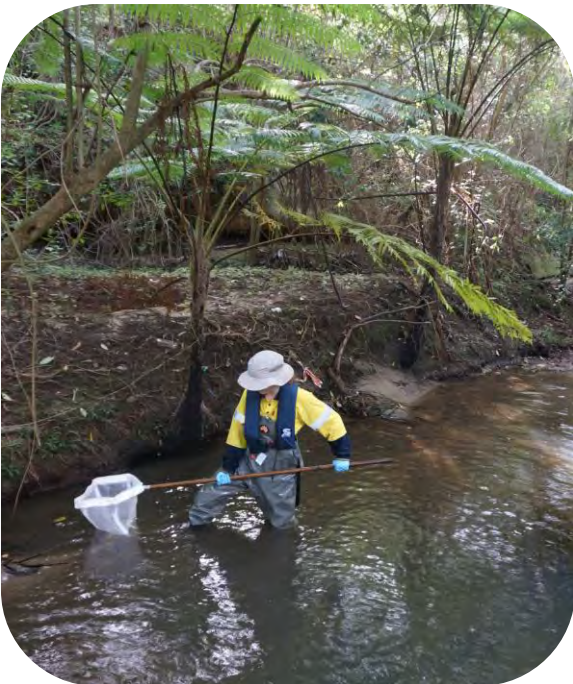
They are collected from the core sites following a standard method detailed in previous reports. This involves using a fine mesh net to upwell the water and dislodge the animals.

Figure 2 Collecting macroinvertebrates from Buffalo Creek (Autumn 2019)

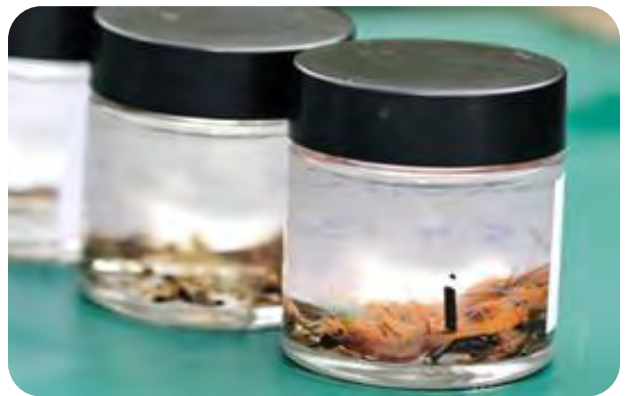
They are picked from the debris and preserved for lab-based identification and enumeration.

Figure 3 Preserved macroinvertebrates

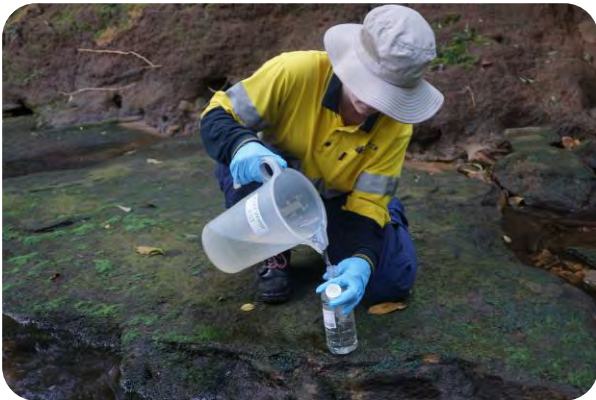
Figure 5 Collecting water samples for analysis

Water quality samples were collected at the same time as the macroinvertebrates to ensure the data was accurate for comparison.

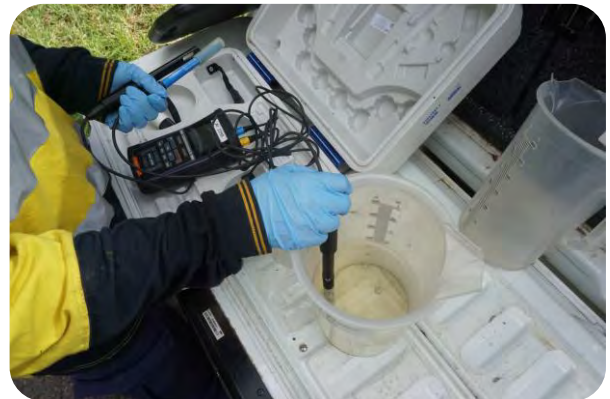
Figure 6 In-field water quality testing

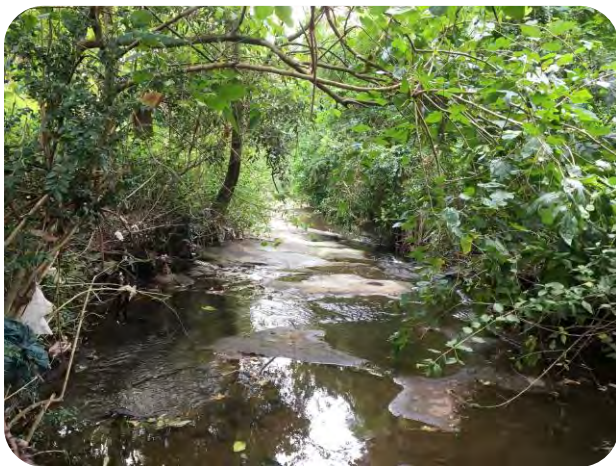
The riparian zone is the area where a body of water or stream, meets the land. The Rapid Riparian Assessment provides information on and assessment of the features of the stream and the vegetation community surrounding the stream.

Figure 7 Shrimptons Creek core site, displaying a high level of riparian vegetation

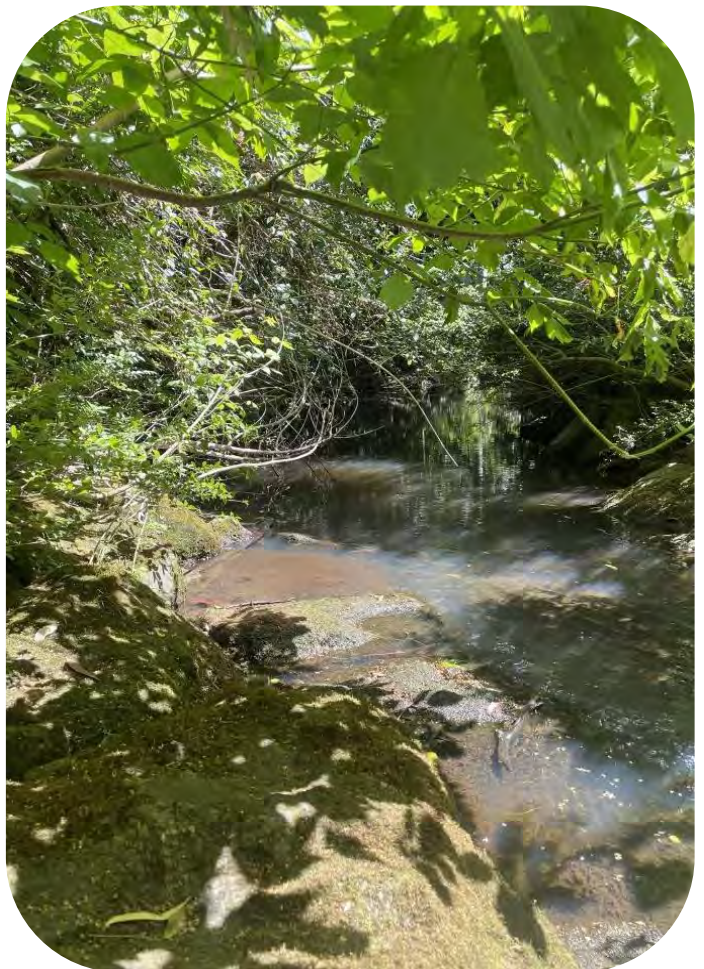
Figure 10 Shrimptons Creek (core site) Spring 2022

The creek flows through a thin riparian corridor, which is a mix of native and exotic species. The creek bed is predominately bedrock and sand/silt.

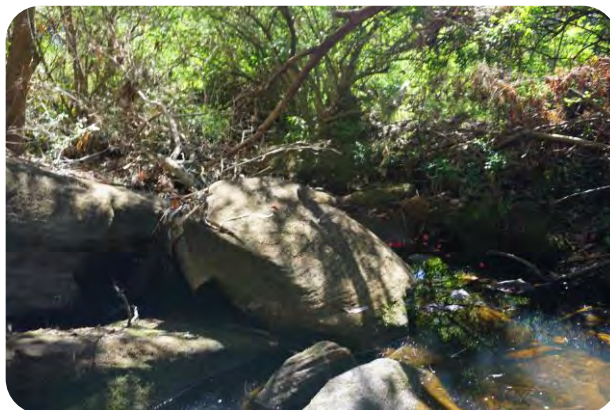
Figure 11 Shrimptons Creek at Kent Rd facing downstream

The Kent Road site is situated at ELS Hall Park amongst a residential area and is lined by a thin section of riparian vegetation that completely shades the creek and comprises a mix of native and exotic species.

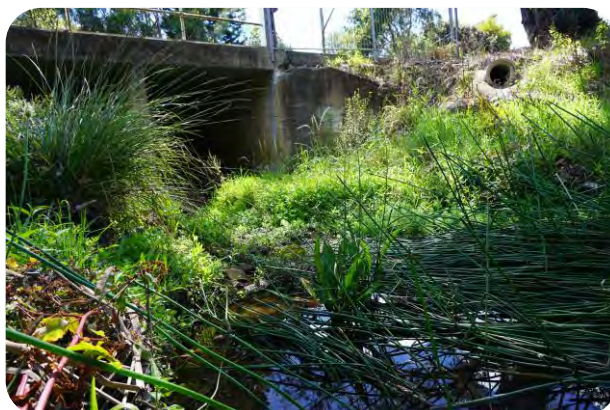
Figure 12 Shrimptons Creek at Bridge Road facing downstream

This site is located at the downstream section of Santa Rosa Park, just before it flows under Bridge St and is surrounded by residential areas. The revegetation of the riparian area is now established adding to bank stabilisation, physical buffer, and filtration.

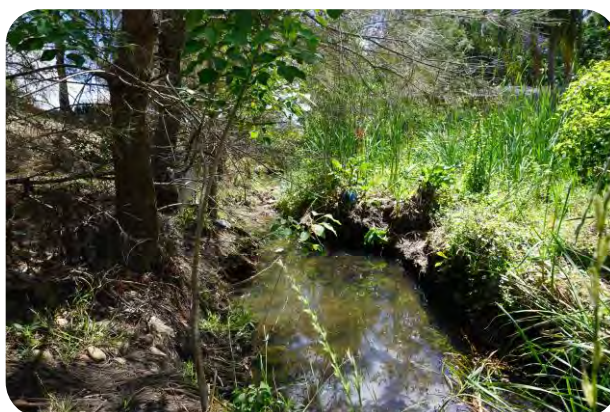
Figure 13 Shrimptons Creek at Quarry Rd facing downstream

The Quarry Road site is located at the upstream section of Santa Rosa Park, at the point where Shrimptons Creek emerges from the underground stormwater system. This site has sandstone blocks around the drain for bank stabilisation.

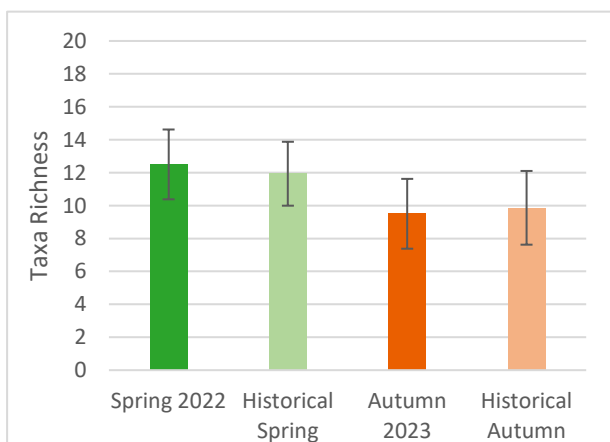
Figure 15 Shrimptons Creek Taxa Richness scores

Shrimptons Creek catchment had the highest Richness result for the Spring season (12.5, Figure 15) when compared to all other sites.

However, during the Autumn season richness results at this site declined (9.5), although values were still within range of the historical average.

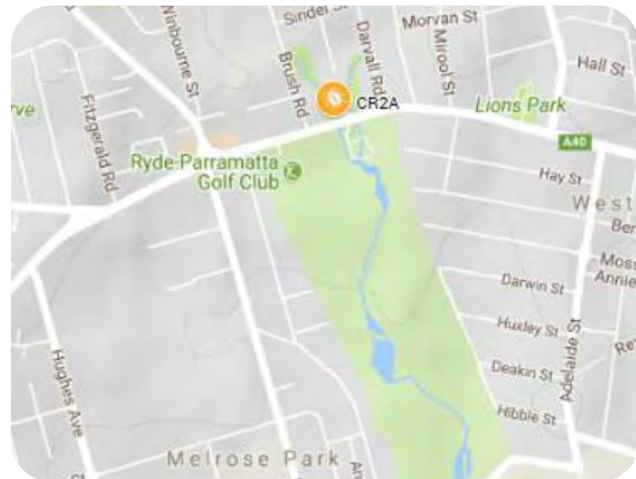
This site is located in Maze Park, West Ryde and is upstream of the Victoria Rd crossing (Figure 17). The upstream surrounding land use is residential and a golf course is present downstream. The bank was relined in the past with sandstone blocks. The creek bed is mostly bedrock with banks of sediment (sand, silt and organic matter, Figure 18). The vegetation within and around the creek is a mix of native and introduced species.

Figure 17 Archers Creek Catchment Area

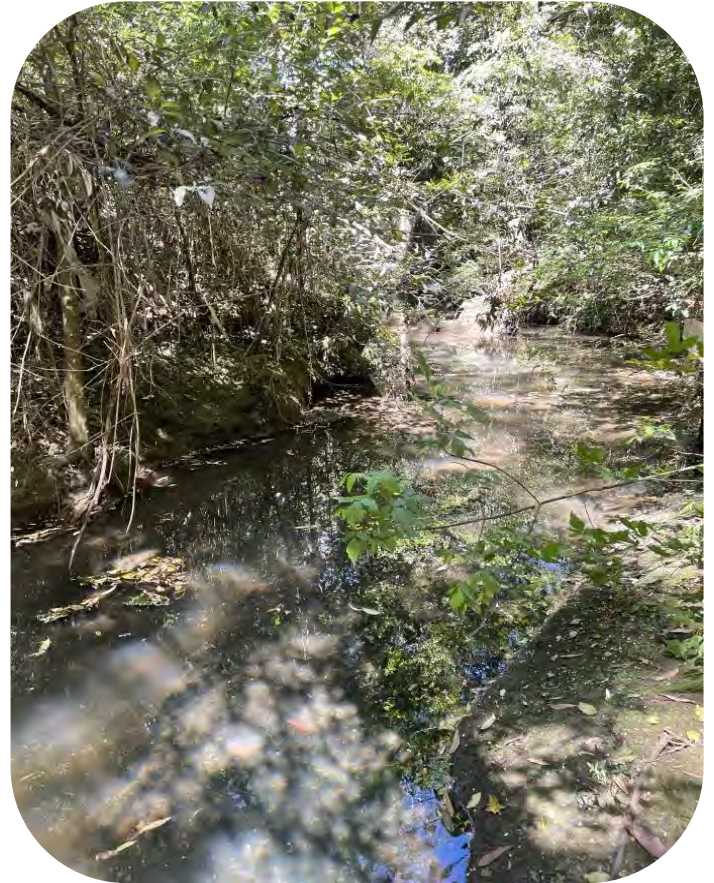
Figure 21 Terrys Creek core site at Forrester Park (CR3T), Spring 2022

This site is located within Somerset Park under the M2 overpass in the suburb of Epping (Figure 21). The surrounding land use is residential, and the creek flows through a bushland corridor. The surrounding riparian area and bank edge is a mix of native and exotic plant species. The creek bed is predominately bedrock, gravel, and sand.

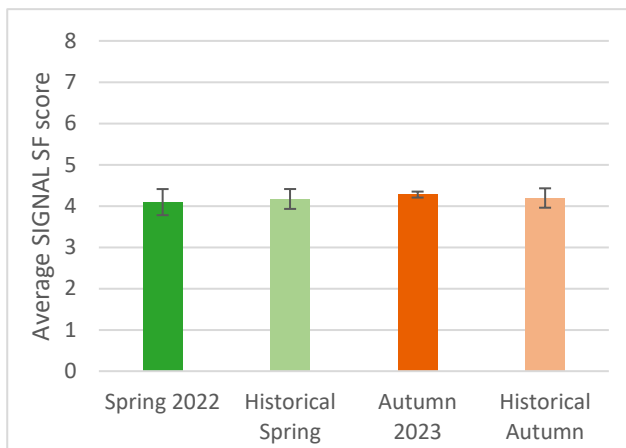
Figure 22 Terrys Creek SIGNAL scores

Terrys Creek average SIGNAL SF scores were consistent between the two sampling seasons and were within range of the historical average

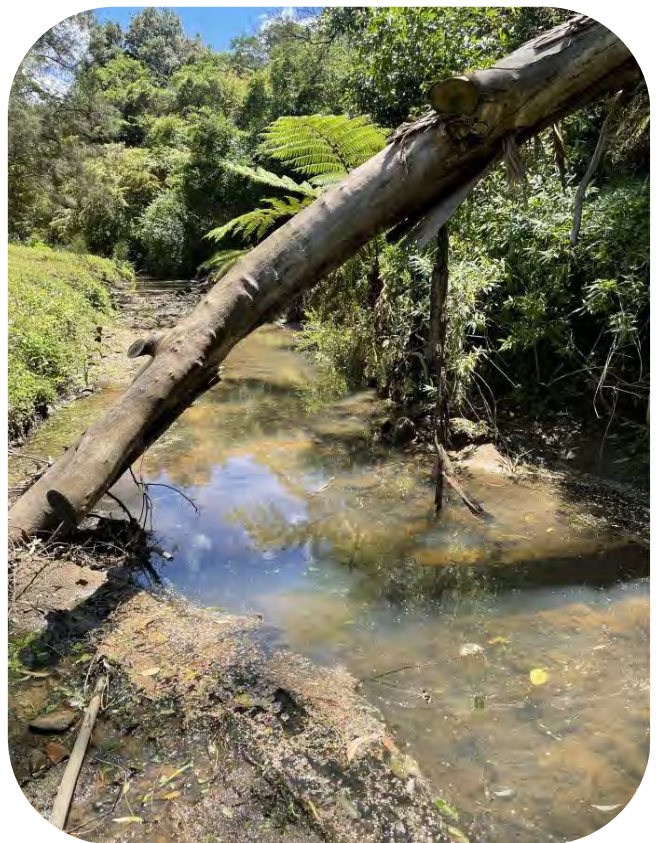
Figure 25 Buffalo Creek core site (CR4B), Spring 2022

The creek bed has a mix of sand, silt and gravel. There is usually some macrophyte growth, *Egeria* and *Potamogeton*, and little algal growth has been observed. Sedimentation has occurred periodically, along with a significant amount of organic debris and domestic rubbish

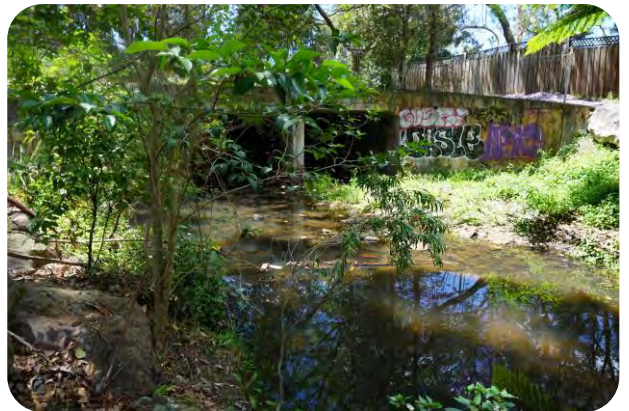
Figure 26 Buffalo Creek Downstream of Burrows Park

The downstream Burrows Park site is accessed off Buffalo Rd and is positioned just before the creek flows under the road. The surrounding land use is residential, and Burrows Park consists mostly of a bush corridor. There are usually obvious signs of bird activity around this site, including extensive bird droppings.

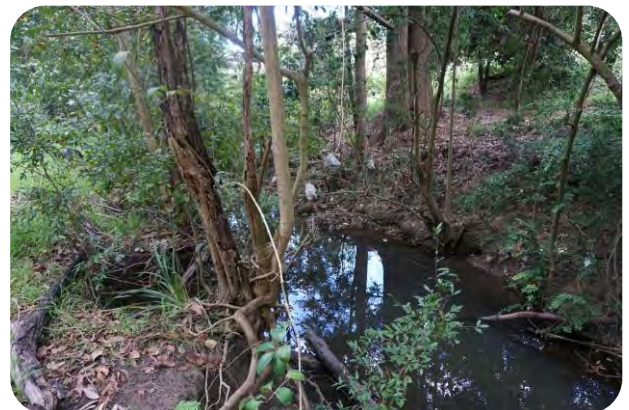
Figure 27 Buffalo Creek Upstream of Burrows Park

The upstream Burrows Park site is about 300 metres upstream of Buffalo Road and lies in the middle of a bush corridor. The site is surrounded by vegetation that completely shades the creek. The creek is shallow at this point and has little flow. The site is positioned just downstream from a stormwater tributary/pipe.

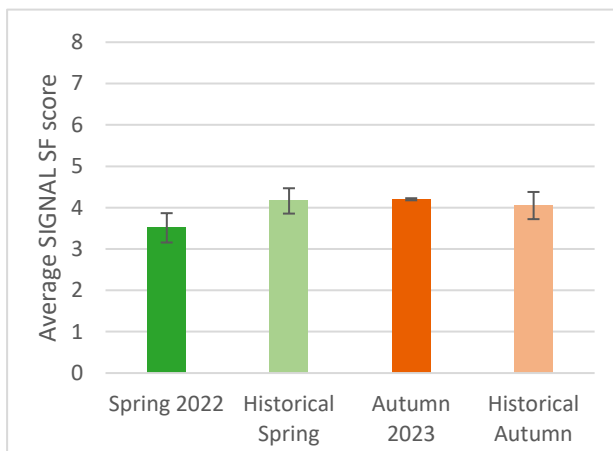
Figure 28 Buffalo Creek SIGNAL scores

Buffalo Creek catchment had the lowest average SIGNAL score result for both Spring 2022 and Autumn 2023 with scores of 3.5 and 4.2 respectively. These results were consistent with values historically observed for this catchment.

Buffalo Creek catchment had the lowest observed SIGNAL score for both sampling periods. Taxa Richness results were consistent between seasons, and within historical ranges for this site.

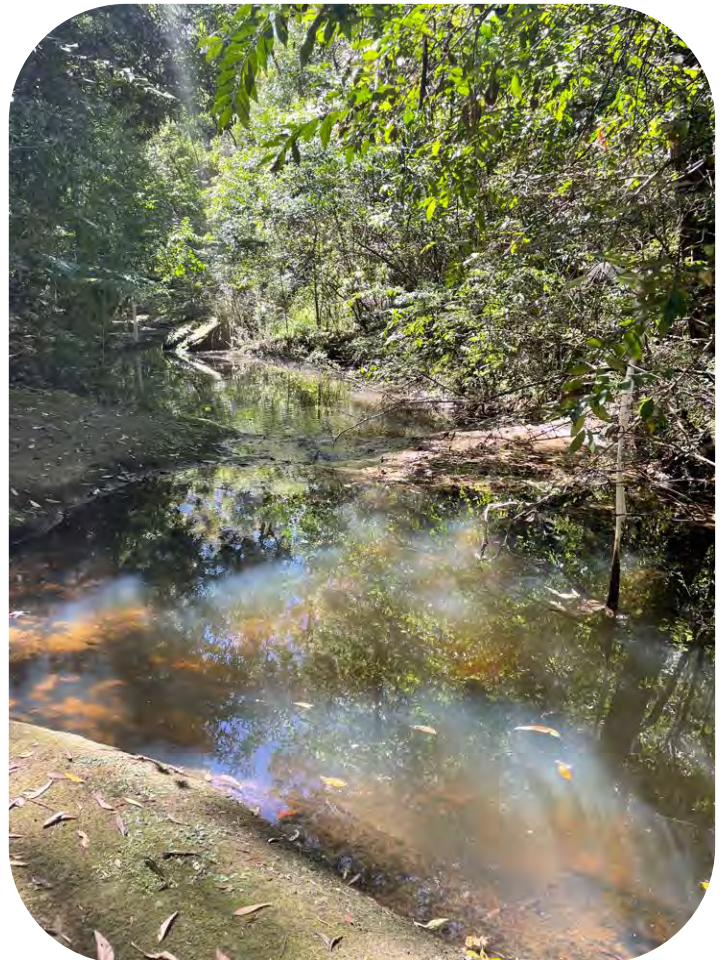
Figure 31 Porters Creek Core Site (CR5P), Spring 2022

The surrounding riparian area is dominated by native plants with a small amount of exotic species. The creek bed is mostly bedrock with some cobble, boulder and sand. No macrophyte growth has been observed at the

site however there has been varying levels of algal growth present.

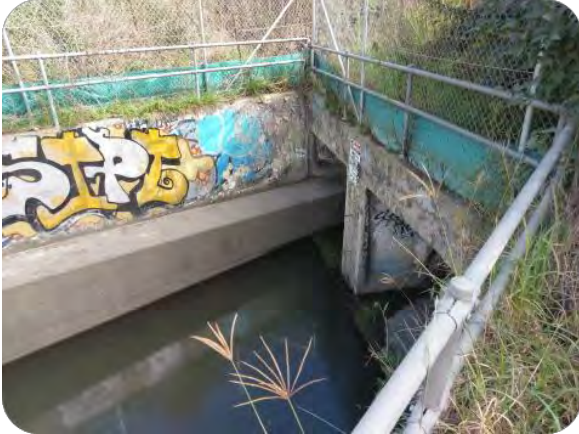
Figure 32 Porters Creek at Main Branch facing downstream

This site is located on the western boundary of the construction waste recycling facility and consists of an open concrete channel. Samples are collected from the retention basin at the end of the channel.

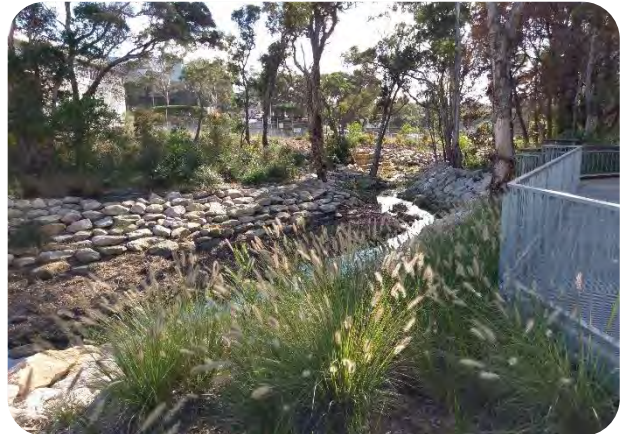
Figure 34 Porters Creek at Wicks Road

This site is the first point that Porters Creek daylights from the underground stormwater system. The site is surrounded by commercial and industrial land uses. The banks have been re-lined with sandstone and surrounding area vegetated with native plants.

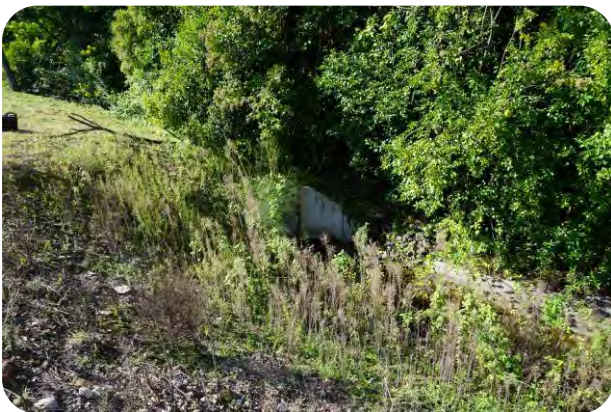
Figure 33 Porters Creek at Spur Branch

This site is in the north-western corner of the centre in an underground drainage pit where several underground stormwater lines meet before joining and draining to the main Porters Creek line. The exact location has changed over the years due to access issues.

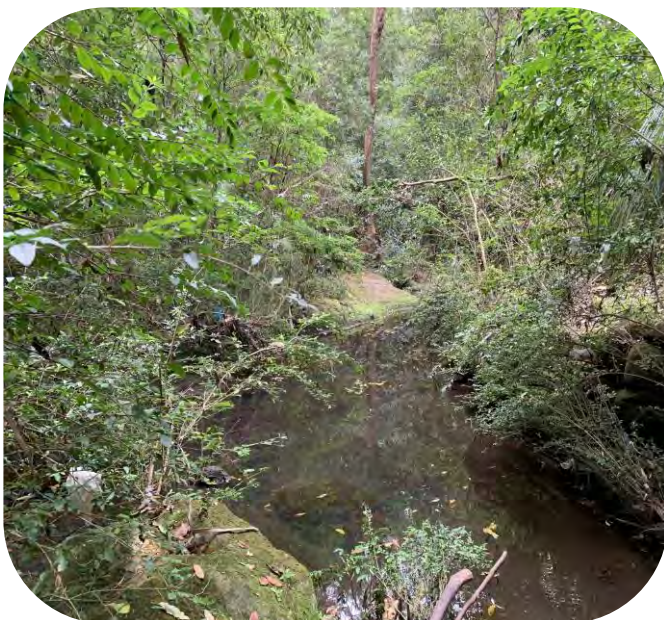
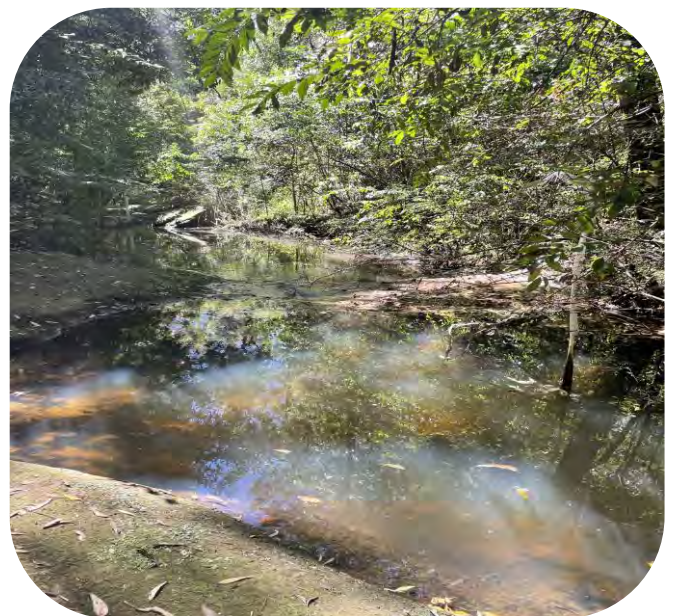
Figure 37 Examples of Riparian environments at Porters Creek core site (CR5P) during Spring 2020 (left) and Spring 2022 (right)

Generally, Rapid Riparian scores during this sampling season were observed to be consistent with the results of the previous Spring. However, both Terrys and Buffalo Creek saw an improvement in RRA score. During Spring 2022, Terrys Creek saw a reduction in the presence of litter observed on site when compared to Spring 2020. There was also an increase in the density of over-hanging vegetation as well as a reduction in the impacts of erosion, for example, there was a lower presence of bank slumps and channel erosion. As with Terrys Creek, less litter was observed at the Buffalo Creek site. During this season there was also a greater density of riparian vegetation. This season also had less observed bank erosion and channel restriction when compared to the previous season.
