City of Ryde

Water Quality Monitoring Report

Spring 2023

Report Name: City of Ryde Water Quality Monitoring Report Spring 2023

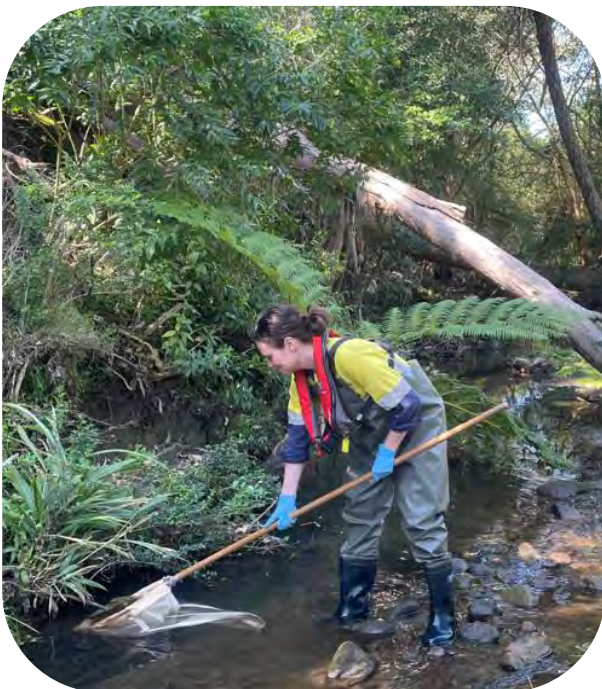
Figure 2 Collecting macroinvertebrates from Buffalo Creek (Spring 2023)

For this project, two replicate macroinvertebrate samples were collected at each of the five core sampling sites. Collection was performed using a fine mesh net to upwell the water and dislodge the animals. After sampling macroinvertebrates were picked out from the debris, preserved, and taken to the laboratory for identification and enumeration.

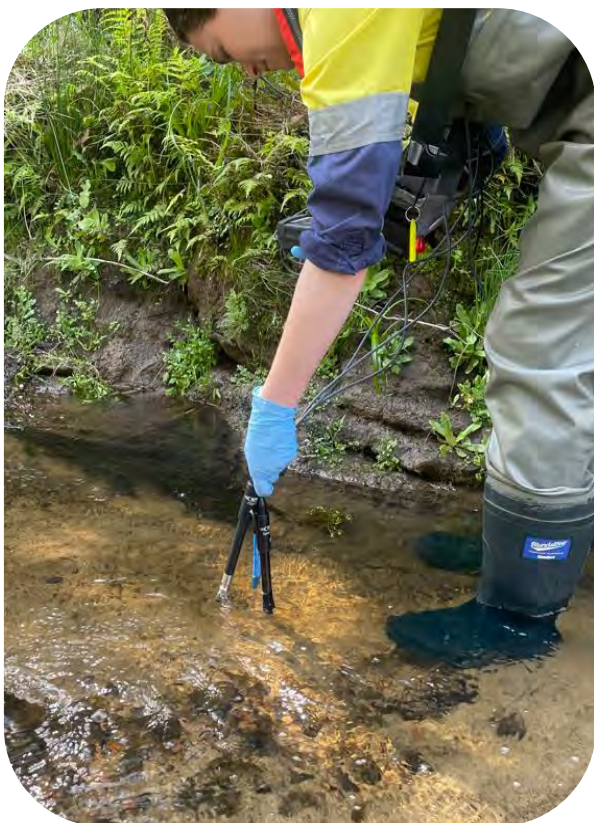
Figure 5 In-field water quality testing

Water quality samples were collected at the same time as the macroinvertebrate samples to ensure the data was accurate for comparison.

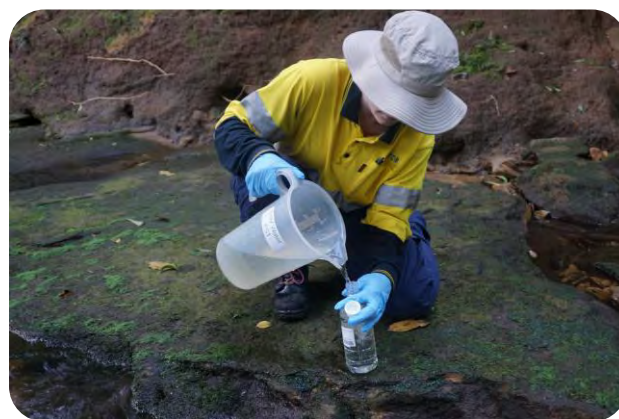
Figure 6 Collecting water samples for analysis

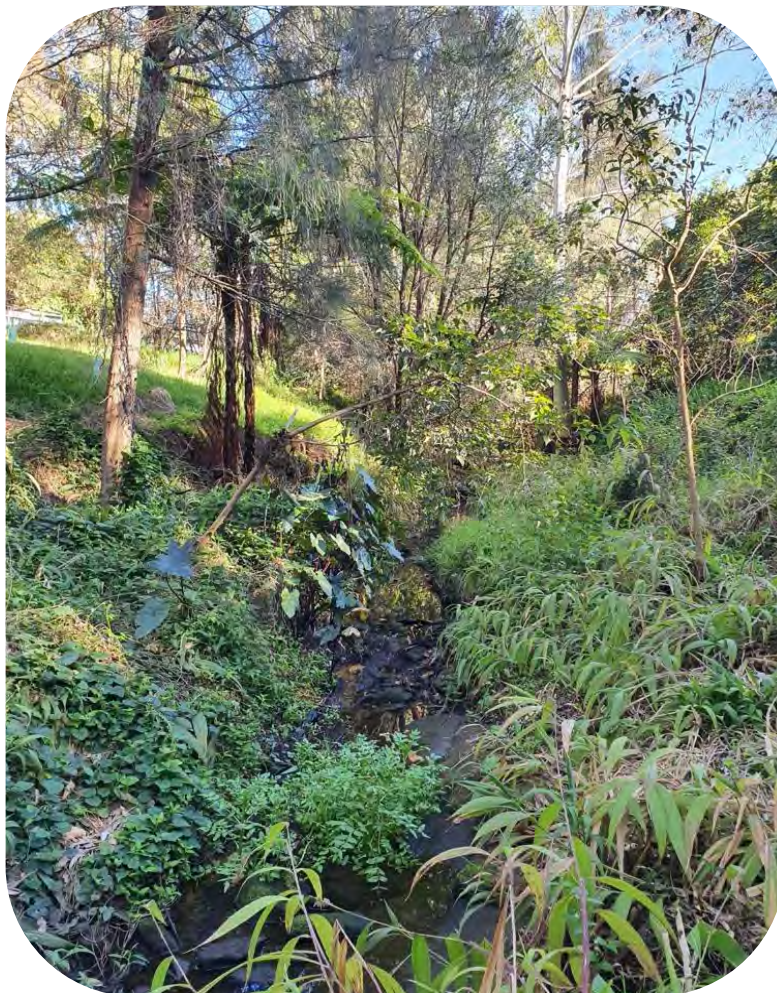
Figure 7 Archers Creek core site at Maze Park (CR2) looking upstream (Spring 2023). Displaying a variety of riparian structure types (ground cover, shrubs, tree canopy) and creek features including a steep sloping bank and bedrock channel.

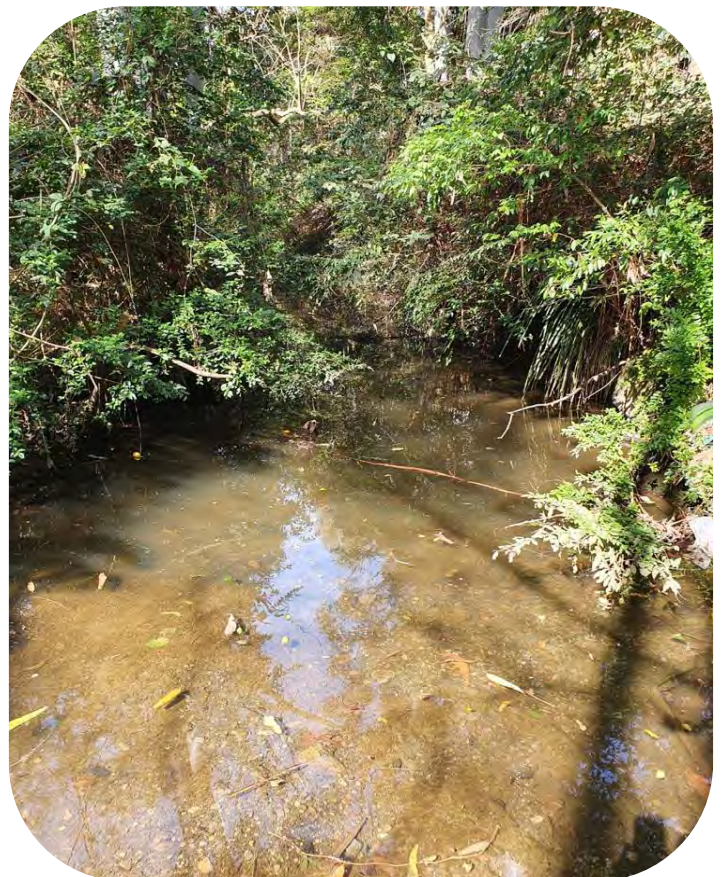
The creek flows through a thin riparian corridor, which is a combination of native and exotic species. The creek bed is predominately bedrock and sand/silt.

Figure 10 Shrimptons Creek at Wilga Park (Spring 2023)

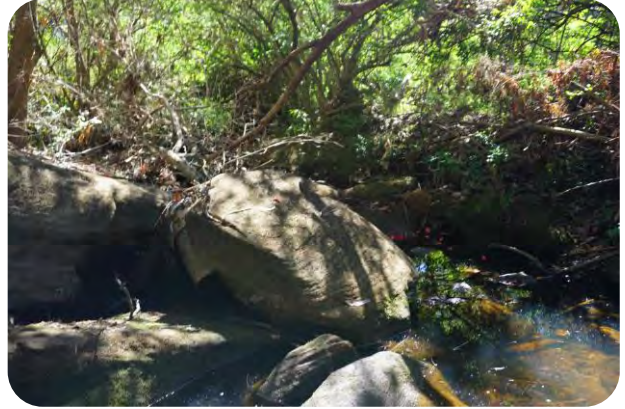
The Kent Road site is situated at ELS Hall Park amongst a residential area and is lined by a thin section of riparian vegetation that completely shades the creek and comprises a mix of native and exotic species.

Figure 11 Shrimptons Creek at Kent Rd facing downstream

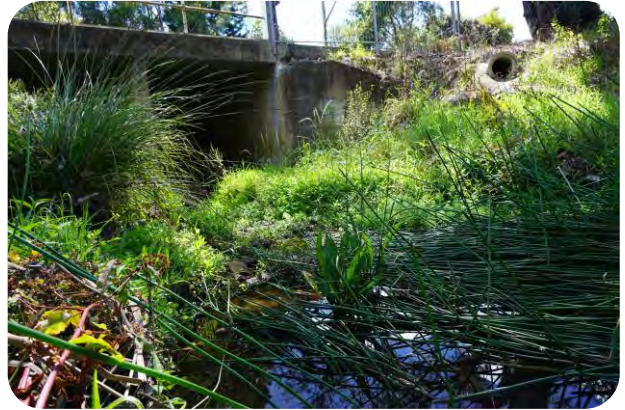
This site is located at the downstream section of Santa Rosa Park, just before it flows under Bridge Road and is surrounded by residential areas. The revegetation of the riparian area is now established adding to bank stabilisation, physical buffer, and filtration.

Figure 12 Shrimptons Creek at Bridge Road facing downstream

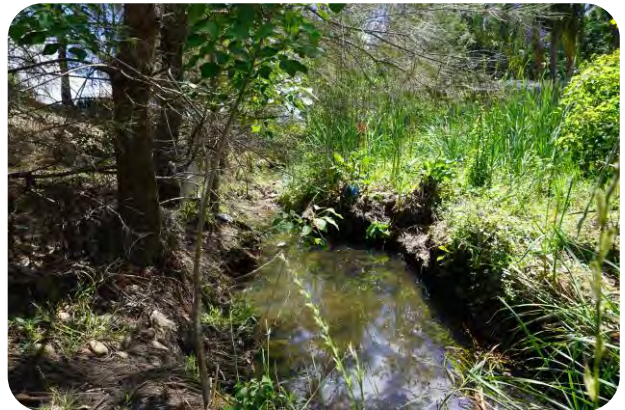
The Quarry Road site is located at the upstream section of Santa Rosa Park, at the point where Shrimptons Creek emerges from the underground stormwater system. This site has sandstone blocks around the drain for bank stabilisation.

Figure 13 Shrimptons Creek at Quarry Rd facing downstream

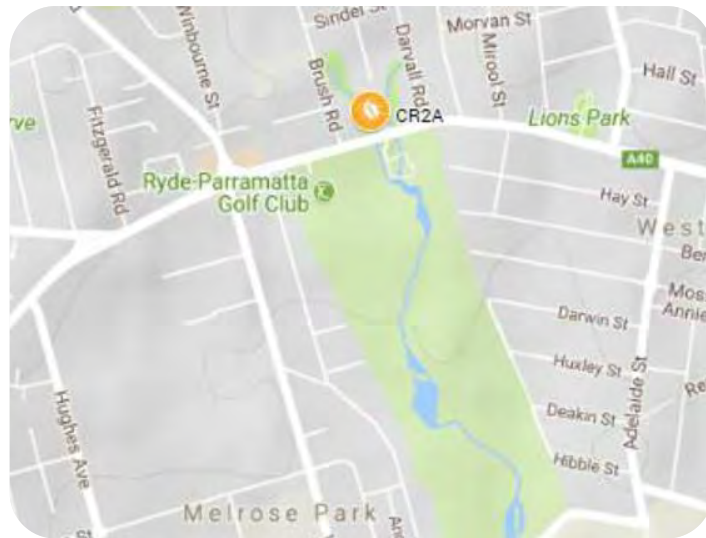
Figure 16 Archers Creek Catchment Area

This site is located in Maze Park, West Ryde and is upstream of the Victoria Rd crossing (Figure 16). The land use upstream of this site is largely residential while a golf course is present downstream. The creek bed is mostly bedrock bordered by banks of sediment (sand, silt and organic matter, Figure 17,18). The creek channel has been previously relined with sandstone blocks. The vegetation within and adjacent to the creek is a combination of native and introduced species.

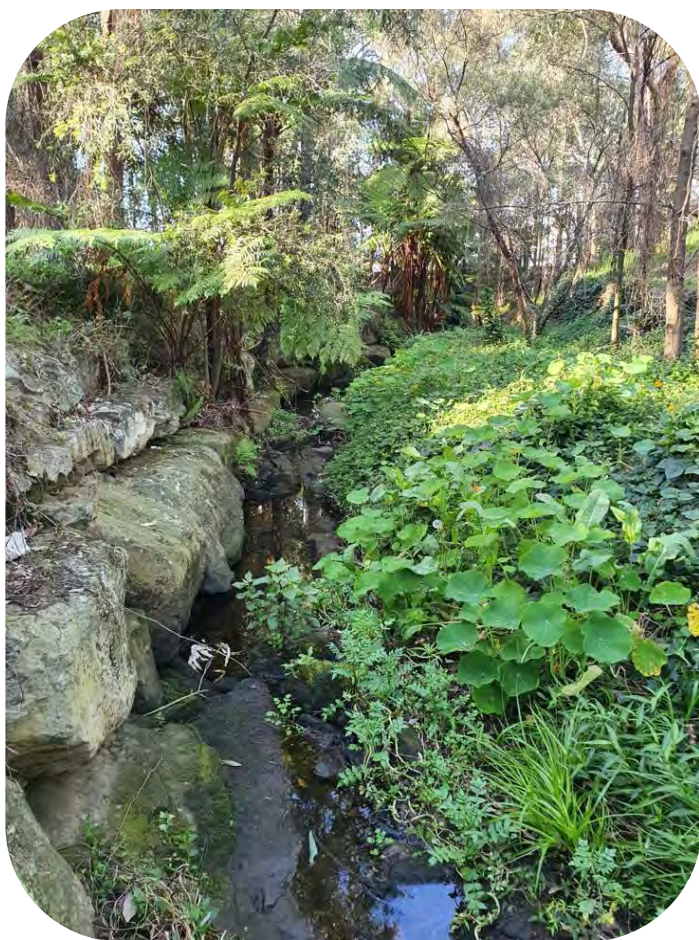
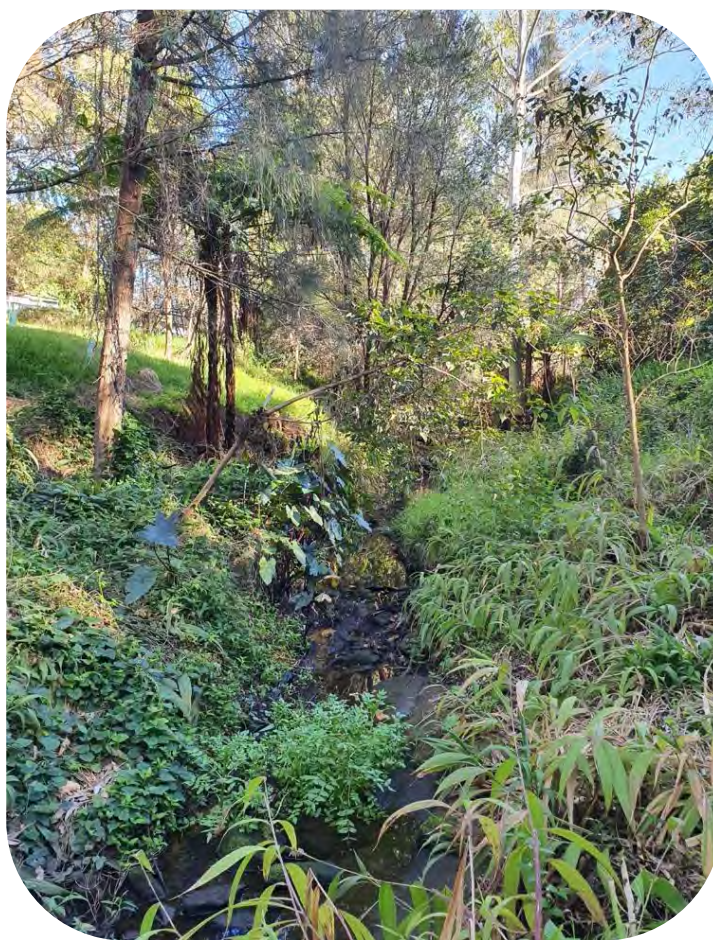
Figure 17 Archers Creek Core site (CR2A) looking downstream (Spring 2023)

Figure 18 Archers Creek Core site (CR2A) looking upstream (Spring 2023)

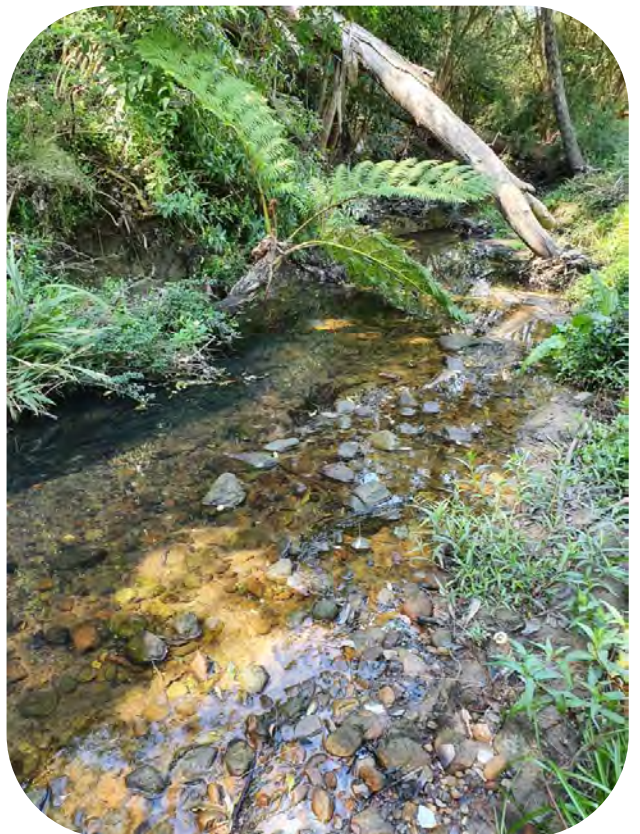
The creek bed is a mixture of sand, silt, and gravel. There is usually some macrophyte growth, (*Egeria* and *Potamogeton*), and a small amount of algal growth observed in the channel. Sedimentation has occurred in the creek channel periodically.

Figure 27 Buffalo Creek core site (CR4B) looking upstream, Spring 2023

Figure 28 Buffalo Creek core site (CR4B) looking downstream, Spring 2023

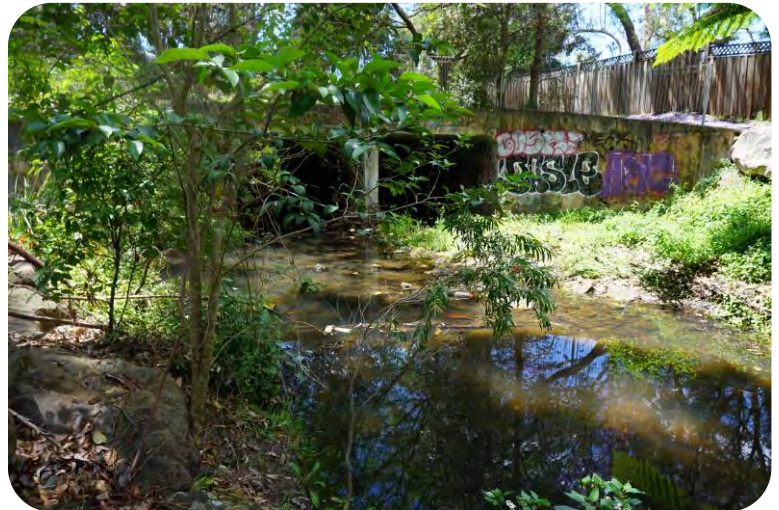
The downstream Burrows Park site is accessed off Buffalo Rd and is positioned just before the creek flows under the road. The surrounding land use is residential, and Burrows Park consists mostly of a bush corridor. There are usually obvious signs of bird activity around this site, including extensive bird droppings.

Figure 29 Buffalo Creek Downstream of Burrows Park

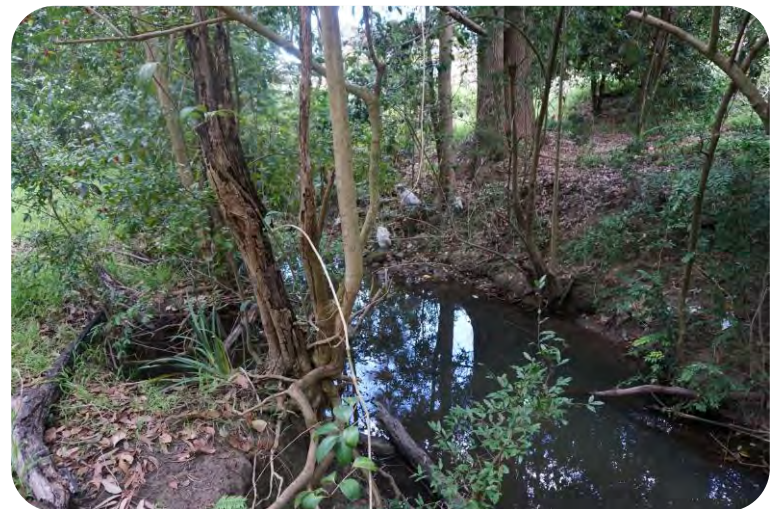
The upstream Burrows Park site is about 300 metres upstream of Buffalo Road and lies in the middle of a bush corridor. The site is surrounded by vegetation that completely shades the creek. The creek is shallow at this point and has little flow. The site is positioned just downstream from a stormwater tributary/pipe.

Figure 30 Buffalo Creek Upstream of Burrows Park

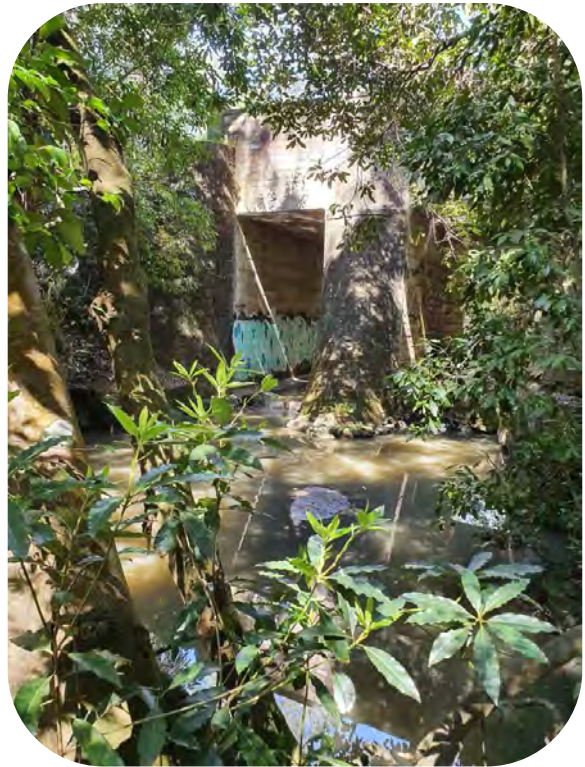
This site is in the Lane Cove National Park, North of the Council's Environmental Construction Materials Recycling Facility. It is at this point that Porters Creek emerges after flowing mostly underground in its upper section. Water quality and macroinvertebrate sampling was conducted near the Porters Creek Bridge. The surrounding riparian area is dominated by native plants with a small number of exotic species. The creek bed is mostly bedrock with some cobble, boulder and sand. No macrophyte growth has been observed although there has been algal growth present.

Figure 34 Porters Creek core site (CR5P) looking upstream, Spring 2023

Figure 35 Porters Creek core site (CR5P) looking downstream, Spring 2023

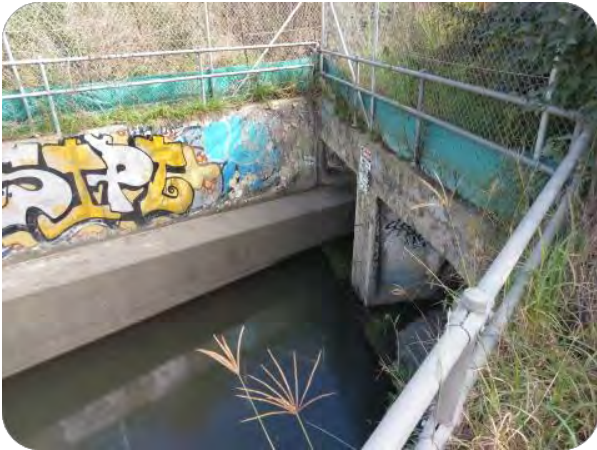
This site is located on the western boundary of the construction waste recycling facility and consists of an open concrete channel. Samples are collected from the retention basin at the end of the channel.

Figure 36 Porters Creek at Main Branch facing downstream

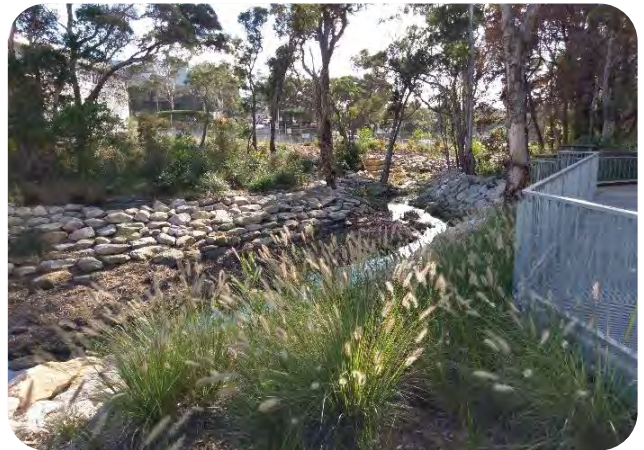
This site is the first point that Porters Creek daylights from the underground stormwater system. The site is surrounded by commercial and industrial land uses. The banks have been re-lined with sandstone and surrounding area vegetated with native plants.

Figure 38 Porters Creek at Wicks Road

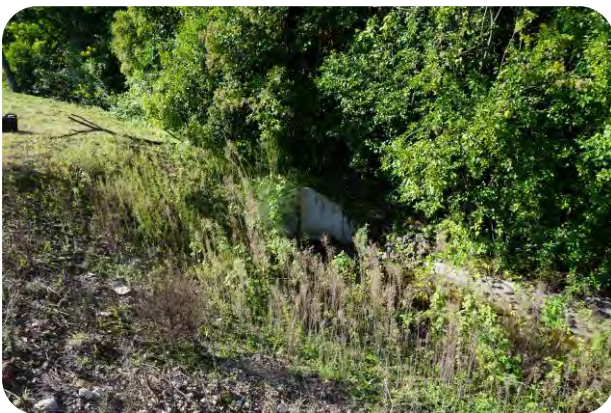
This site is in the north-western corner of the centre in an underground drainage pit where several underground stormwater lines meet before joining and draining to the main Porters Creek line. The exact location has changed over the years due to access issues.

Figure 37 Porters Creek at Spur Branch

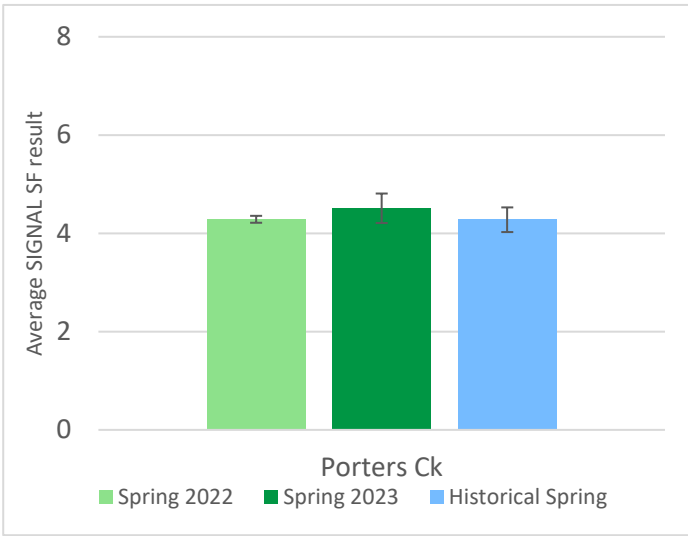
The average SIGNAL score for Porters Creek core site during Spring 2023 was 4.5. This was consistent with the Spring 2022 result (4.3) as well as the historical average for the season (4.3, Figure 39).

Figure 39 Porters Creek Average SIGNAL-SF scores

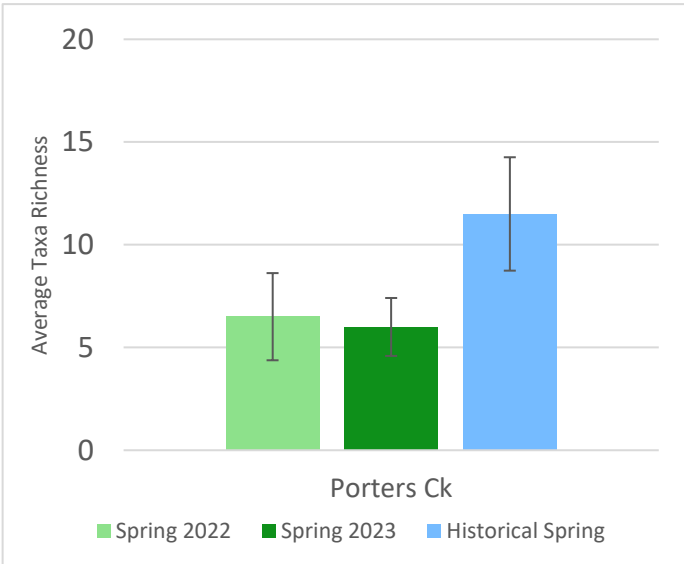
Figure 40 Porters Creek Average Taxa Richness scores

Porters Creek average Taxa Richness result for Spring 2023 was 6 (Figure 40) which was slightly lower than the previous Spring (6.5, 2022). The result was also lower than the historical average for this site. During this season, the macroinvertebrate community was almost entirely comprised of families from the True Flies group (Figure 40A). An over-representation of a highly tolerant taxa group is indicative of impacted environment.
