# **City of Ryde**

## **Water Quality Monitoring Report**

**Spring 2024 & Autumn 2025**

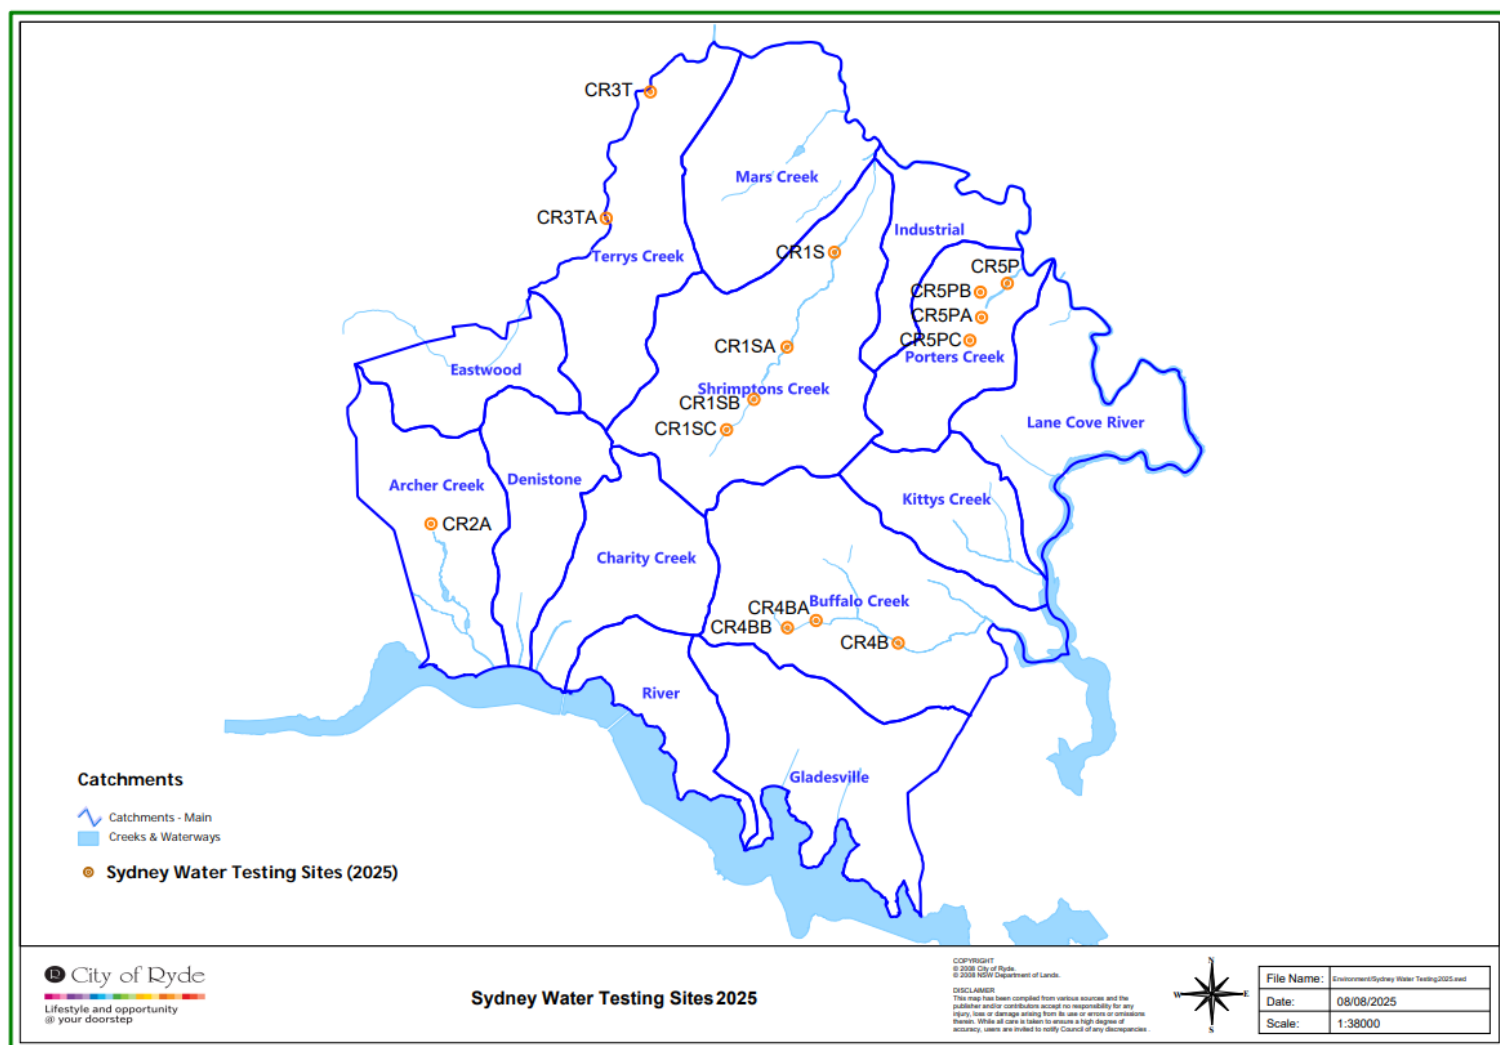
Figure 1 City of Ryde Water Quality Management Program Sites Map for chemical and ecological monitoring across five creeks.

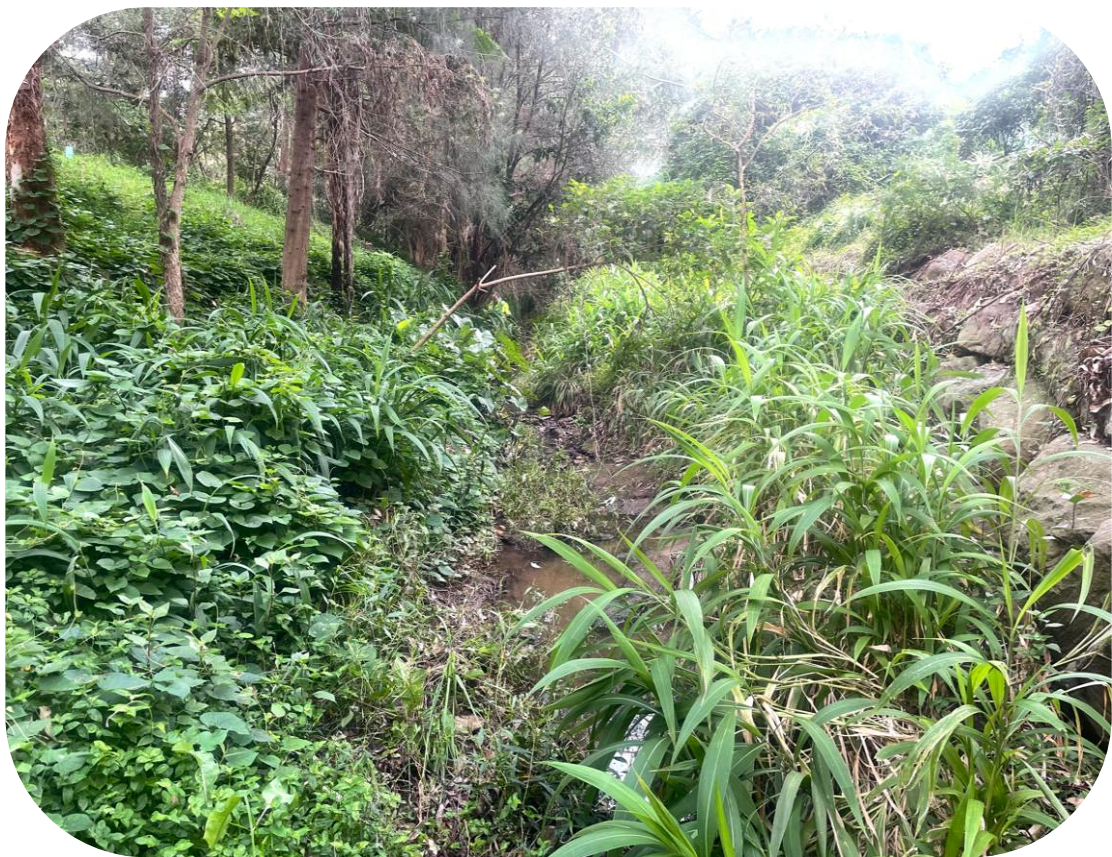
Figure 6 Archers Creek core site at Maze Park (CR2) looking upstream (Autumn 2024). This site has a consistently high density of riparian vegetation including a range of weedy riparian types (ground cover, shrubs, and an extensive tree canopy).

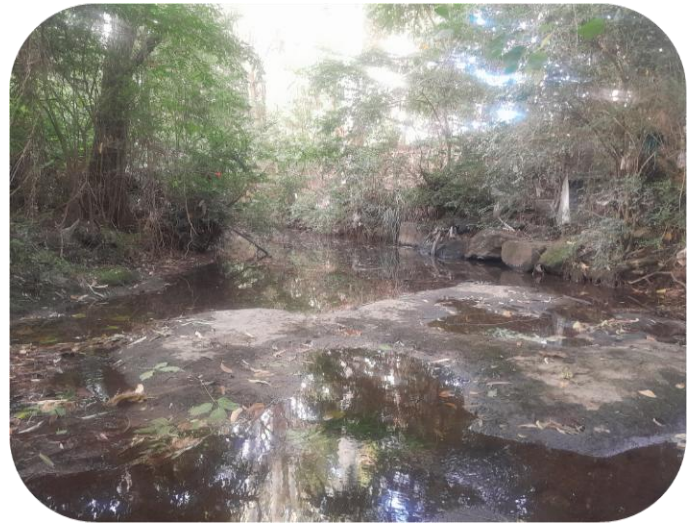
The Shrimptons Creek core site is located within Wilga Park in the suburb of Macquarie Park. Land use in this area is primarily residential, commercial, and light industrial. The creek flows through a thin riparian corridor, which is a mix of native and exotic species (Figure 9,10). The creek bed is predominately bedrock and sand/silt.

Figure 9 Shrimptons Creek (core site) looking downstream (Autumn 2025)

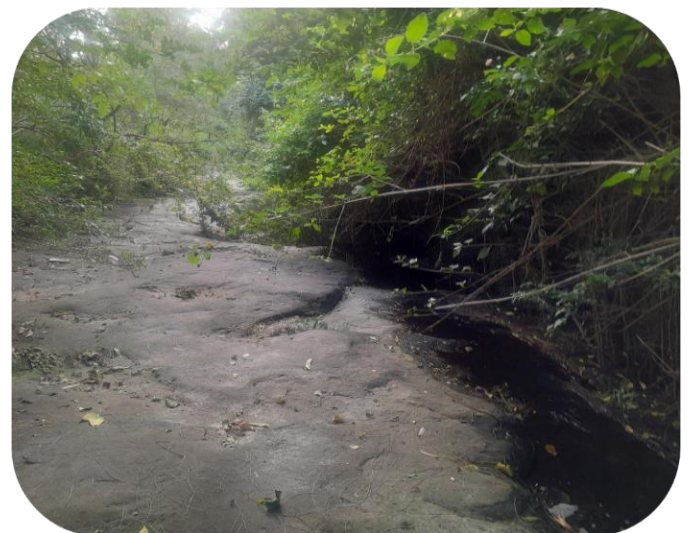
Figure 10 Shrimptons Creek (core site) looking upstream (Autumn 2025)

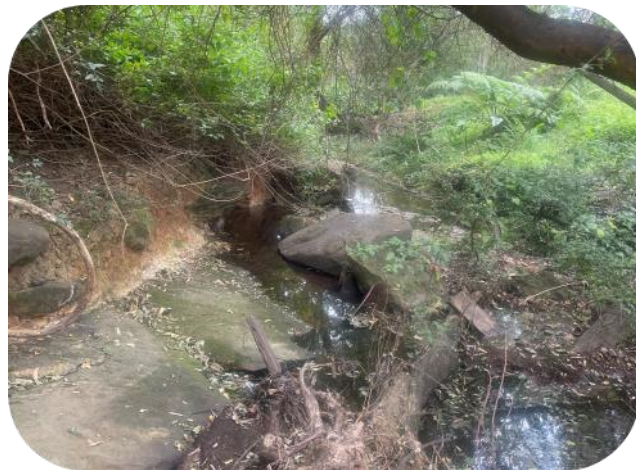
The Kent Road site is situated at ELS Hall Park amongst a residential area and is lined by a thin section of riparian vegetation comprised of native and exotic species that completely shades the creek (Figure 11)

Figure 11 Shrimptons Creek at Kent Road facing downstream (Autumn 2025)

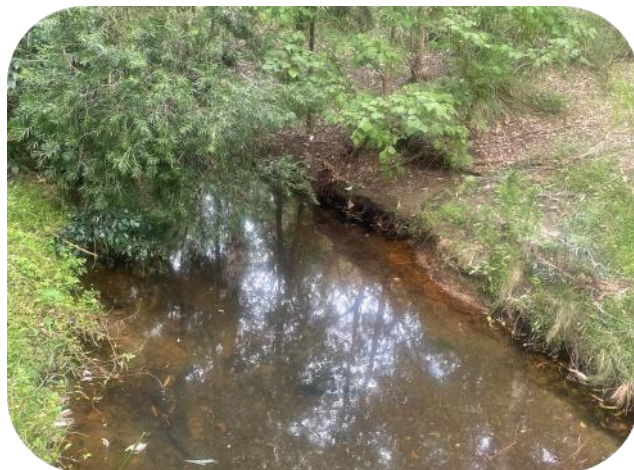
This site is located at the downstream section of Santa Rosa Park, just before it flows under Bridge Road and is surrounded by residential areas (Figure 12). Revegetation of the riparian area has enhanced the physical buffer improving bank stabilisation and filtration.

Figure 12 Shrimptons Creek at Bridge Road facing upstream (Autumn 2025)

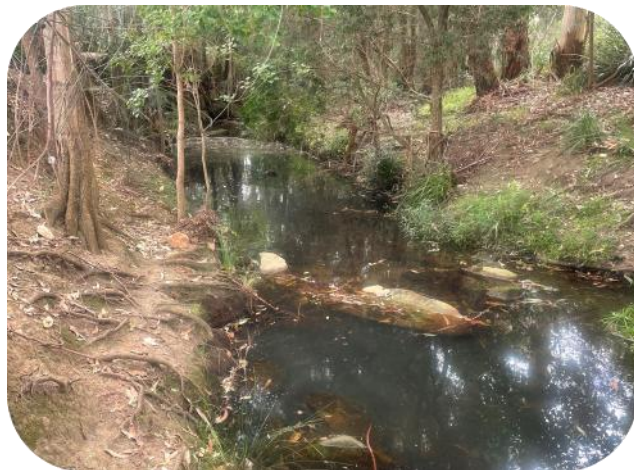
The Quarry Road site is located at the upstream section of Santa Rosa Park, at the point where Shrimptons Creek emerges from the underground stormwater system (Figure 13). This site has sandstone blocks around the drain for bank stabilisation.

Figure 13 Shrimptons Creek at Quarry Road facing downstream (Autumn 2025)

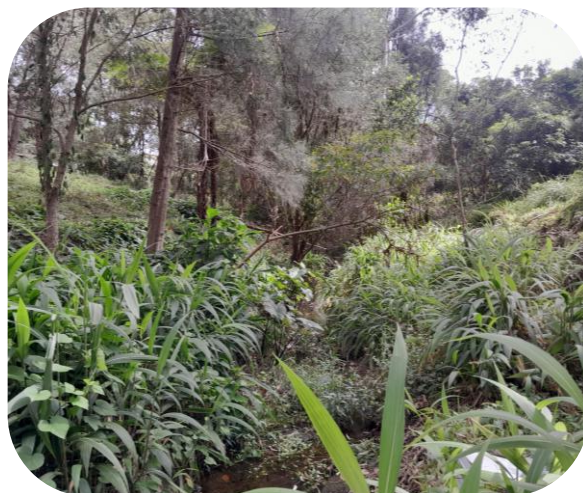
This site is located in Maze Park, West Ryde and is upstream of the Victoria Road crossing (Figure 17). The land use upstream of this site is largely residential while a golf course is present downstream. The creek bed is mostly bedrock bordered by banks of sediment (sand, silt and organic matter, Figure 18, 19). The creek channel has been previously relined with sandstone blocks. The vegetation within and adjacent to the creek is a combination of native and introduced species.

Figure 19 Archers Creek looking upstream (Autumn 2025)

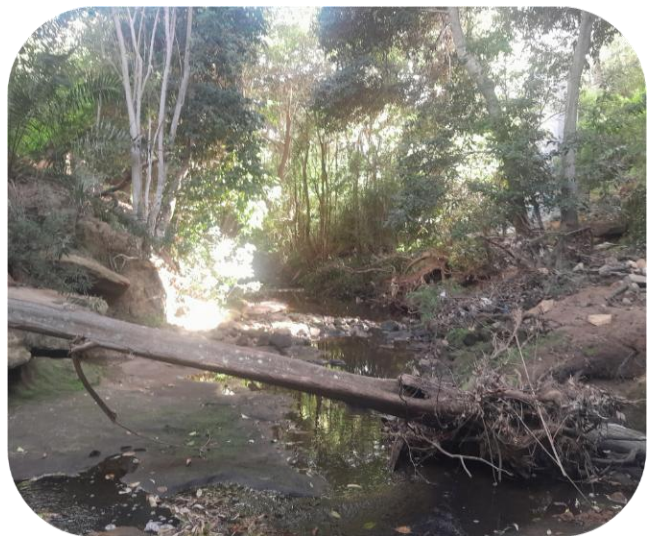
This site is located within Somerset Park under the M2 overpass in the suburb of Epping (Figure 23). The surrounding land use is residential, and the creek flows through a bushland corridor. The riparian area bordering the creek contains both native and exotic plant species. The creek bed is predominately bedrock, gravel, and sand (Figure 24, 25).

Figure 25 Terrys Creek (core site) looking upstream (Autumn 2025)

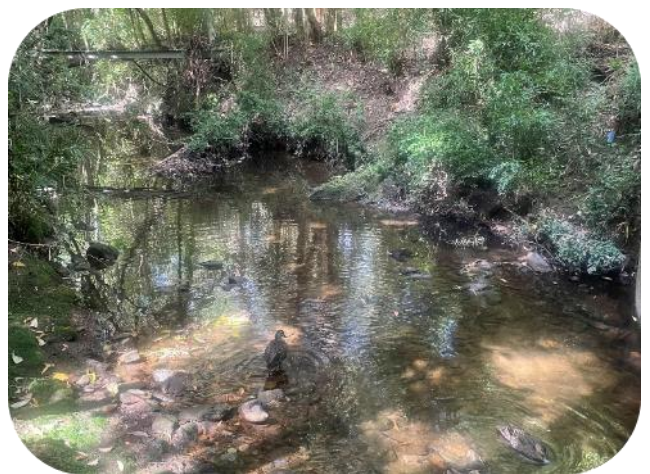
This site is located downstream of Terrys Creek Waterfall, which is an area surrounded by bushland (Figure 26). Dense vegetation covers both banks and consists of a mixture of native and introduced species. The bank is comprised of sediment (mostly sand and silt) and river rocks, which create riffle areas.

Figure 26 Terrys Creek at Forrester Park looking upstream (Autumn 2025)

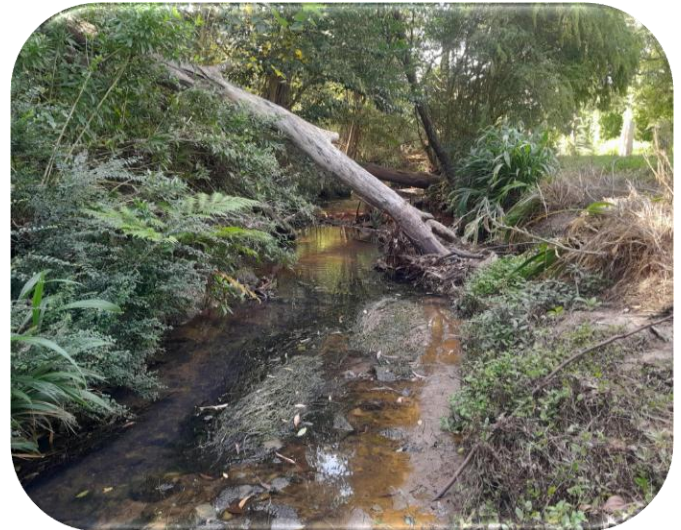
The Buffalo Creek core sampling site is located along the Southern border of the Field of Mars Reserve in the suburb of Gladesville and is accessed through private property (Figure 31, 32). The surrounding land use is a mix of residential, light industry/commercial and reserves. The surrounding vegetation is a mix of native and exotic species, with exotic species dominating. The southern bank is mostly residential lawns.

The creek bed is a mixture of sand, silt, and gravel. There is usually some macrophyte growth, (*Egeria* and *Potamogeton*), and a small amount of algal growth observed in the channel. Sedimentation has occurred in the creek channel periodically.

Figure 31 Buffalo Creek core site looking downstream (Autumn 2025)

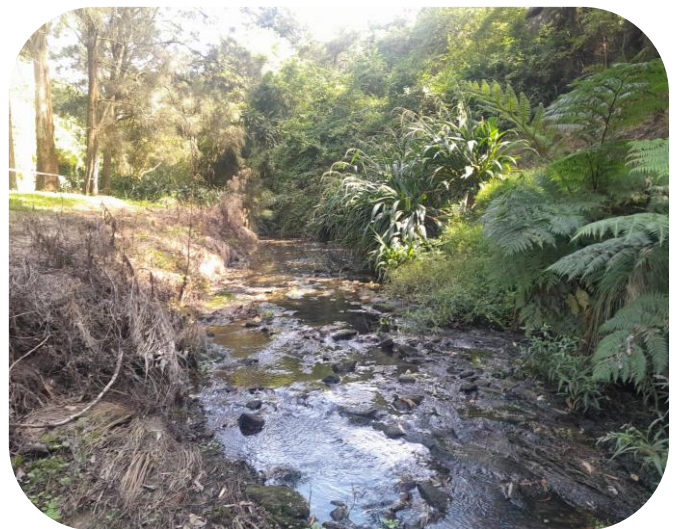
Figure 32 Buffalo Creek core site looking upstream (Autumn 2025)

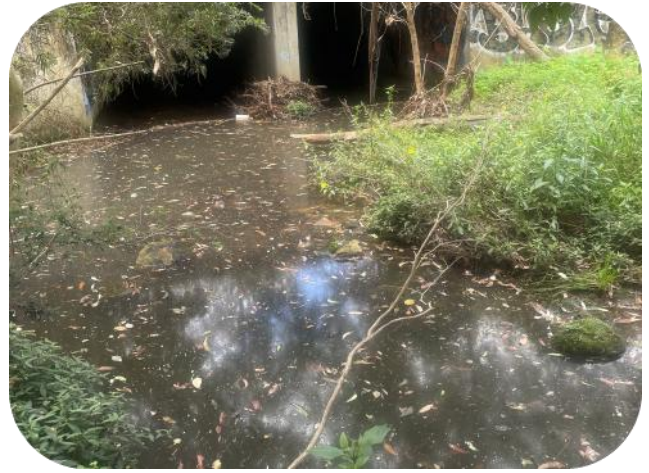
The downstream Burrows Park site is accessed off Buffalo Road and is positioned just before the creek flows under the road (Figure 33). The surrounding land use is residential, and Burrows Park consists mostly of a bush corridor. There are usually obvious signs of bird activity around this site, including extensive bird droppings.

Figure 33 Buffalo Creek Downstream of Burrows Park facing downstream (Autumn 2025)

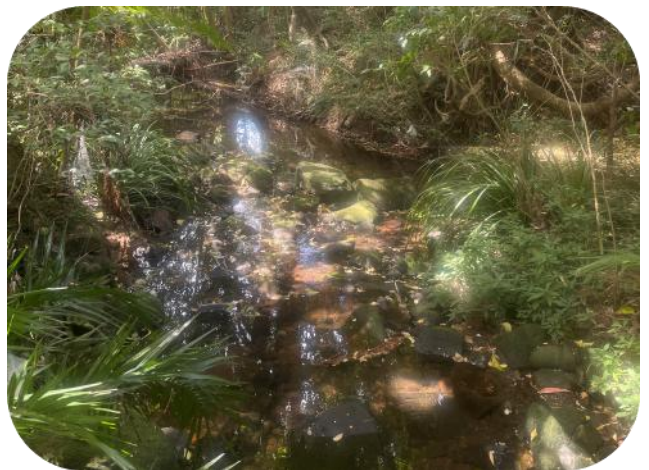
The upstream Burrows Park site is about 300 metres upstream of Buffalo Road and lies in the middle of a bush corridor (Figure 34).

The site is surrounded by vegetation that completely shades the creek. The creek is shallow at this point and has little flow.

Figure 34 Buffalo Creek Upstream of Burrows Park facing downstream (Autumn 2025)

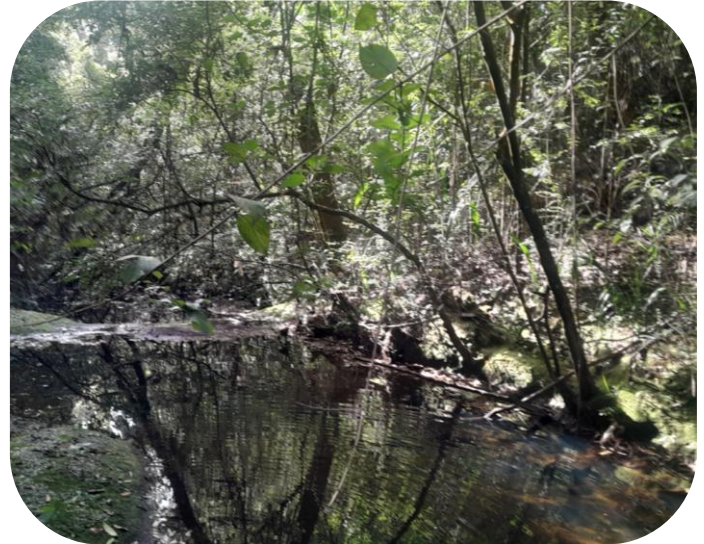
The surrounding riparian area is dominated by native plants with a small number of exotic species. The creek bed is mostly bedrock with some cobble, boulder, and sand (Figure 39). No macrophyte growth has been observed although there has been algal growth present.

Figure 39 Porters Creek Core Site looking downstream (Autumn 2025)

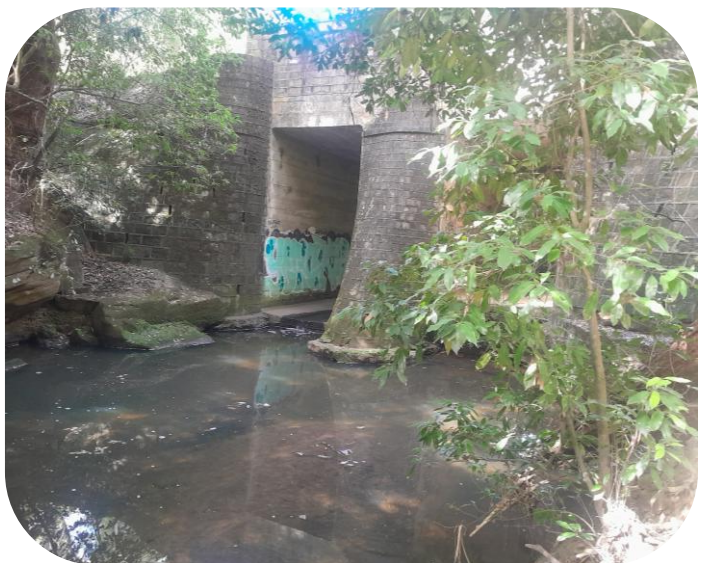
This site is in the Lane Cove National Park, North of the Council's Environmental Construction Materials Recycling Facility. It is at this point that Porters Creek emerges after flowing mostly underground in its upper section. Water quality and macroinvertebrate sampling was conducted near the Porters Creek Bridge (Figure 40).

Figure 40 Porters Creek Core Site looking upstream (Autumn 2025)

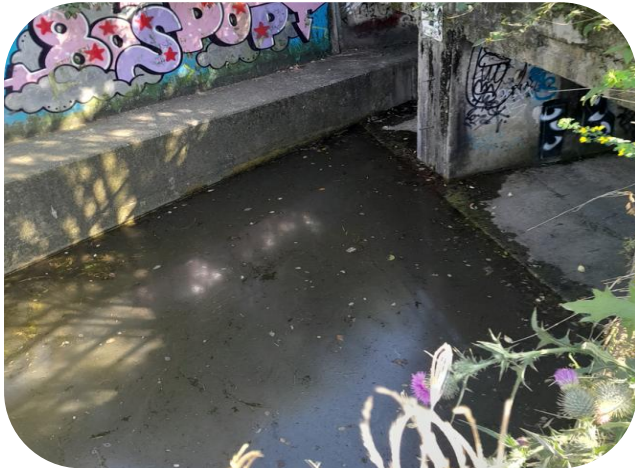
This site is located on the western boundary of the construction waste recycling facility and consists of an open concrete channel (Figure 41). Samples are collected from the retention basin at the end of the channel.

Figure 41 Porters Creek at Main Branch facing downstream

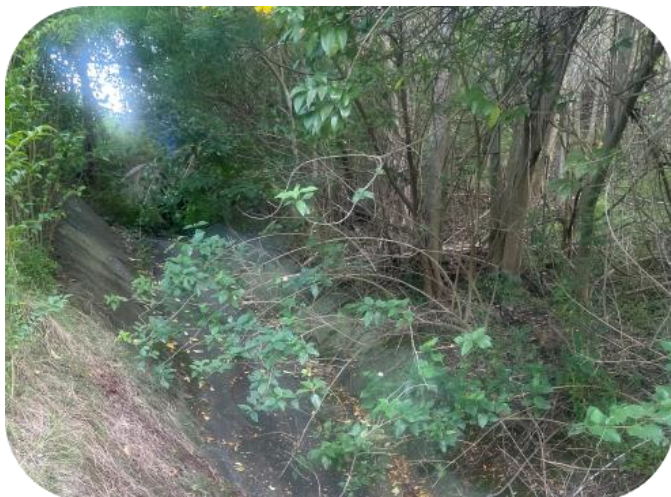
This site is in the north-western corner of the centre in an underground drainage pit where several underground stormwater lines meet before joining and draining to the main Porters Creek line (Figure 42). The exact location has changed over the years due to access issues.

Figure 42 Porters Creek at Spur Branch (Autumn 2025)

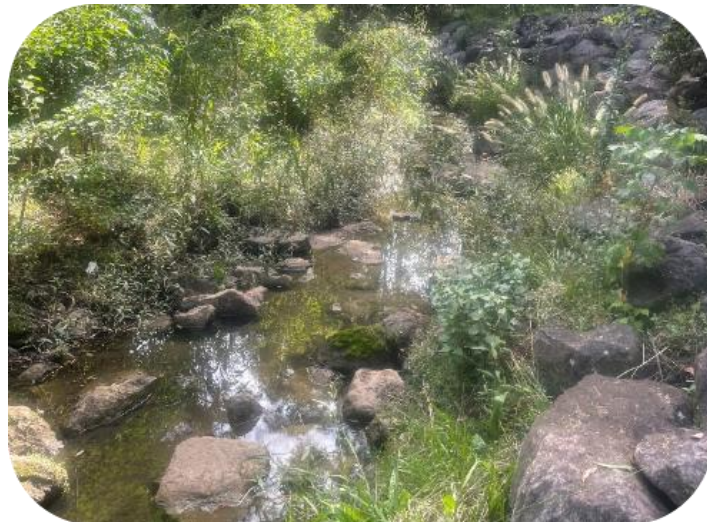
This site is the first point that Porters Creek emerges from the underground stormwater system. The site is surrounded by commercial and industrial land uses. The banks have been re-lined with sandstone and surrounding area vegetated with native plants (Figure 43).

Figure 43 Porters Creek at Wicks Road (Autumn 2025)
