Appendix B

Tree Assessment

ARBORICULTURAL ASSESSMENT

SITE ADDRESS
PROPOSED RYDE RIVER WALK

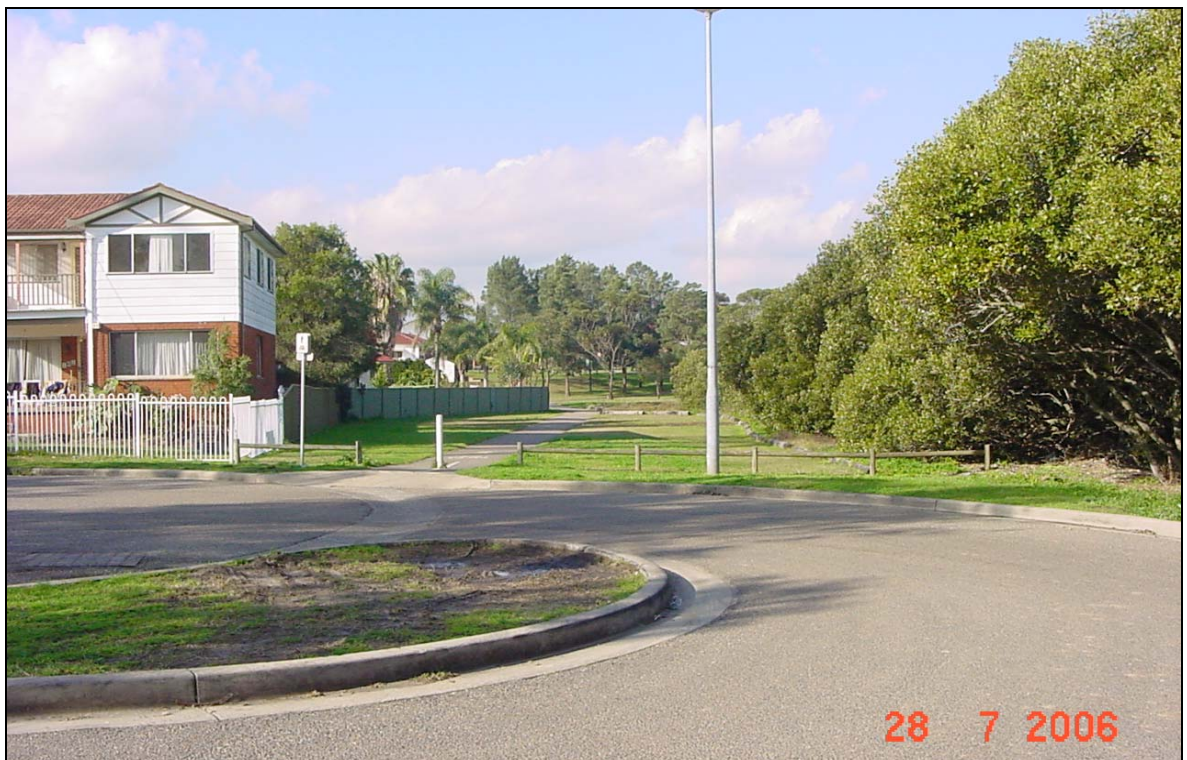
The westernmost location of the proposed river walk begins at the Wharf Road car park. The existing path through Koonadan Reserve is well away from any significant trees or vegetation, and can be easily upgraded without any special arboricultural requirements for tree protection.

Figure 1 KOONADAN RESERVE
Looking east towards Melrose Park.

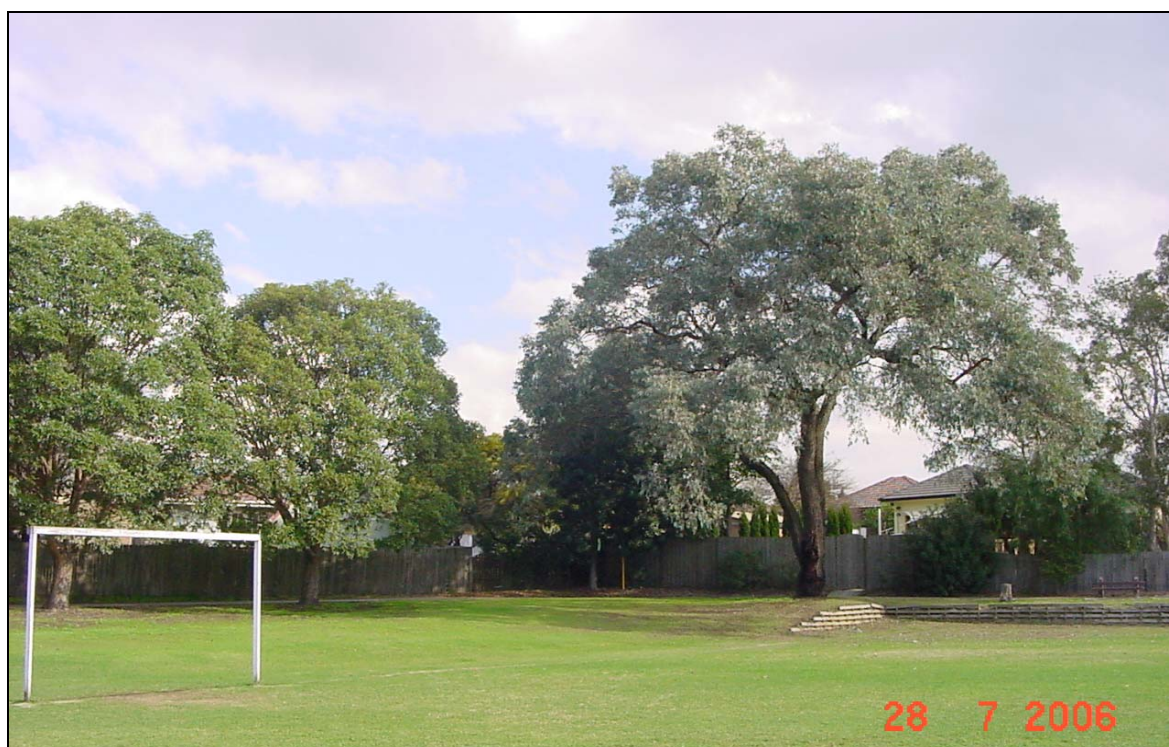
Figure 4 MEADOWBANK PARK

Looking south between end of row of Brush Boxes, and significant red Ironbark.

- 3.2.3 A large and significant Red Ironbark (*Eucalyptus sideroxylon*) was noted West of the Brush Boxes. The proposed path does not impact on this tree.
- 3.2.4 The proposed shared loop path can be easily accommodated between the existing Broad-leaved Paperbark (*Melaleuca quinquenervia*) on the left in the photograph (Figure 5, following page), and the very young sapling on the right.

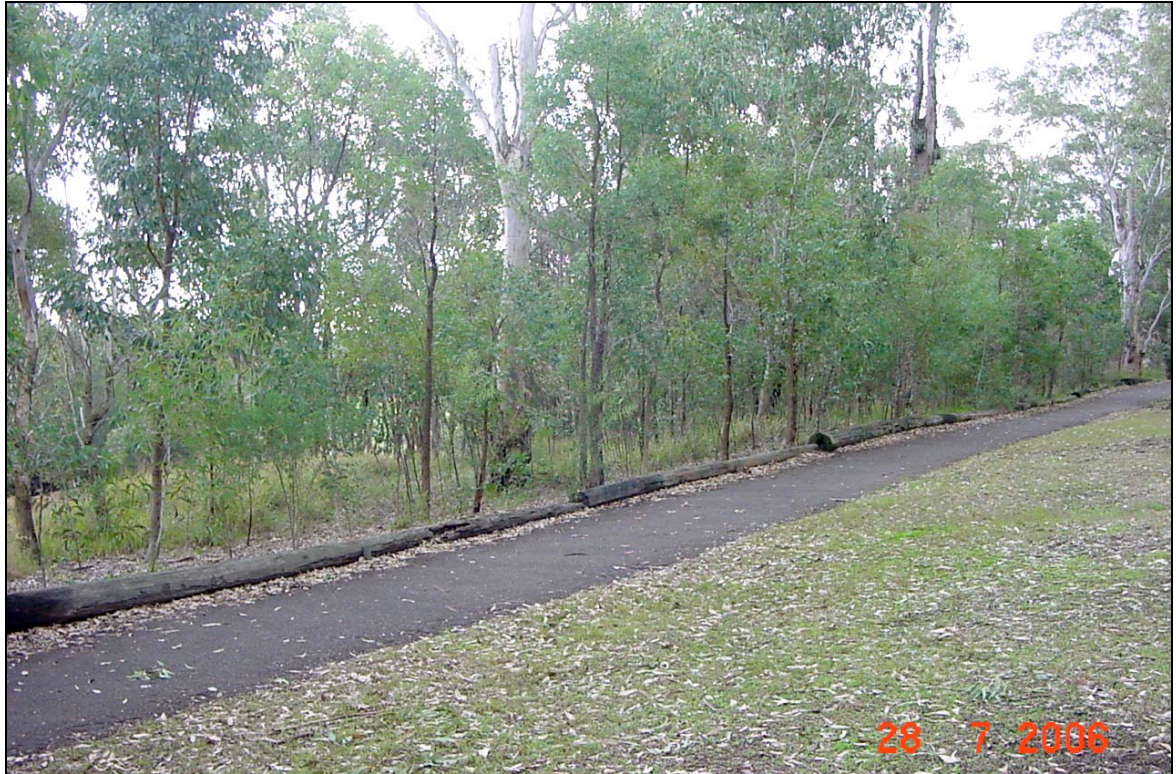
Figure 8 MEMORIAL PARK

An existing path from Meadowbank Park to Charity Point is generally of good condition. Any future widening should consider the presence of existing trees and vegetation, and follow the general guidelines set out in the recommendations section of this report. There were no stand alone significant trees noted through this section.

Section of existing path climbing the slope in a north direction towards Meadow Crescent.

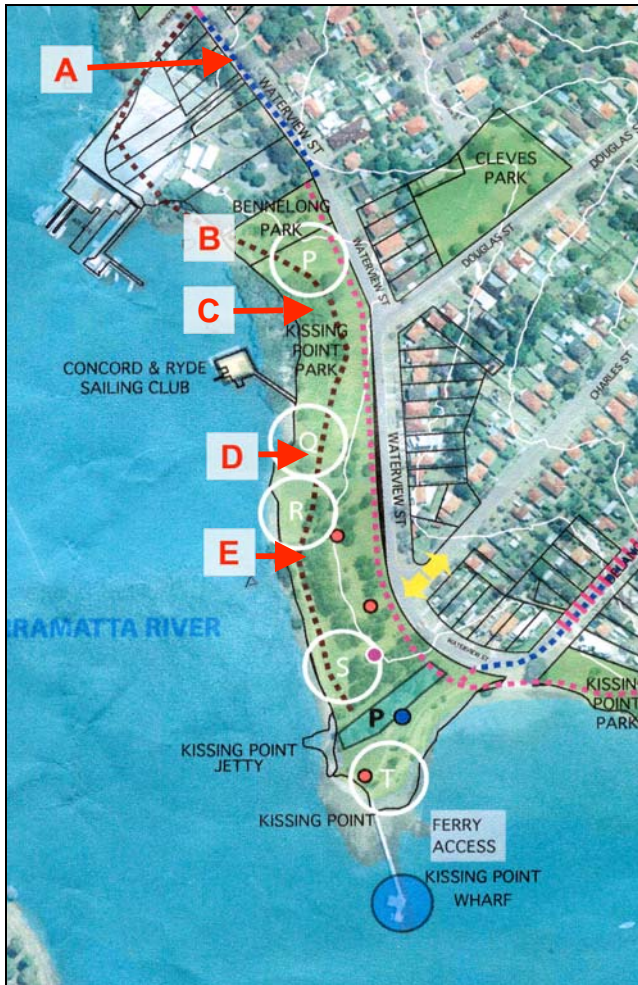
Figure 14

It was noted the street is not kerbed and guttered along the west side. The distance from the edge of the road surface to the closest row of trees is several metres. It is possible a cycle lane could be accommodated in this location, and the pedestrian path installed between the two rows of trees.

It is preferable to incorporate the existing 'desire' line, rather than to cause impacts on other trees by diverting a path through the group.

There is ample room for a 1.5 – 2 metre shared path from the Kissing Point Park car park to approximately 125 metres northwest.

At this point there is a group of semi-mature She-oaks that encroach into the potential path area. These trees are unlikely to suffer from any path installed through this 'pinch point'; however, they are quite likely to damage any path over the root zones.

Plan showing the locations of Areas A to E, in Waterview Street, Bennelong and Kissing Point Parks.

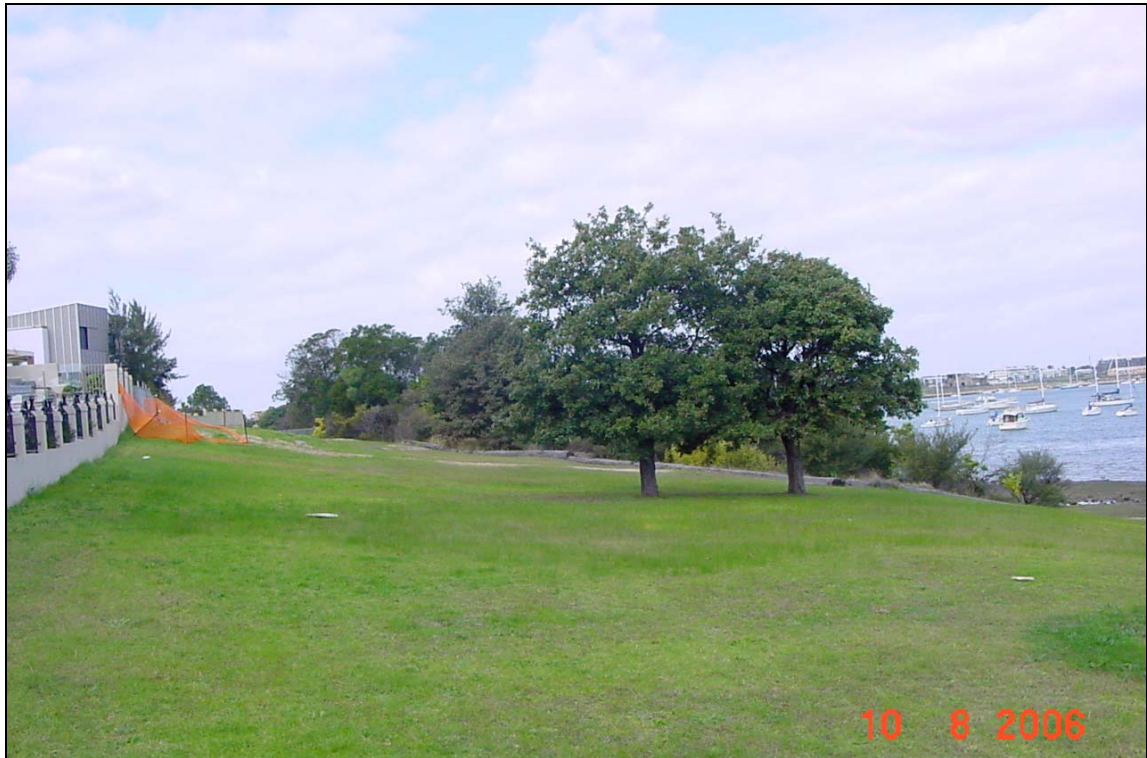
Figure 16 KISSING POINT PARK

3.4.7 The proposed path can easily be constructed without impacts on the two young Turpentines (*Syncarpia glomulifera*) seen in Figure 16, below.

From the southern end of Delange Road, looking southeast.

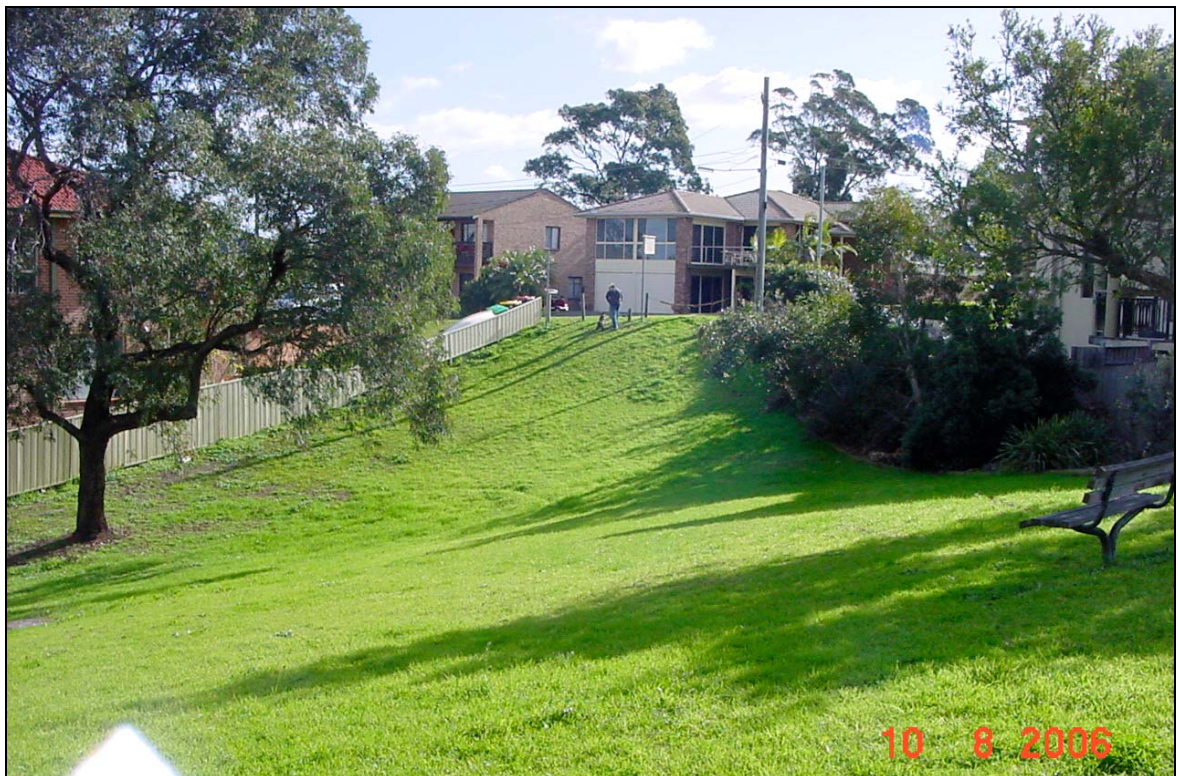
Figure 17 HOFFMAN PARK
Looking west to Chadwick Street.

Adequate space is available for the proposed Type 1 path without impacting on existing trees. Preference is to be given to locating the path outside the drip line of the Small-leaved Peppermint (*Eucalyptus nicholii*) shown in the left of the photograph below - Figure 17.

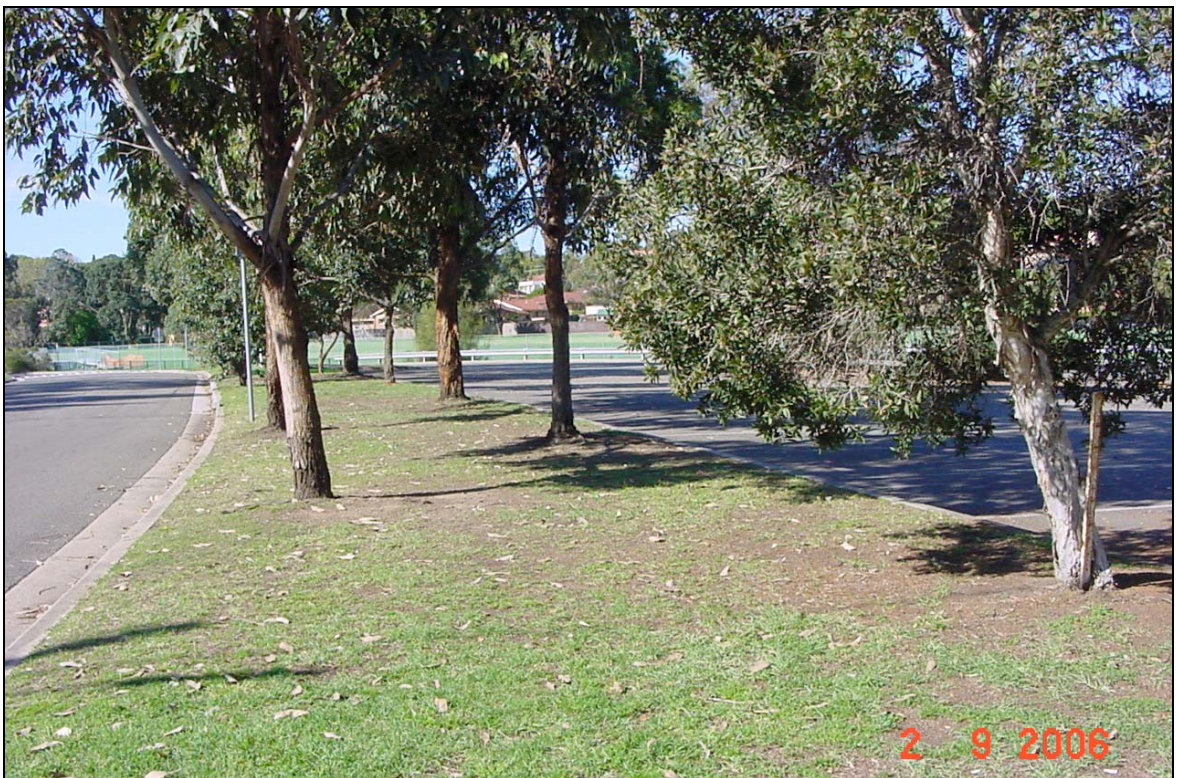
Figure 22 MORRISONS BAY PARK
Looking northeast along Frances Road. Trees located in road reserve.

- 3.6.4 Between the sports ground car park and Frances Road, there are two rows of trees within the road reserve (Figure 22). There is little space to accommodate the proposed type 1 path without removal of several trees, and specific construction methods used to reduce impacts on tree roots would need to be adopted.

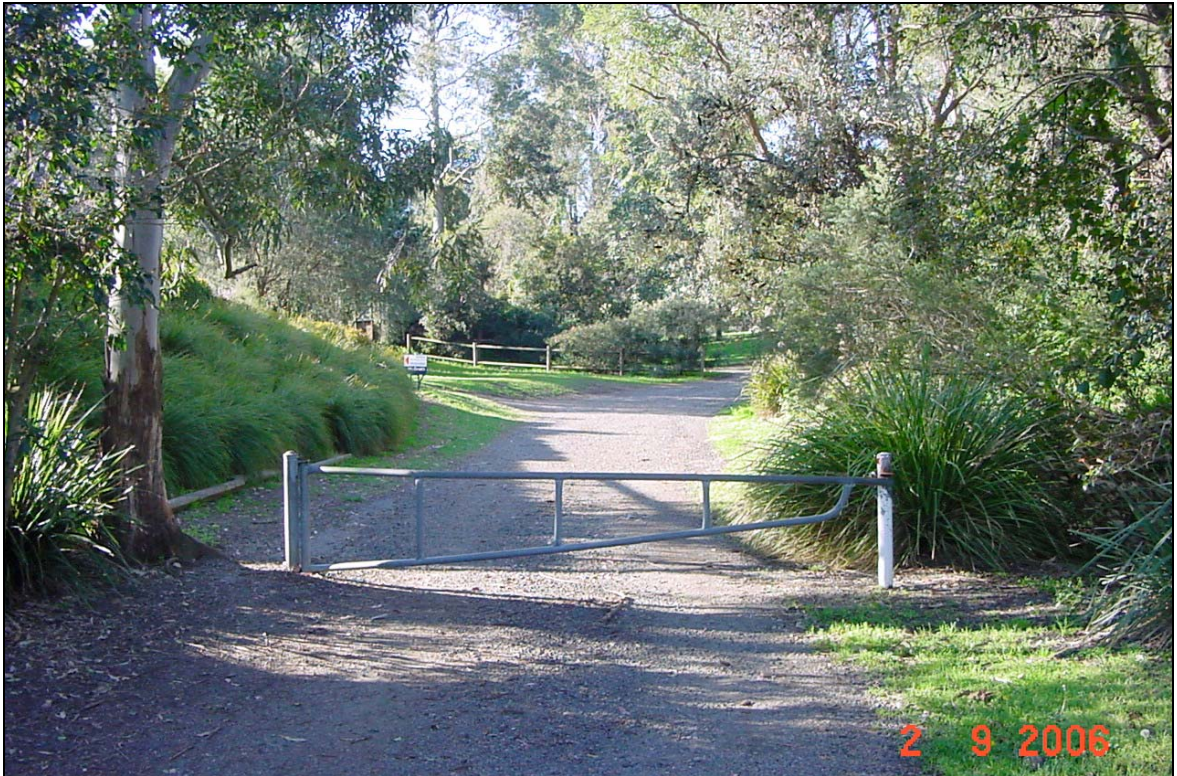
The location of the secured access gate restricts walkers and cyclists. On the right side of the gate (east) a couple of *Lomandras* could be removed, and some shrubs pruned, to create a narrow path access to the park. (Figure 23)

Figure 23 BILL MITCHELL PARK
Looking north, towards Morrison Road. Note driveway access to residences on left side of photograph.

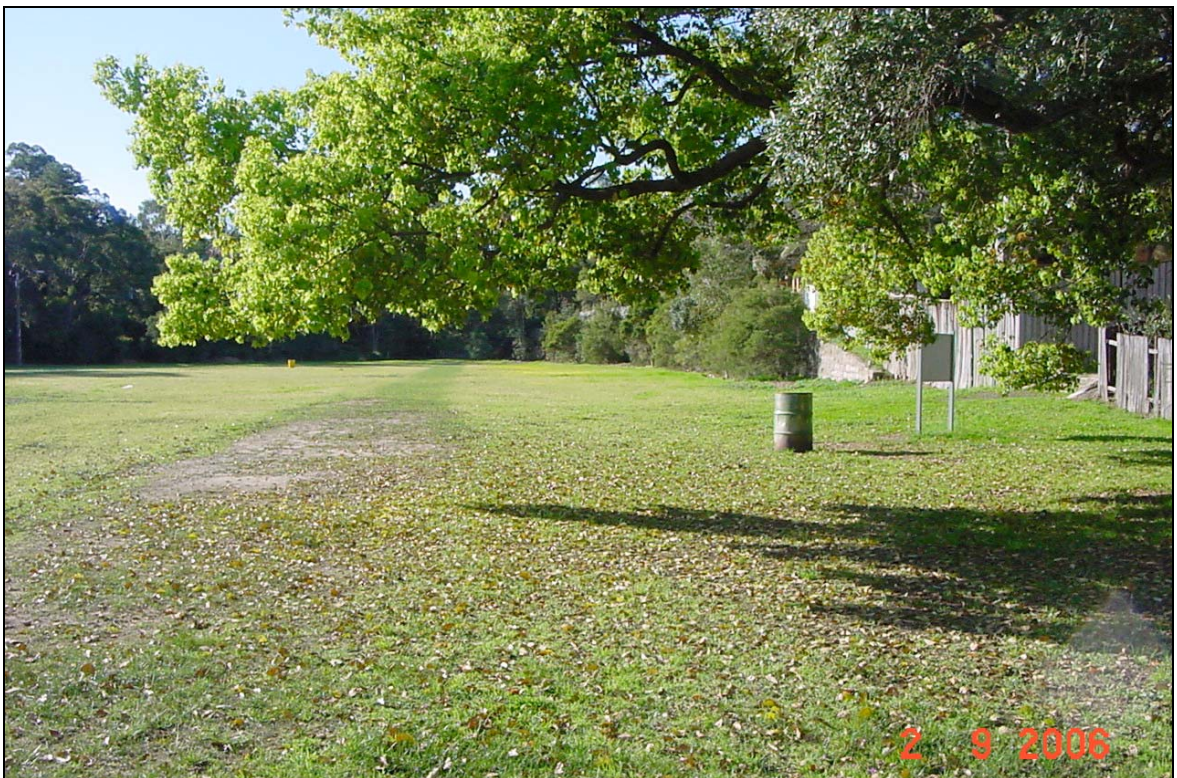
- 3.6.8 A concrete path along the east side of the park ends just short of the steep steps leading from the park to Western Crescent. At this point it appears the path has been removed and/or filled over. The photograph (Figure 24) shows the darkened strip leading back to the north entry to the park. This strip is in line with the direction of the existing concrete path. A new path could be located in this position, or closer to the park boundary. A large Camphor Laurel, located near the boundary, would need to be pruned to allow clearance for walkers and cyclists. If possible, the path should be kept to the outer extremity of the tree's dripline to reduce root impacts; otherwise, an arboriculturist should provide specific details of construction methods over the root zone to avoid unnecessary impacts on tree roots.

Figure 24 BILL MITCHELL PARK
Looking north, towards park entry. Note darkened strip in grass, indicating probable location of old concrete path. This path may have been removed, or simply turfed over.

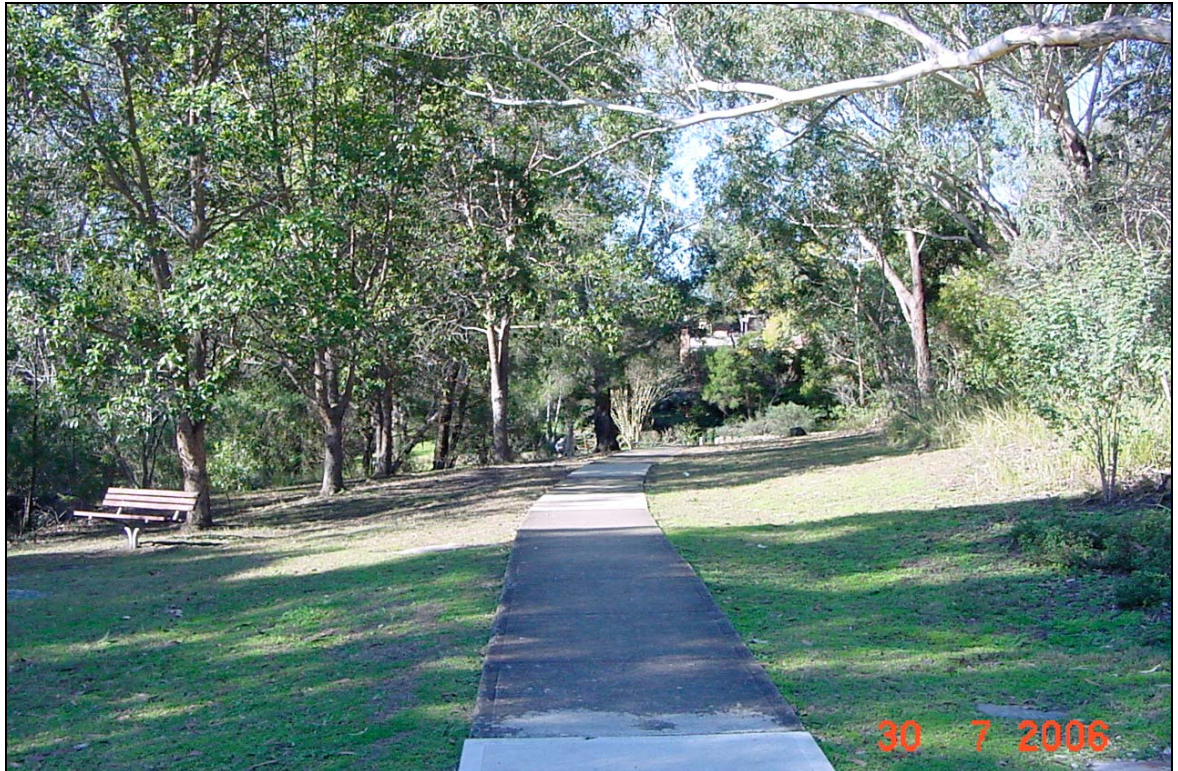
Figure 27 GLADES BAY PARK
Looking northeast from southern end of park, near entry from Delmar Parade.
Any path widening through this section will not impact on trees.

Any widening of the path in the future would need to ensure that works within proximity to mature trees should be initially subject to review by an arboriculturist.

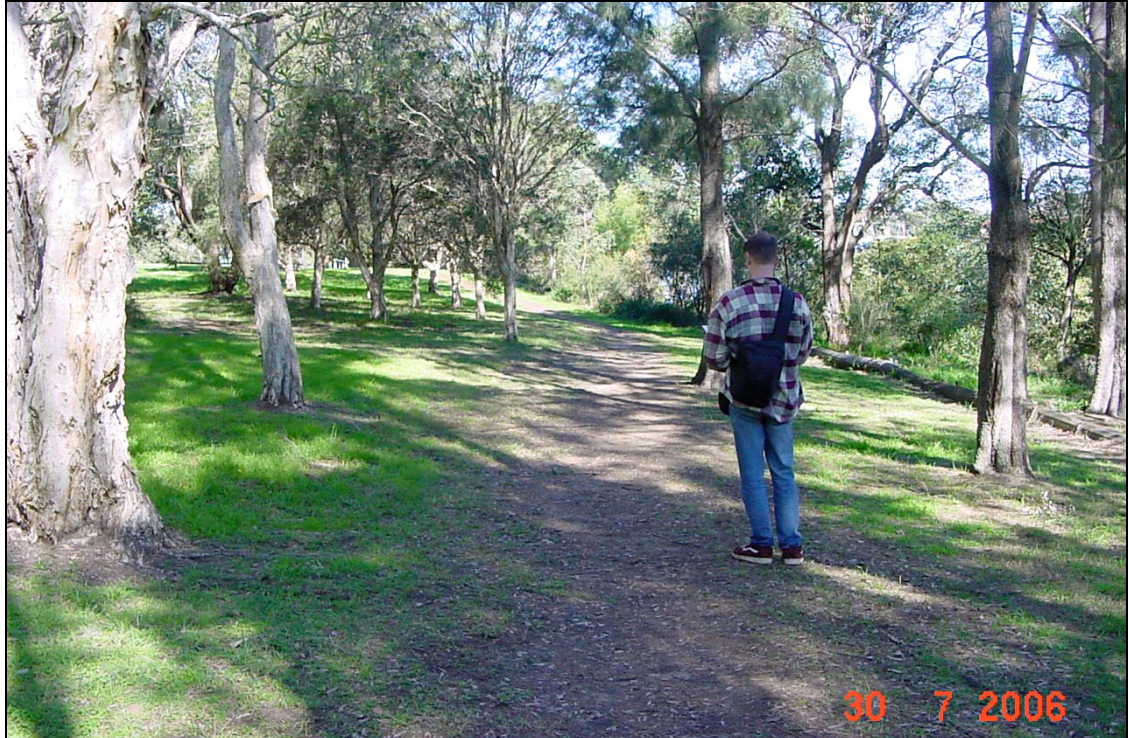
Figure 28 LOOKING GLASS BAY PARK
Southern end of Looking Glass Bay Park. The unformed dirt track links to the north end of Banjo Paterson Park in the background (obscured from view).

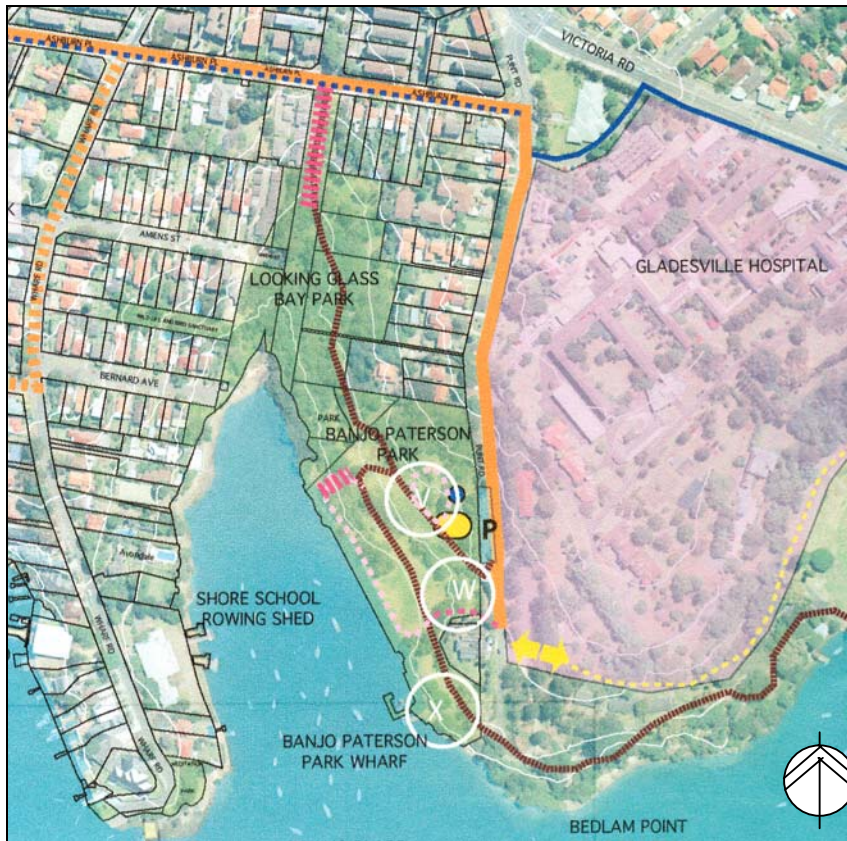
Figure 30 LOOKING GLASS BAY PARK
Approximate location of existing, unformed dirt track shown in brown.

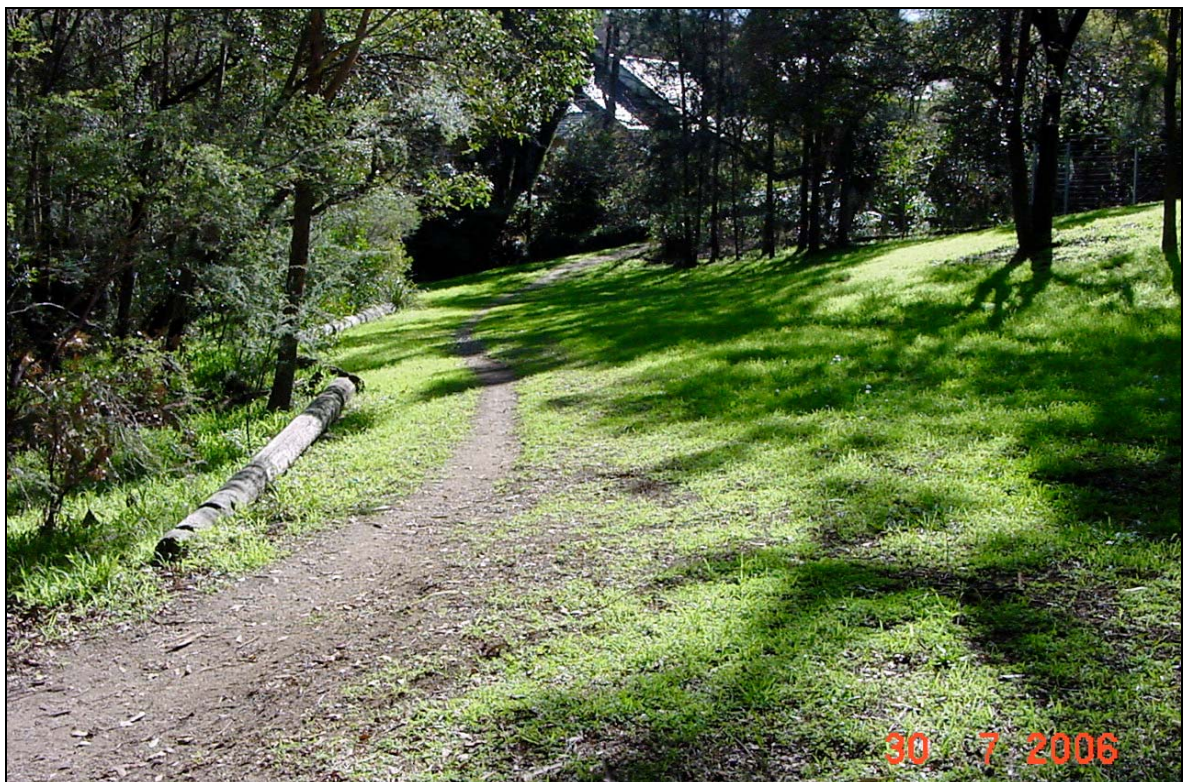
- 3.7.7 Much of the path that links Looking Glass Bay Park with Banjo Paterson Park is edged on the west side with old timber poles, and there are few significant trees to the west, within metres of the existing unformed path.

Figure 31 LOOKING GLASS BAY PARK
Part of the track through Looking Glass Bay Park, linking Banjo Paterson Park to Ashburn Place.

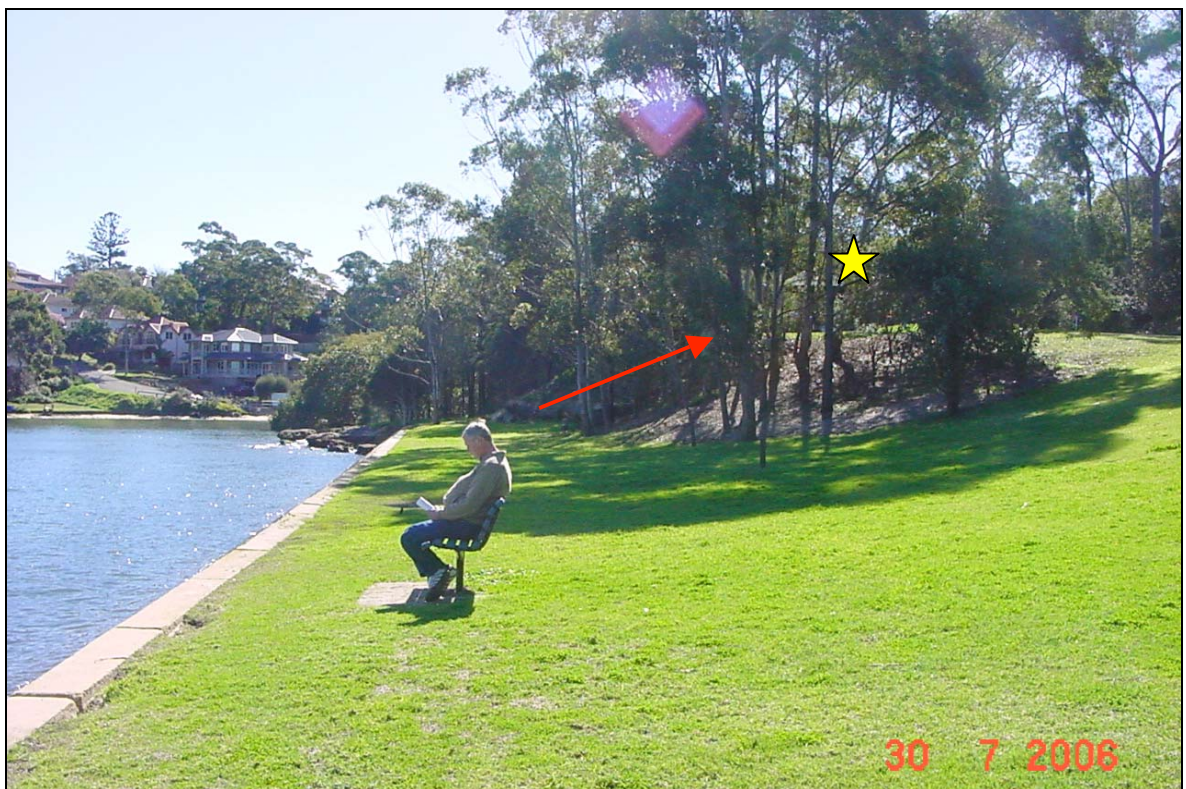
Figure 32 BANJO PATERSON PARK

There are some mature trees along the top and bottom of the rock outcropping. Any path construction (and possible rock cutting or excavation) may impact on trees nearby. Arboricultural advice would need to be sought prior to final design.

Looking northwest towards mangroves. Ample opportunity for a Type 1 shared path.

3.7.11 There is ample area to accommodate a type 1 shared path along the foreshore between a group of Casuarinas just north of the Banjo Paterson wharf, and the trees south of the mangroves. The red arrow in Figure 32 indicates a steep access between the proposed lower path and the existing path above.
