## **Appendix H Coating Condition Assessment Report**

**To:** Anand Thakur  
**From:** Gideon Chapman (prepared by George Symonds)  
**Subject:** Angas Street Bridge Paint Study Outcomes  
**Our ref:** PS213457-WSP-SYD-STR-MEM-00001 Rev1  
**Date:** 1 April 2025

## Angas Street Bridge Coating Condition Assessment Report

Remedy Asset Protection (RemedyAP) performed a condition assessment of coatings applied to Angas Street bridge steel structure, in Meadowbank.

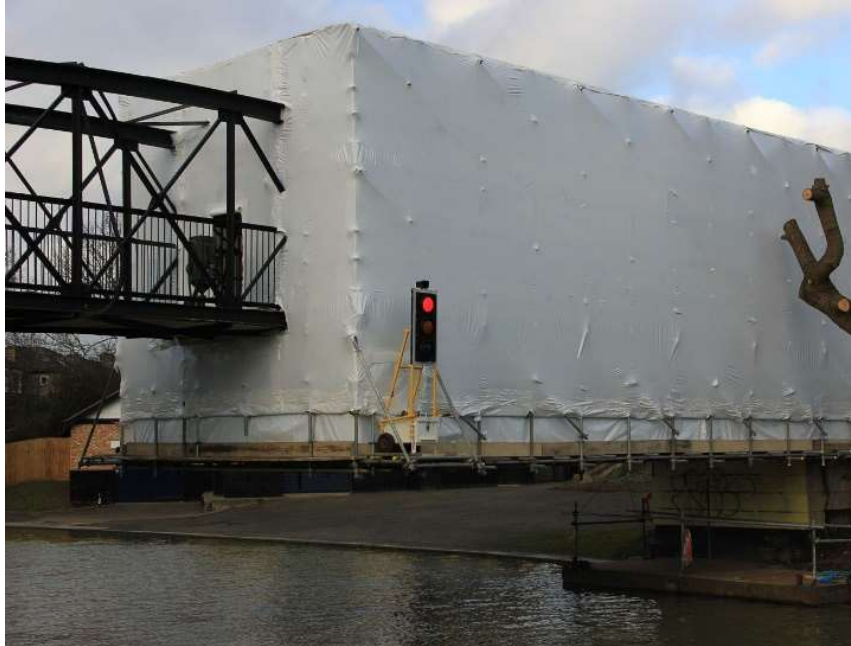
2. The paint was found to be in poorer condition than previous reports indicated. Across large areas of the bridge, poor paint adhesion and delamination was identified.

3. Steel corrosion was identified at interface regions between bridge elements. For example, where transverse members sit on longitudinal members and vice versa (see example photograph below).

Effectively cleaning out the corrosion product and repainting in these regions is likely to be too difficult in situ.

Refurbishment work would necessitate full removal of the existing coating, preparation of the substrate, and full re-coat. Spot repair is not suitable.

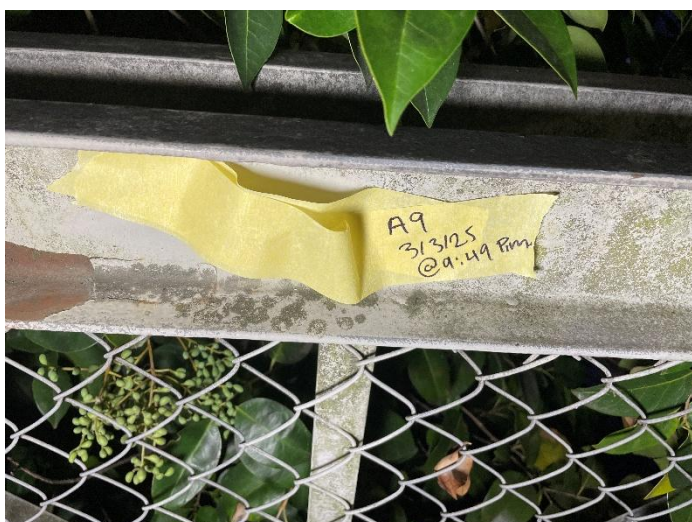
Figure 19- Dollies attached and labelled

RemedyAP conducted pull-off adhesion tests in accordance with AS 3894.9- Method C, to quantify the tensile force required to disbond the coating from the surface. This test was performed on 6 areas on the soffit, and 3 areas above the deck. Nominated areas were selected from areas with the sound quality of coating.

The coating surface was cleaned with a clean rag and solvent (Xylene), and then smoothly abraded with sandpaper to remove gloss. 20mm dollies were abraded and glued to the surface and left for a minimum of 22 hours before the test.

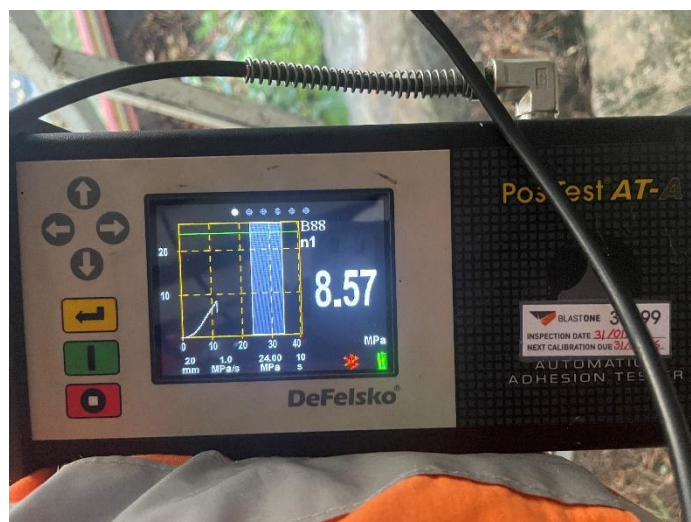
Figure 20- Adhesion pull-off test

Referring to Table 4, the average DFT of the coating was below 500µm in all tested areas, so no scoring was performed around the dollies in accordance with the test standard.

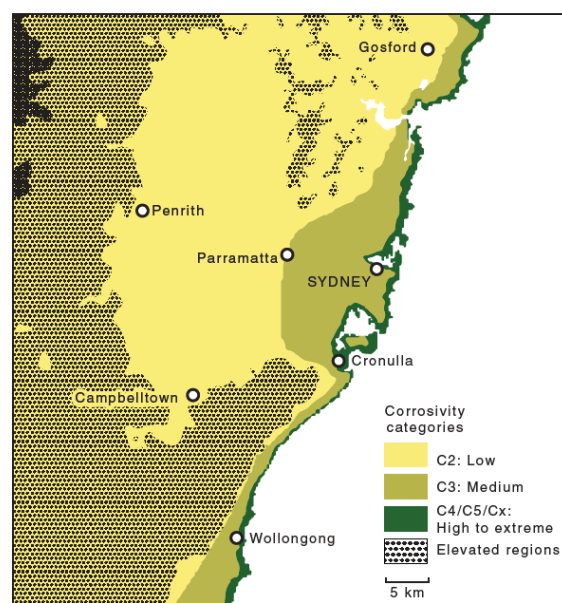
Figure 22- ISO corrosivity categories for Sydney- AS 4312:

Referring to AS 4312:2019-figure A4; *ISO Corrosivity Categories for Sydney*, the location of Angas Road bridge is classified as **corrosivity zone of C3 (Medium)**. According to the standard, *much of the metropolitan areas of Sydney, are in this category.*
