GEOTECHNICAL INVESTIGATION

FOR PROPOSED MIXED-USE DEVELOPMENT

AT 2-12 TENNYSON ROAD, GLADESVILLE, NSW

> 29 October 2012 Ref: 26029SPrpt

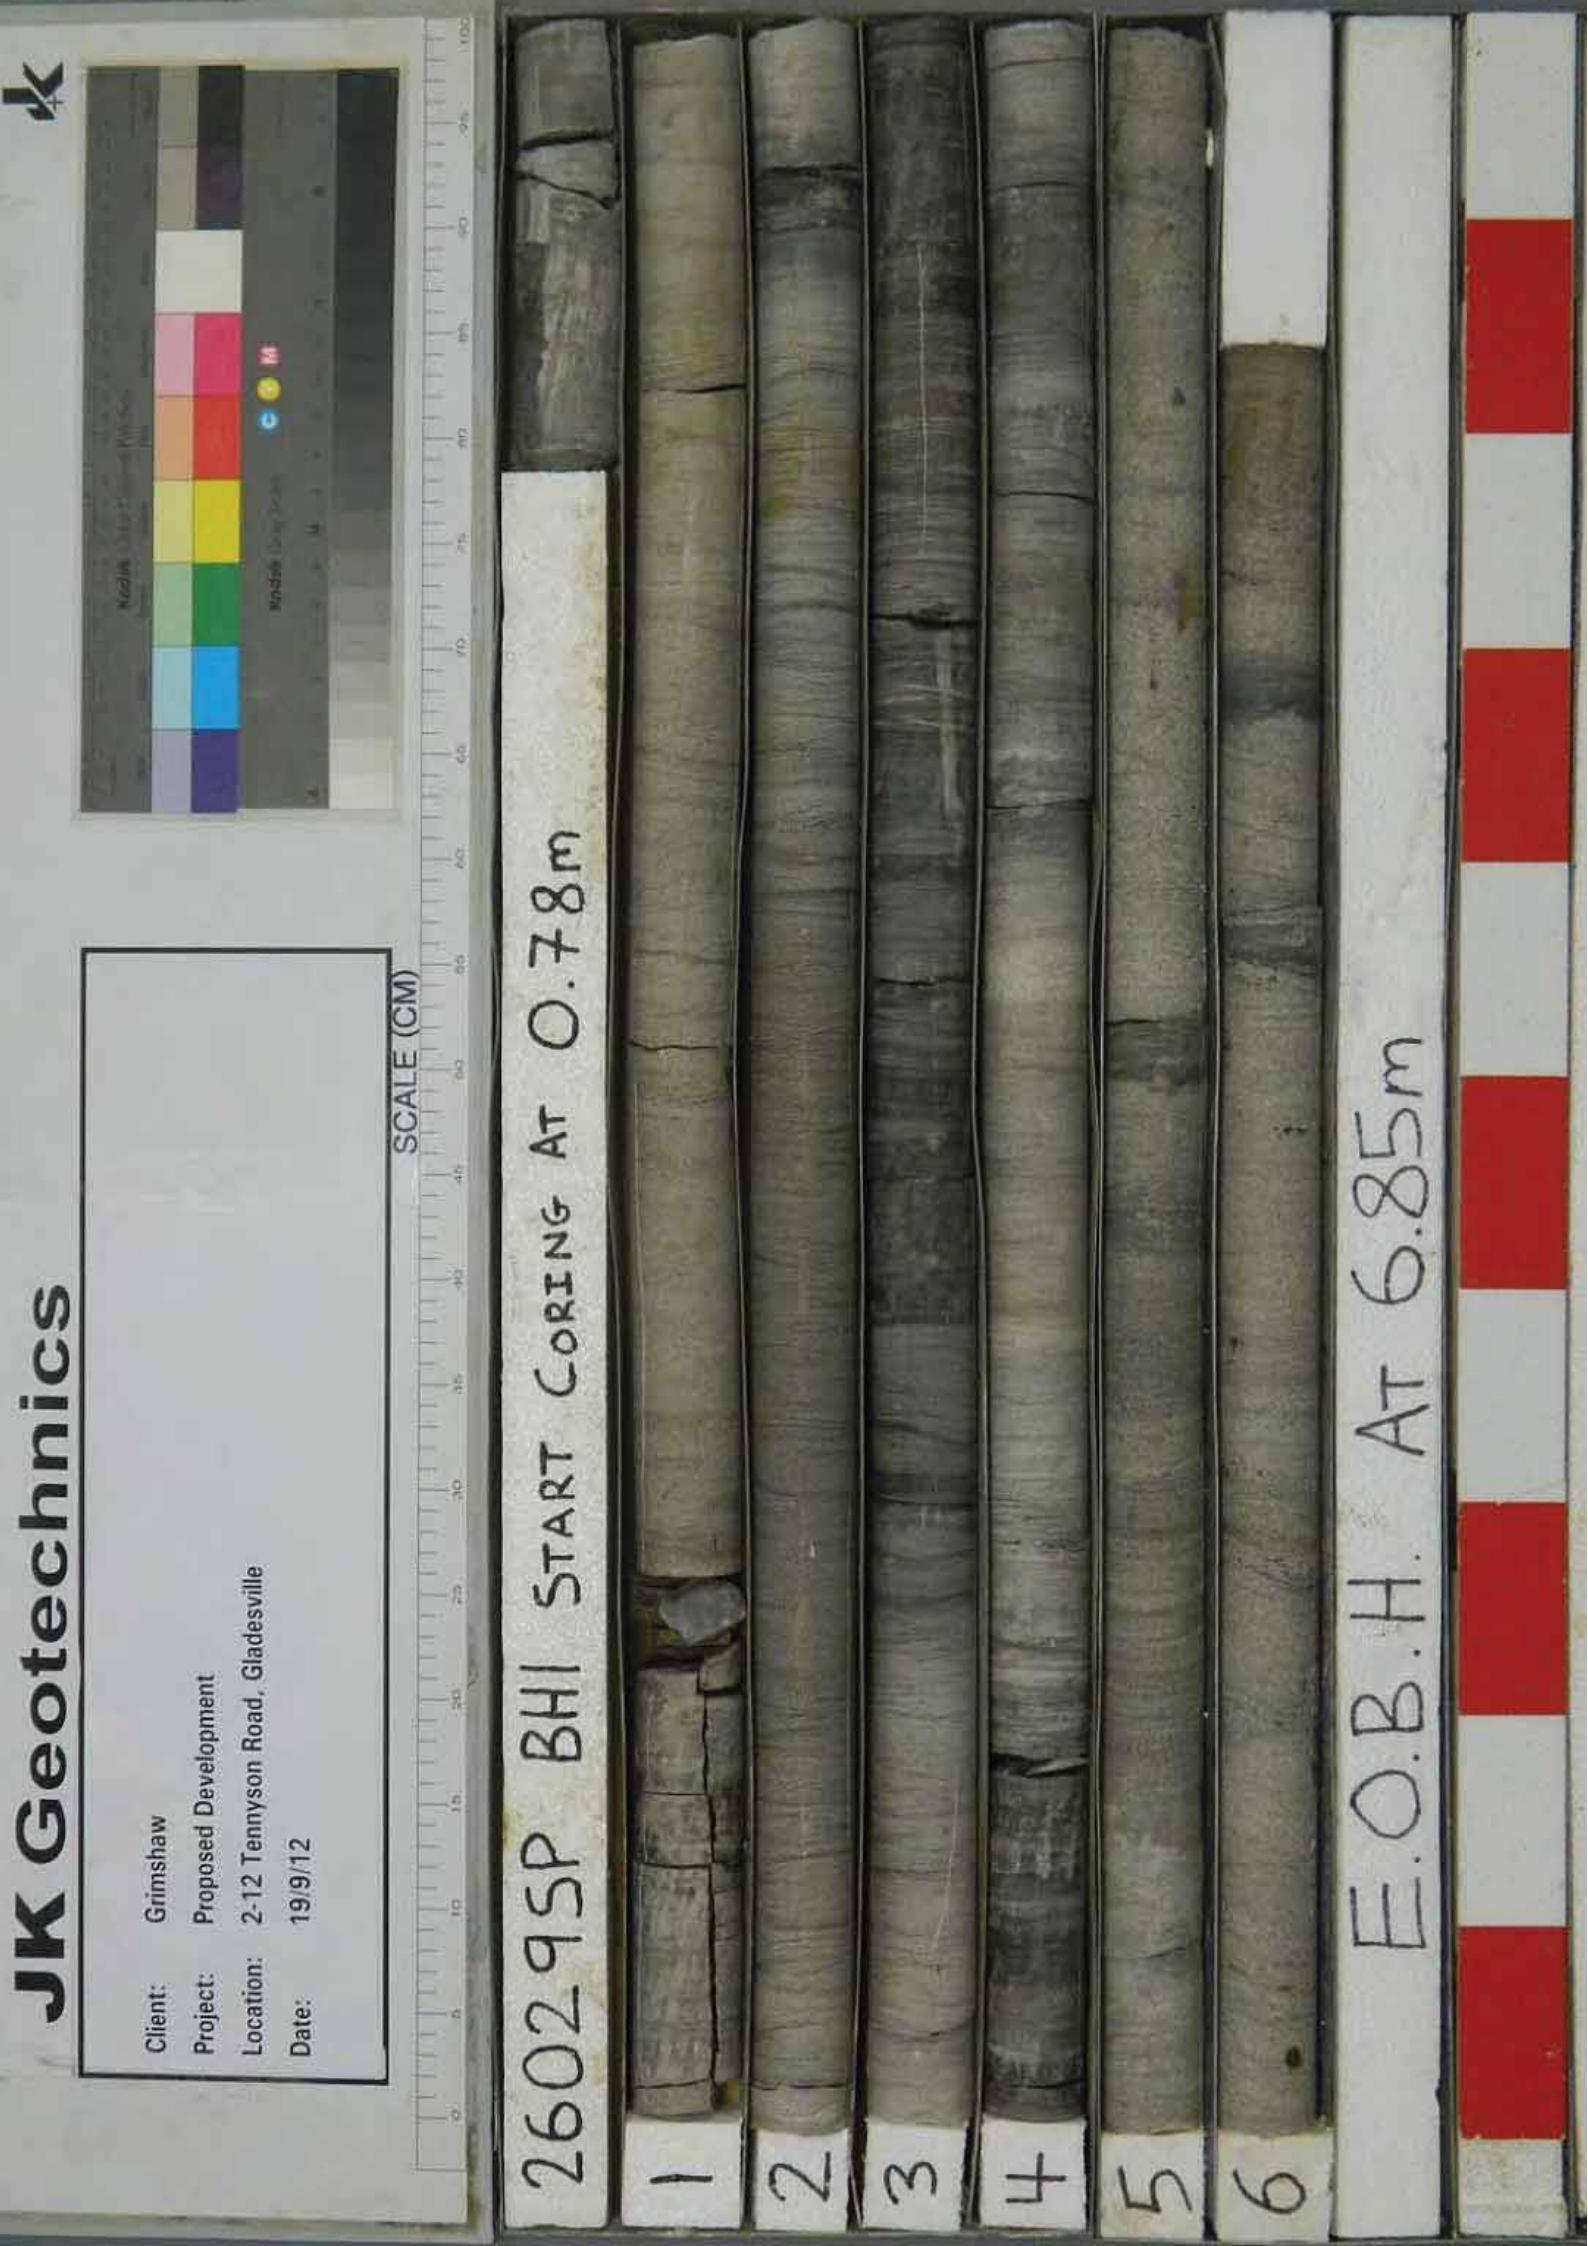
Borehole No. 1/2

Client: Dare	csol Ltd Pty	у							
Project:	PROPO								
Location:	2-12 TE	ΞΝΝΥ	/SON	ROAD	D, GLADESVILLE, NSW				
Job No. 26	029SP			Meth	od: SPIRAL AUGER	R.L. Surface: ≈ 33.4m			
Date: 19-9-	-12			_	JK500	D	atum:	AHD	
	Logo	ged/Checked by: R.V.C./P.W							
Groundwater Record ES DS AMPLES	Field Tests	Depth (m)	Graphic Log	Unified Classification	DESCRIPTION	Moisture Condition/ Weathering	Strength/ Rel. Density	Hand Penetrometer Readings (kPa.)	Remarks
DRY ON COMPLET				-	CONCRETE: 100mm.t	W			10mm DIA. - \REINFORCEMENT
ION OF AUGER- ING				-	grained crushed shale, fine to medium grained sand, trace of silt.	DW	L-M		 BANDED LOW TO MODERATE 'TC' BIT
					REFER TO CORED BOREHOLE				
					LOG

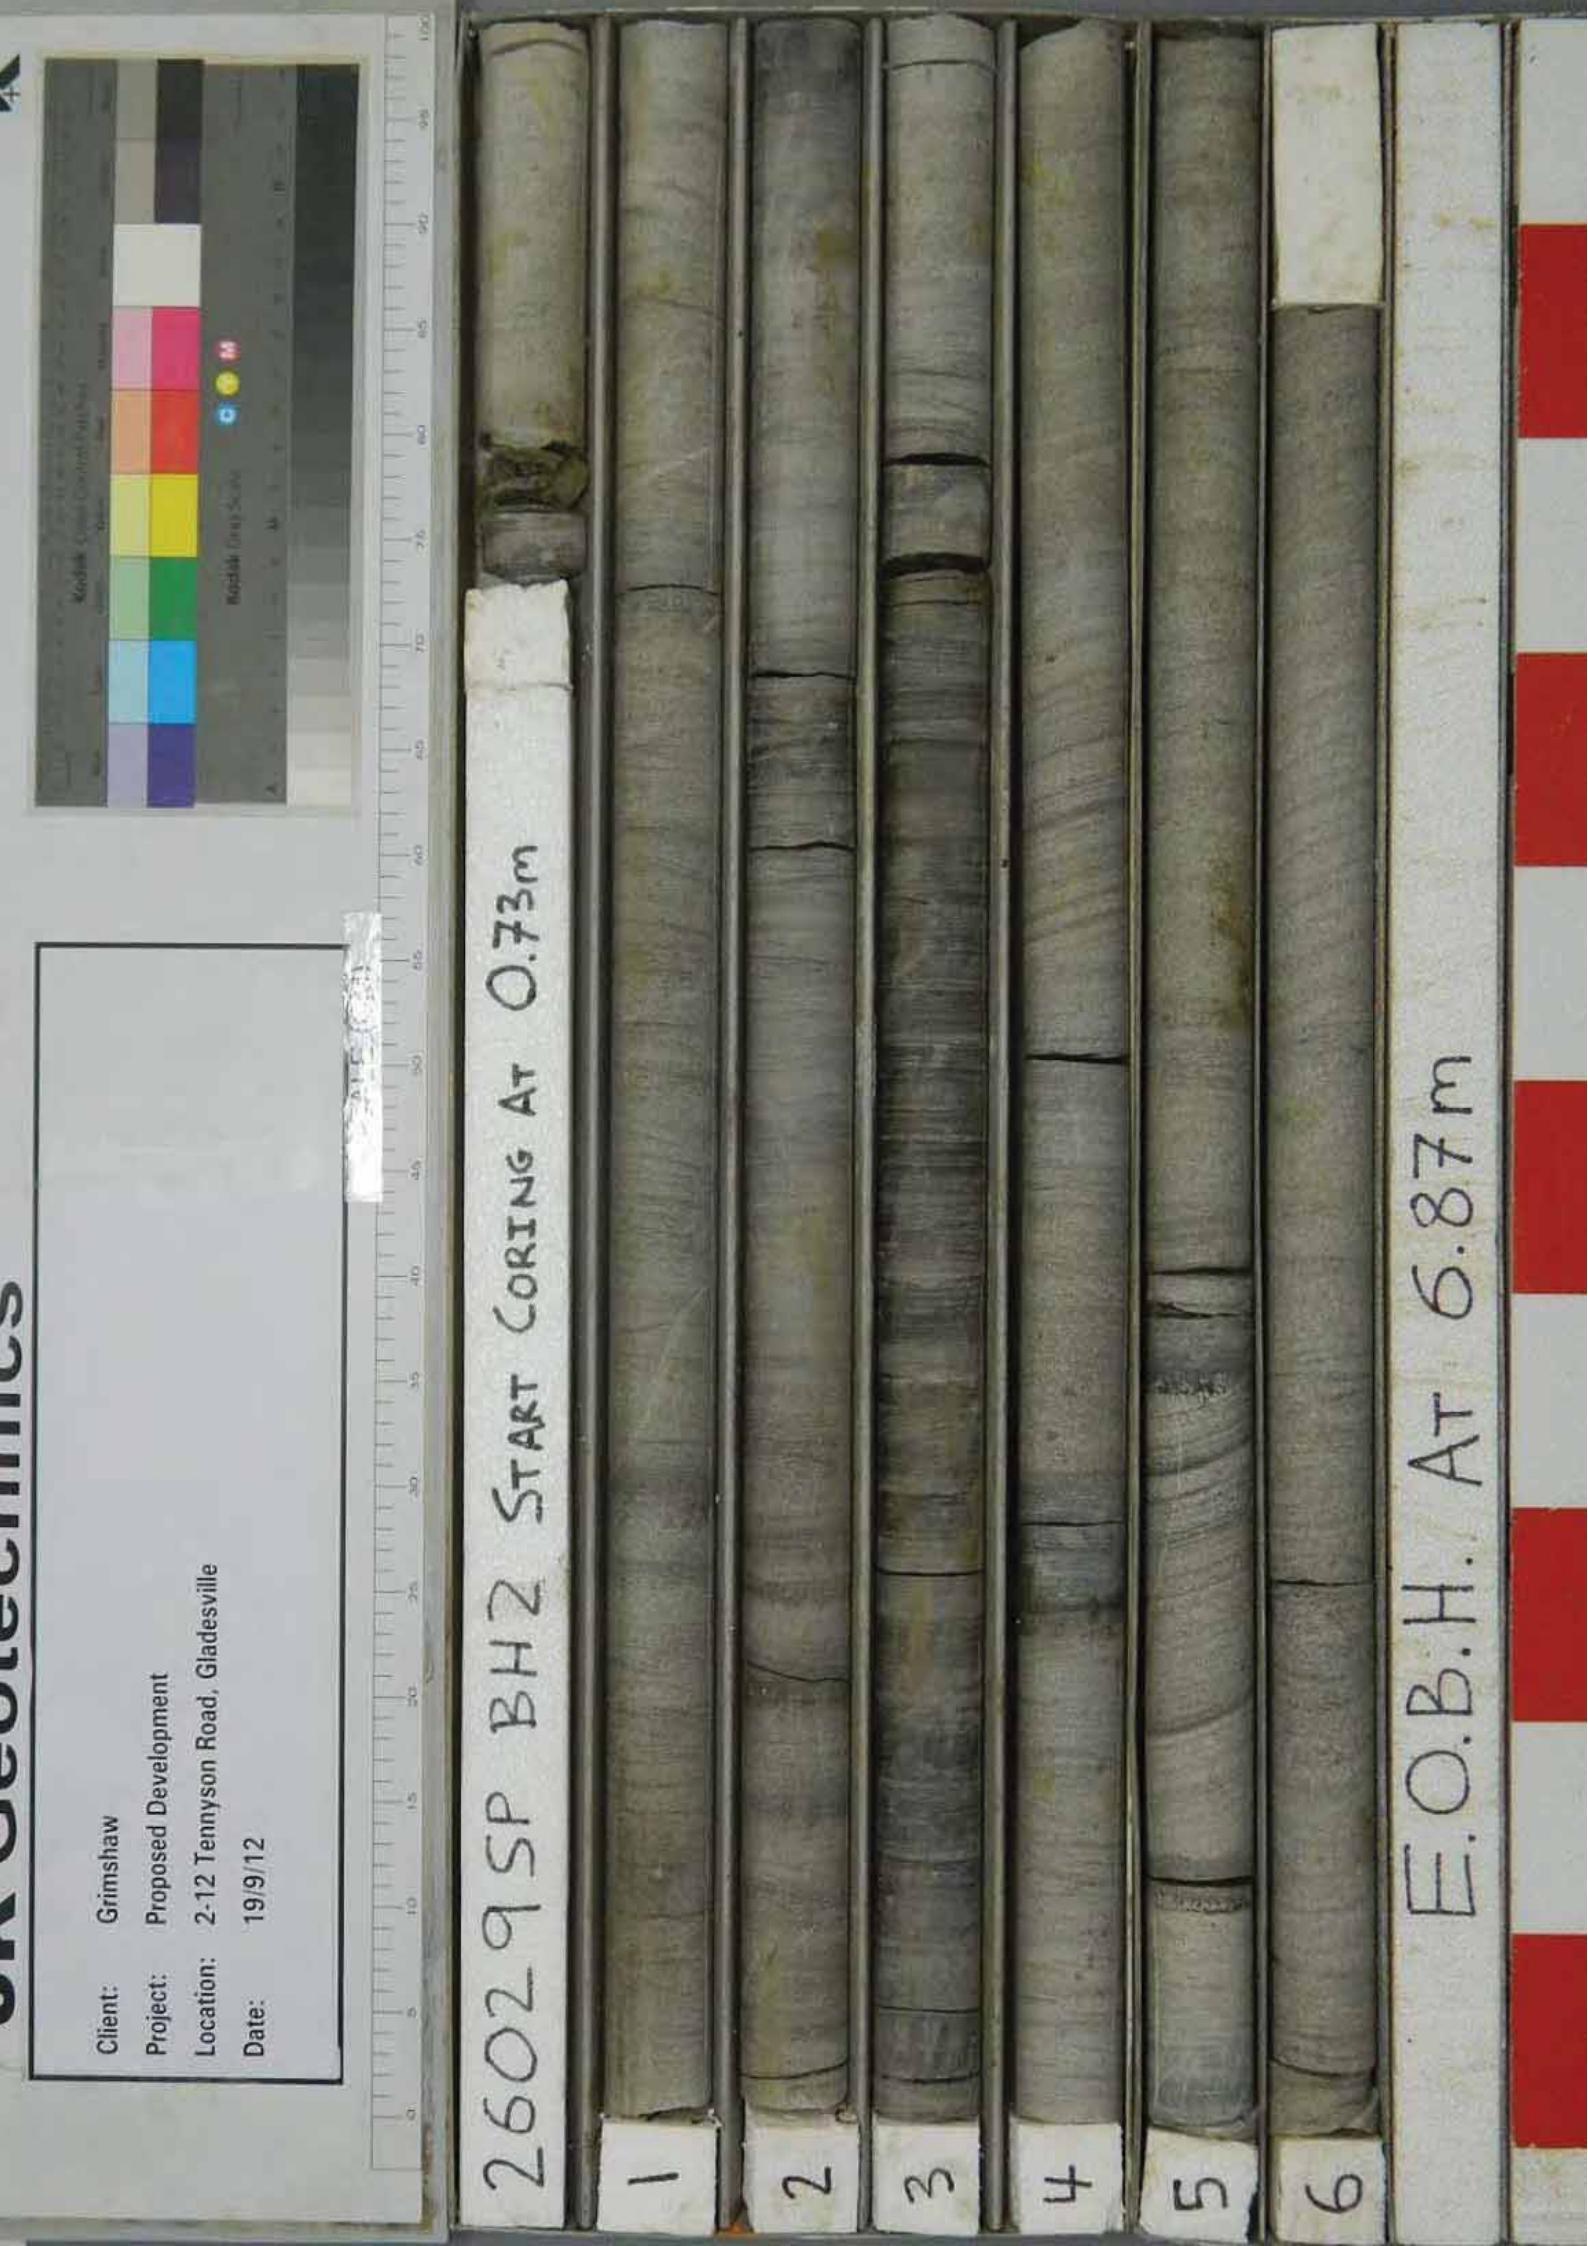
Borehole No. 2 1/2

Client: Da	rcsol Ltd	Pty							
Project:	PROF	POSEI	D DEV	'ELOF	MENT				
Location:	2-12	[ENN]	YSON	ROAI	D, GLADESVILLE, NSW				
Job No. 20	6029SP			Meth	NOd: SPIRAL AUGER		R	.L. Sur	f ace: ≈ 33.1m
Date: 19-9	-12			المع		,	D	atum:	AHD
<u>0</u>				Log	Jed/Checked by: R.V.C./P.W				
Groundwater Record ES DS SAMPLE DS	Field Tests	Depth (m)	Graphic Log	Unified Classification	DESCRIPTION	Moisture Condition/ Weathering	Strength/ Rel. Density	Hand Penetrometer Readings (kPa.	Remarks
DRY ON COMPLET		0 -		-	ASPHALTIC CONCRETE: 60mm.t	М			-
AUGER-	SPT	-		-	to medium grained shale gravel and fine and clay	MC>PL DW	M-H		- MODERATE TO HIGH
ING	A/100mm REFUSAL			_	And clay. FILL: Gravelly silty clay, low to medium plasticity, dark grey, fine to coarse grained shale gravel, trace of fine grained sand. SHALE: dark grey. REFER TO CORED BOREHOLE LOG	DW	M-H		- MODERATE TO HIGH 'TC' BIT RESISTANCE - 'TC' BIT REFUSAL - - - - - - - - - - - - -

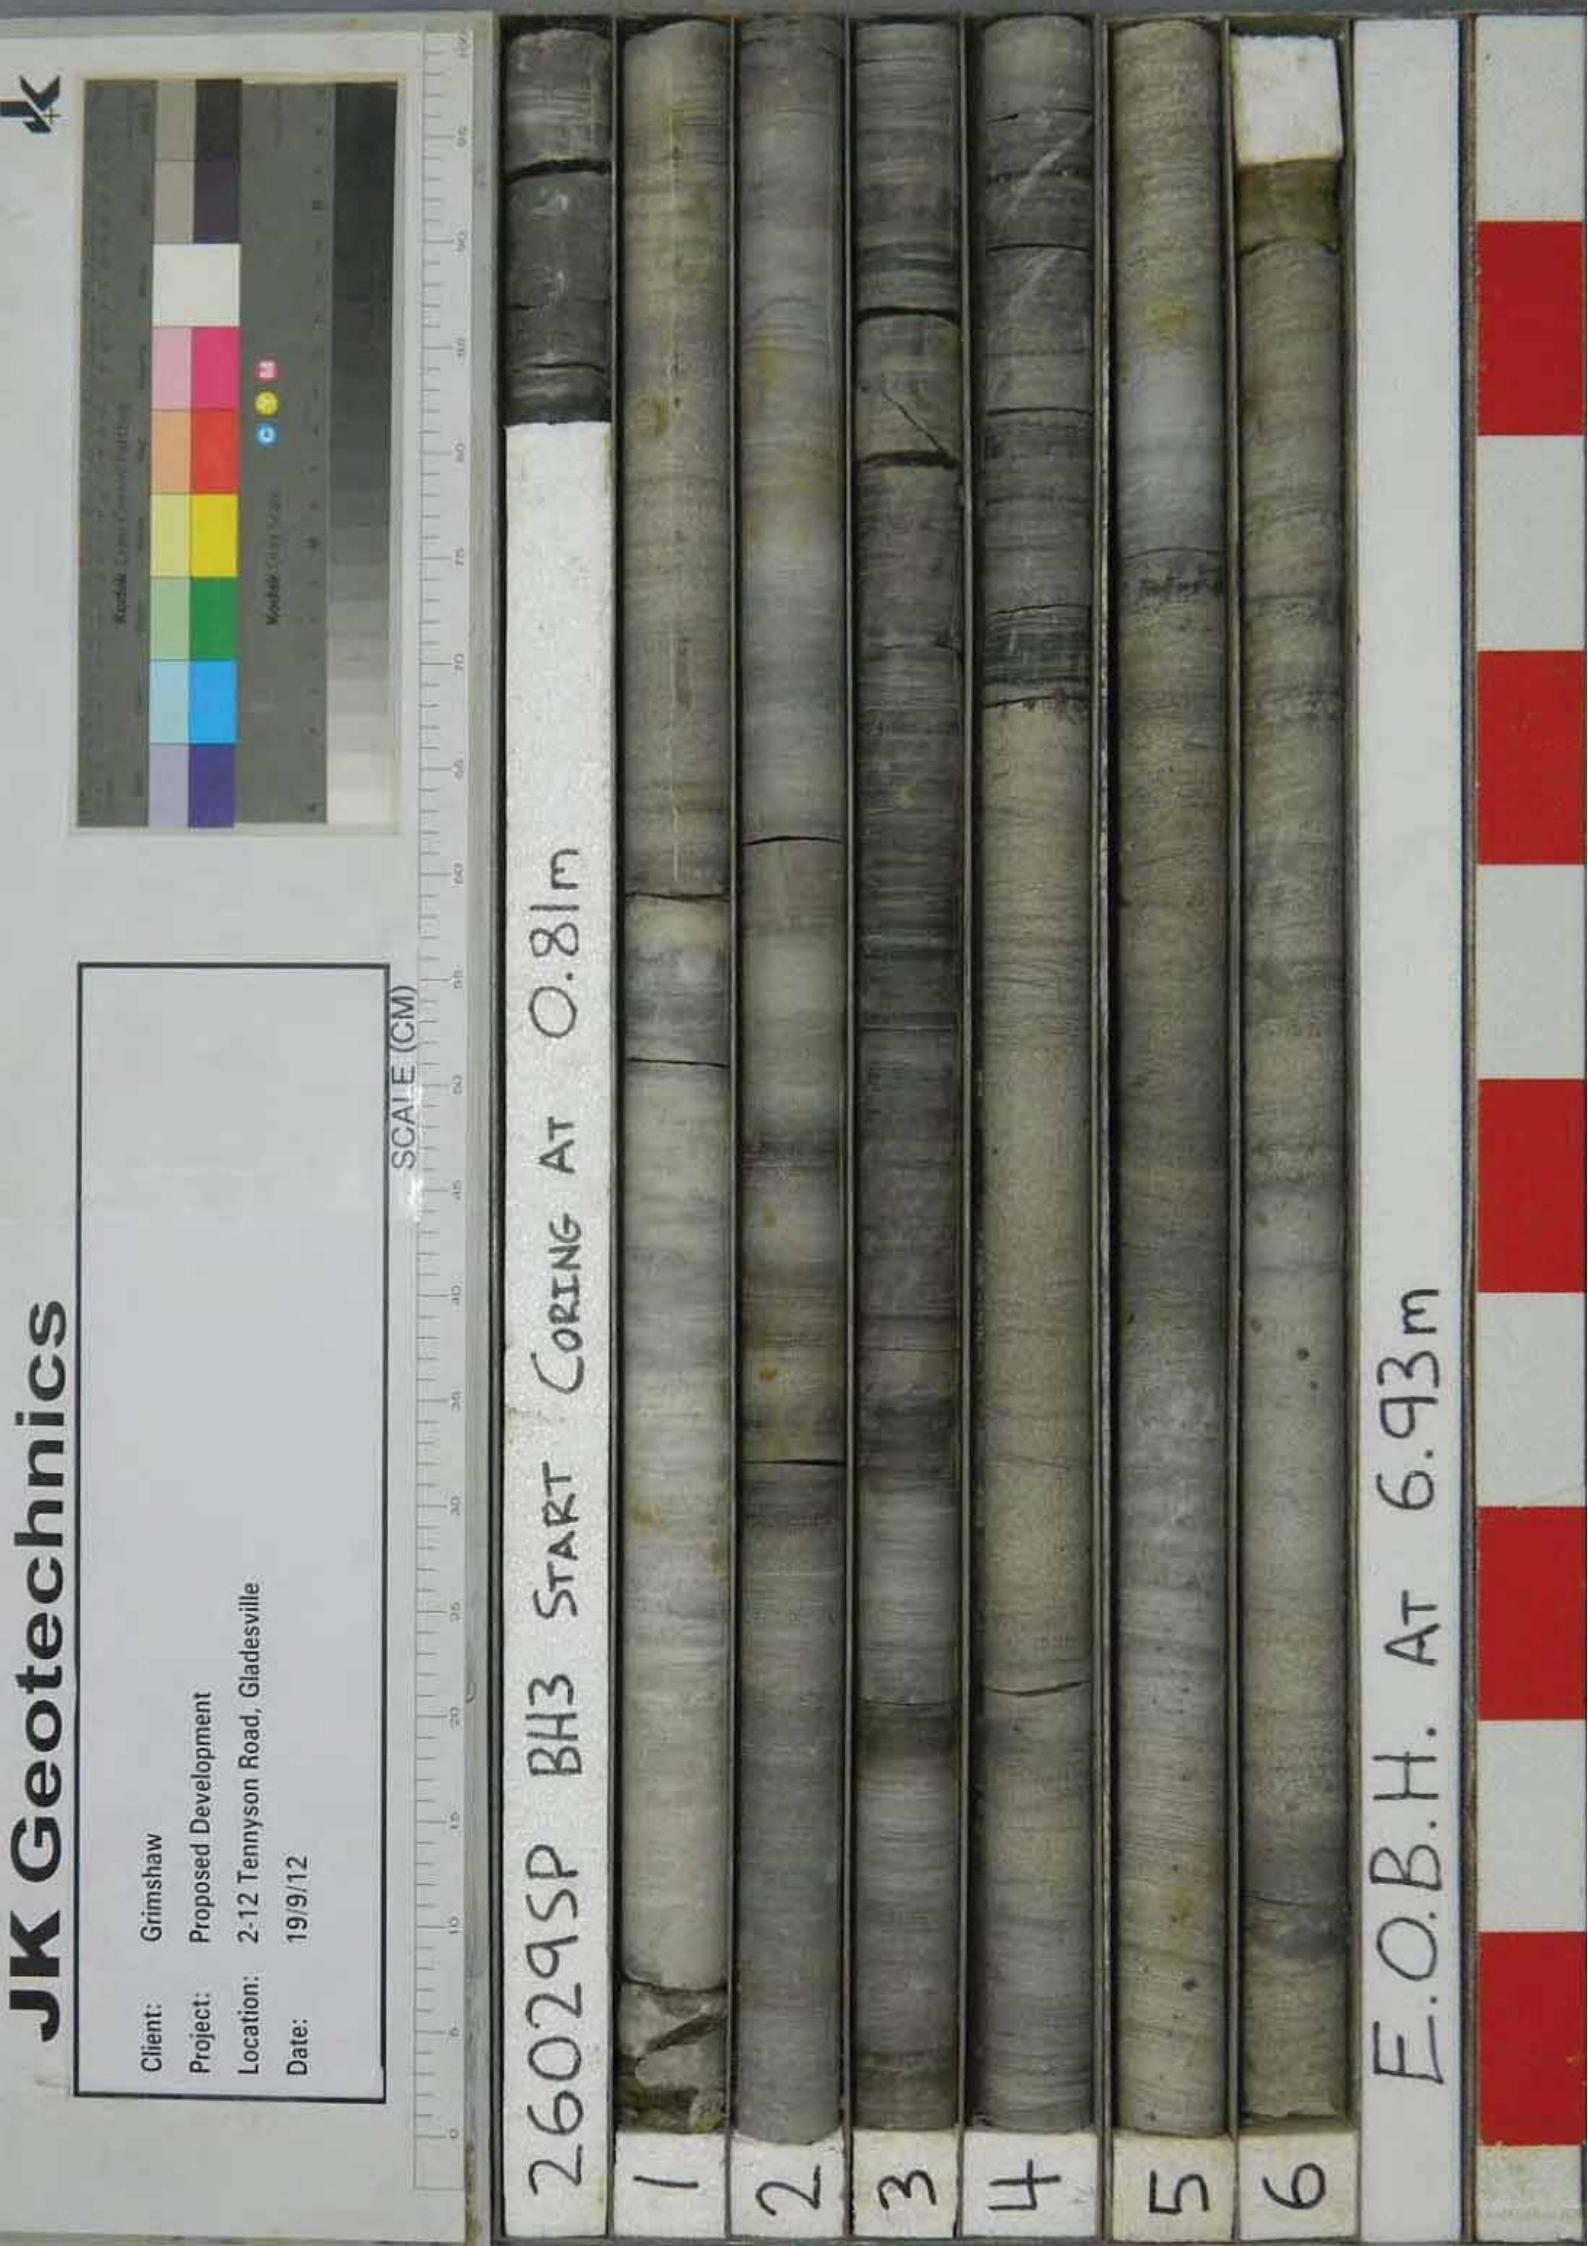
Borehole No. 3 1/2

Clien Proje	nt: Darcs	ol Ltd F	iy POSEI	D DEV	'ELOP	MENT					
Loca	tion:	2-12 7									
Job I Date	No . 260 : 19-9-1	29SP 2			Meth	od: SPIRAL AUGER JK500		R.L. Surface: ≈ 32.7m Datum: AHD			
					Logo	ged/Checked by: R.V.C./P.W		1	1		
Groundwater Record	USO SAMPLES	Field Tests	Depth (m)	Graphic Log	Unified Classification	DESCRIPTION	Moisture Condition/ Weathering	Strength/ Rel. Density	Hand Penetrometer Readings (kPa.)	Remarks	
DRY ON COMPLET ION OF AUGER- ING	- <u>3</u> , R	N > 13 13/50mm EFUSAL	0		-	FILL: Gravelly silty clay, low to medium plasticity, brown and grey, fine to coarse grained shale and ironstone gravel. SHALE: dark grey. REFER TO CORED BOREHOLE LOG	MC <pl DW</pl 	(H) M	400 520 460		
			4 - - 5 - - - - - - - - - - - - - -

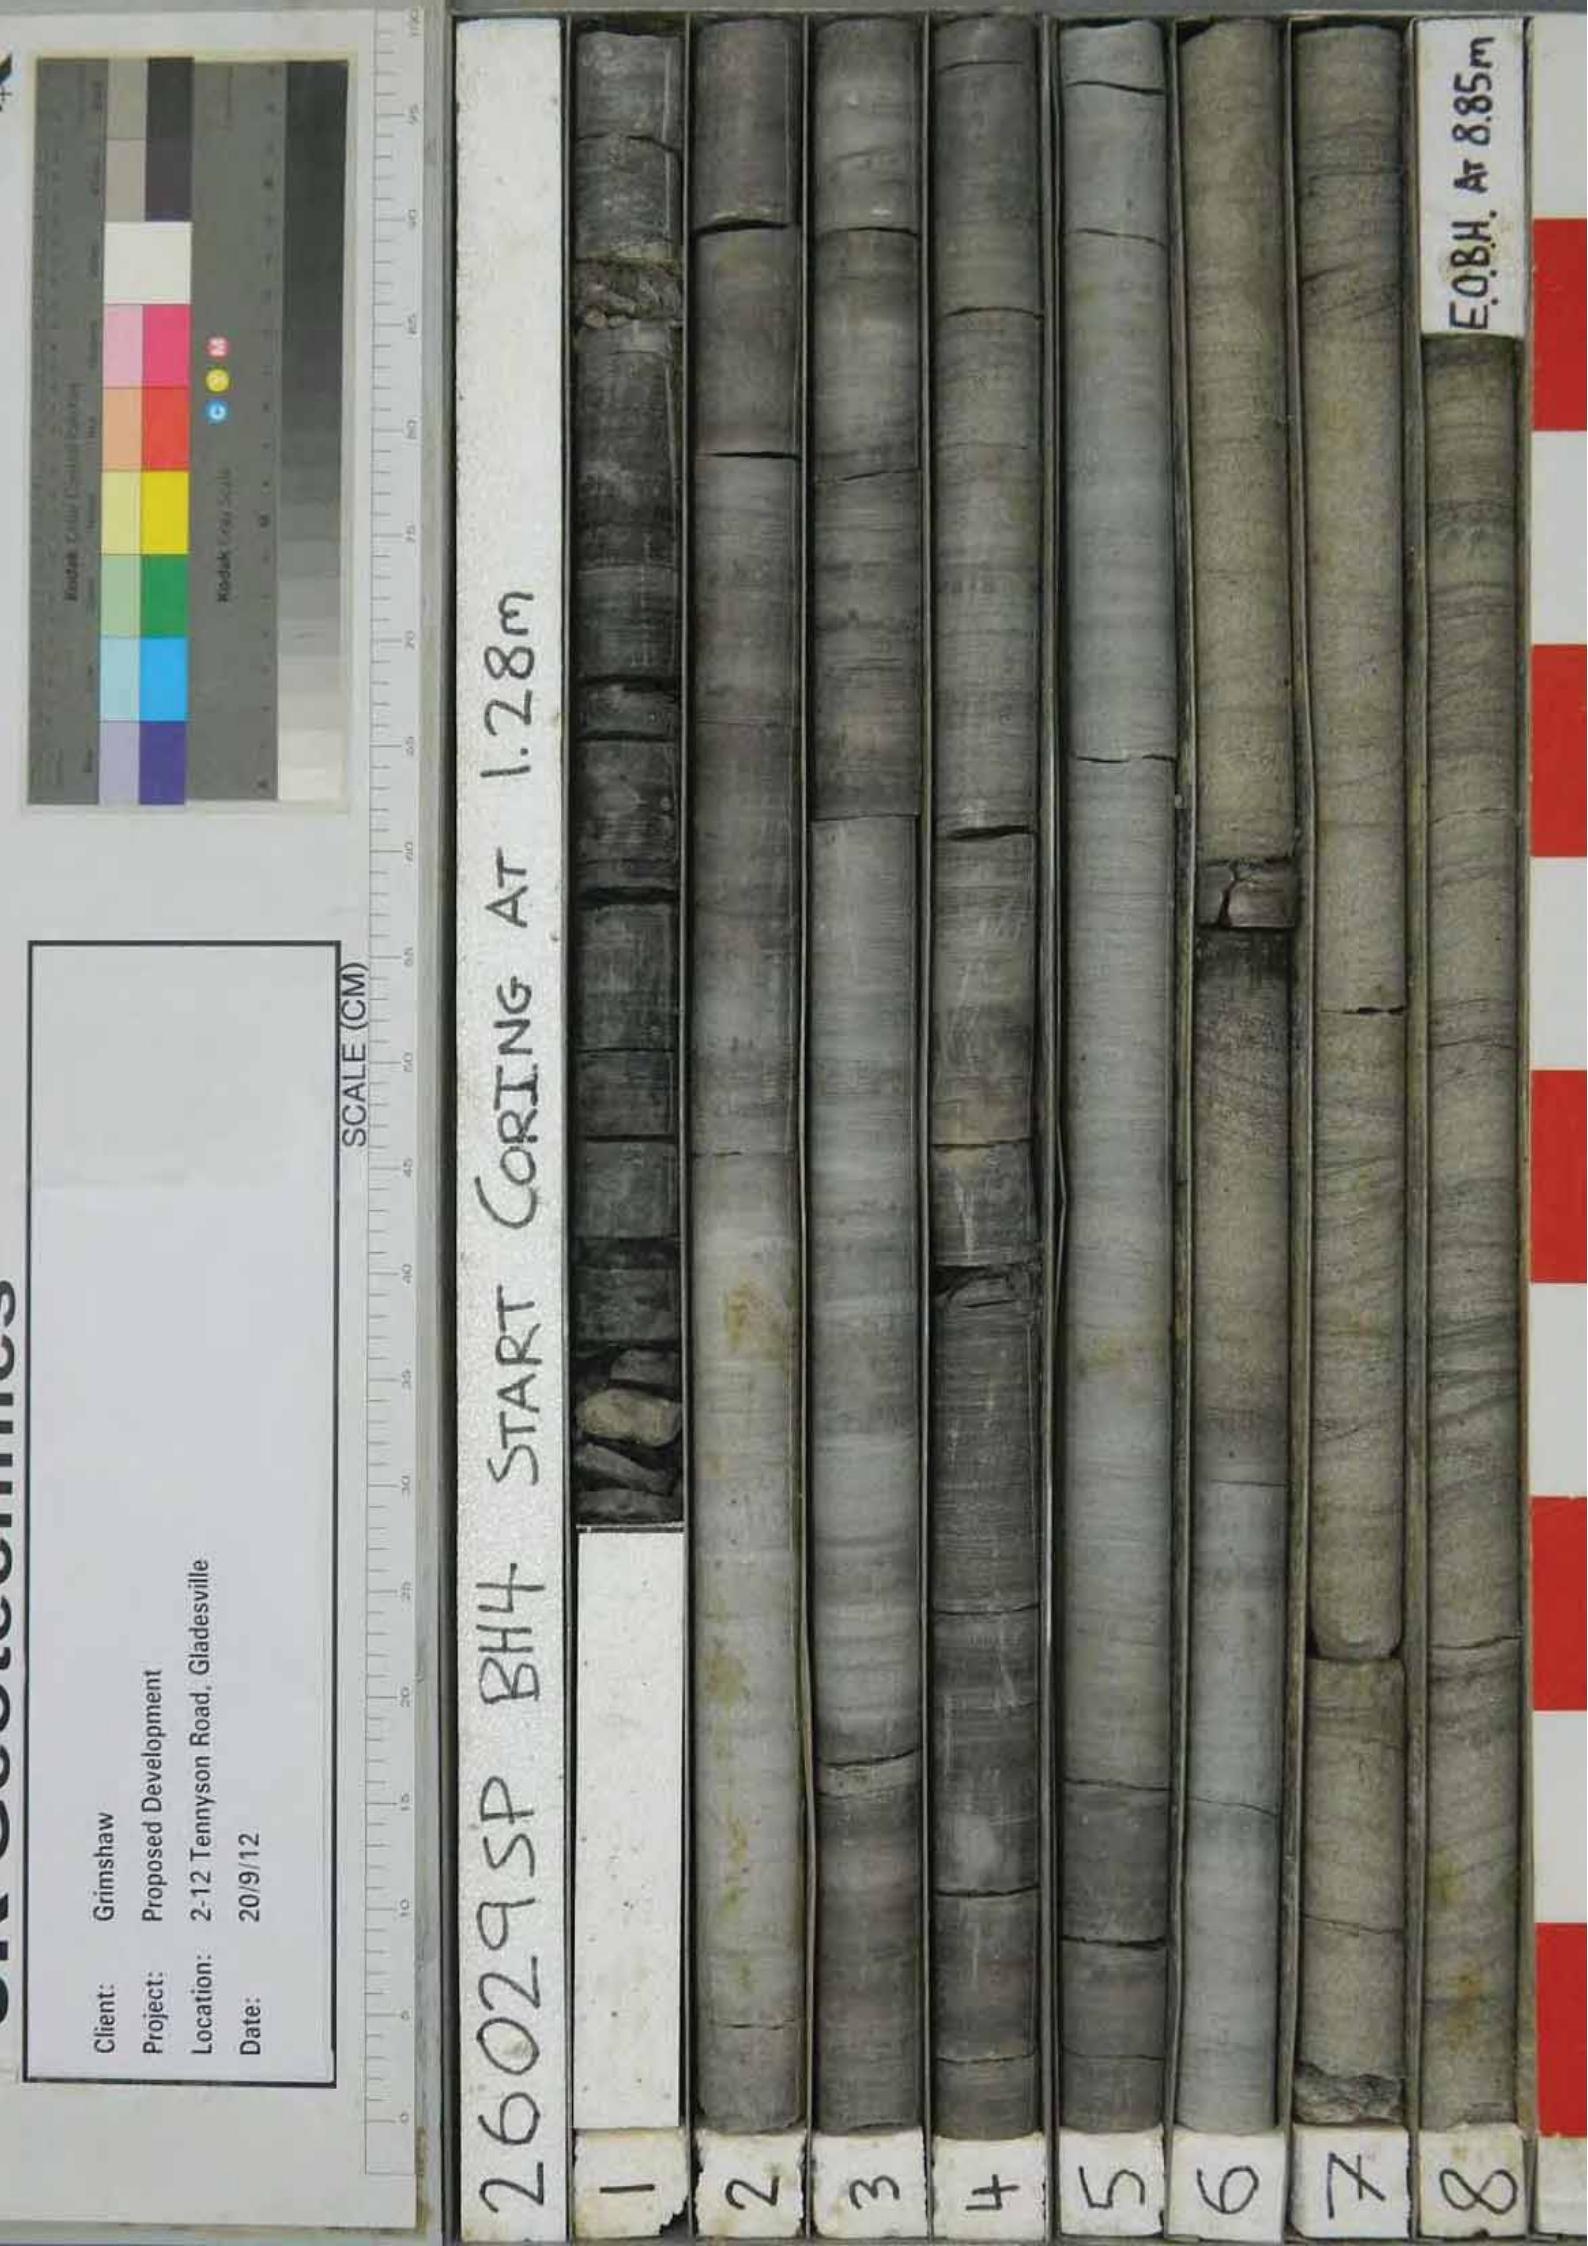
Borehole No. 4 1/3

Clien	it: Dai	rcsol Ltd	Pty							
Proje	ect: tion:	PROF 2-12								
Job N Date:	No . 26	6029SP -12		10011	Meth	nod: SPIRAL AUGER JK500	R.L. Surface: ≈ 32.7m Datum: AHD			
					Log	<i>!</i> .				
Groundwater Record FS	U50 DB DS	Field Tests	Depth (m)	Graphic Log	Unified Classification	DESCRIPTION	Moisture Condition/ Weathering	Strength/ Rel. Density	Hand Penetrometer Readings (kPa.)	Remarks
DRY ON COMPLET ION OF AUGER- ING		N = 11 3,4,7	0		-	ASPHALTIC CONCRETE: 60mm.t / FILL: Gravelly silty clay, medium plasticity, dark grey, grey and orange brown, fine to coarse grained crushed shale gravel.	MC>PL		240 210 220	APPEARS - MODERATELY COMPACTED
			1-		-	SHALE: dark grey.	DW	L-M		LOW 'TC' BIT RESISTANCE
			2 3 4 5 6			LOG				- <u>\ RESISTANCE</u>

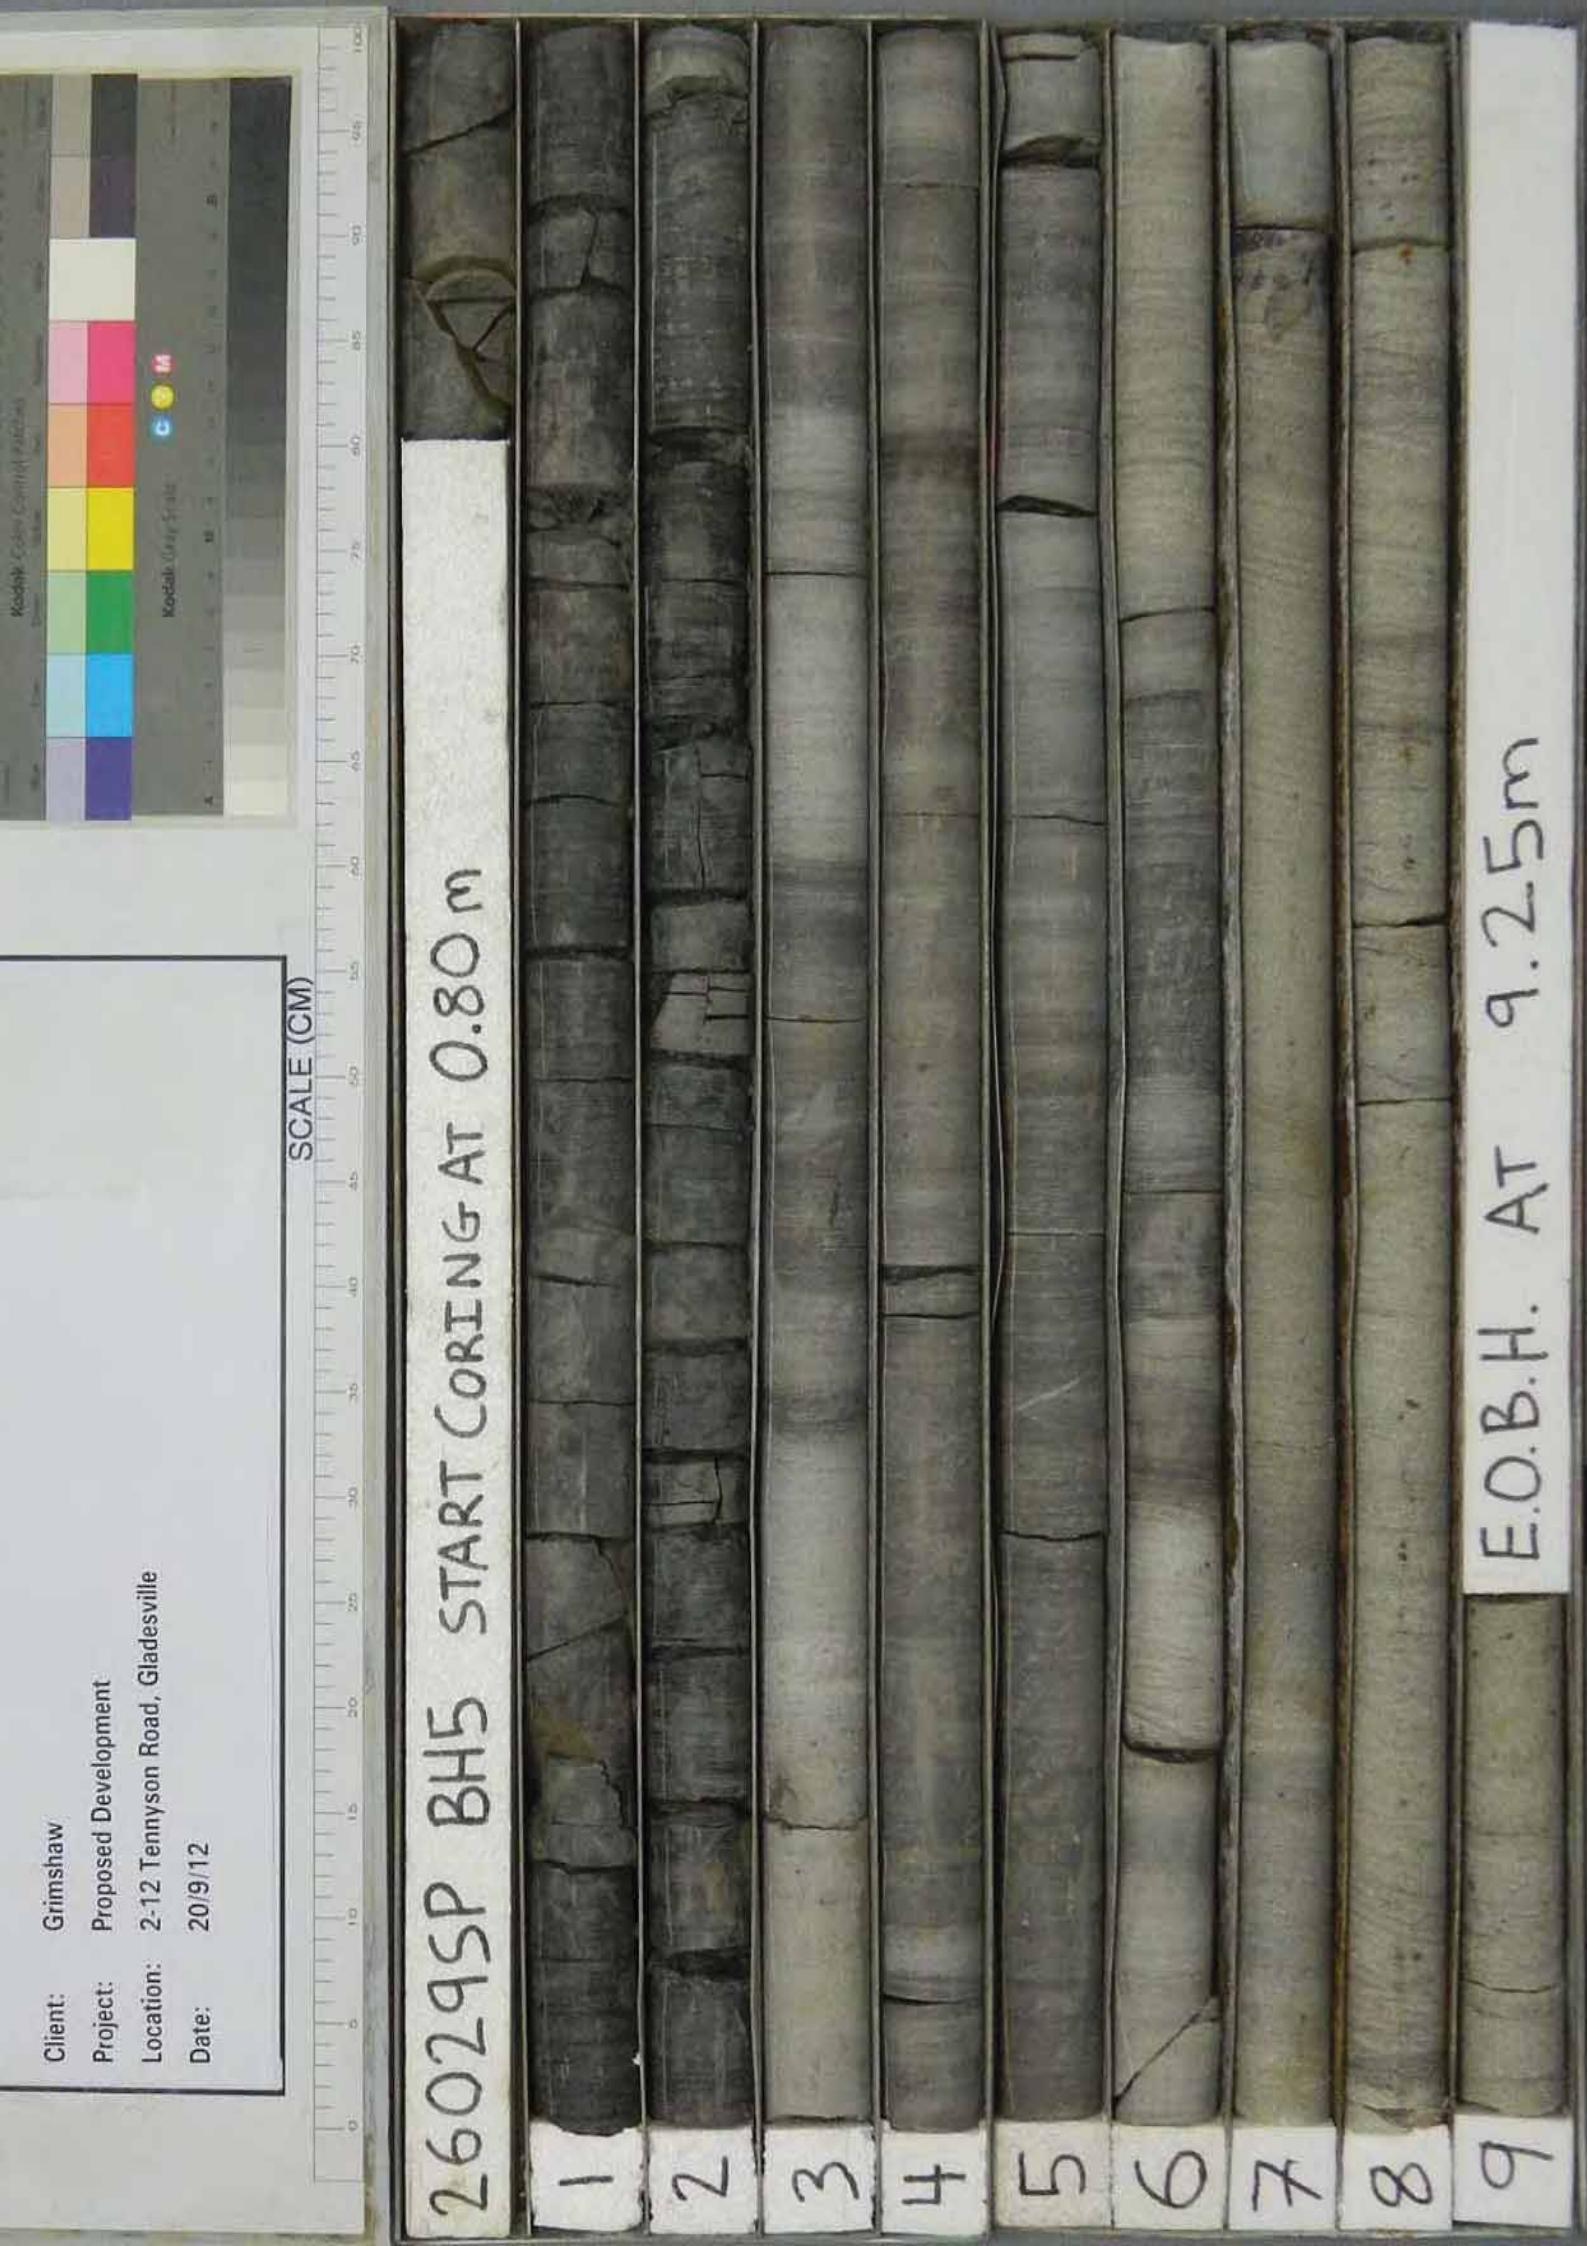
Borehole No. 5 1/3

Client:	Darc	sol Ltd I	Pty							
Project Locatio	t: on:	PROP 2-12 T	OSEI	D DEV YSON	ELOF ROAI	MENT D. GLADESVILLE, NSW				
Job No Date: 2	5. 260)29SP 12			Meth	nod: SPIRAL AUGER JK500		R	.L. Sur	face: ≈ 32.7m AHD
					Log	ged/Checked by: R.V.C./P.W				
Groundwater Record ES	DB SAMPLES	Field Tests	Depth (m)	Graphic Log	Unified Classification	DESCRIPTION	Moisture Condition/ Weathering	Strength/ Rel. Density	Hand Penetrometer Readings (kPa.)	Remarks
DRY ON COMPLET			0		-	ASPHALTIC CONCRETE: 40mm.t				6mm DIA. - \REINFORCEMENT
ION OF AUGER- ING			-		-	FILL: Clayey gravel, fine to coarse grained crushed shale.	SW	Н		 MODERATE TO HIGH 'TC' BIT RESISTANCE
			1 - - - - - - - - - - - - - - - - - -			REFER TO CORED BOREHOLE LOG

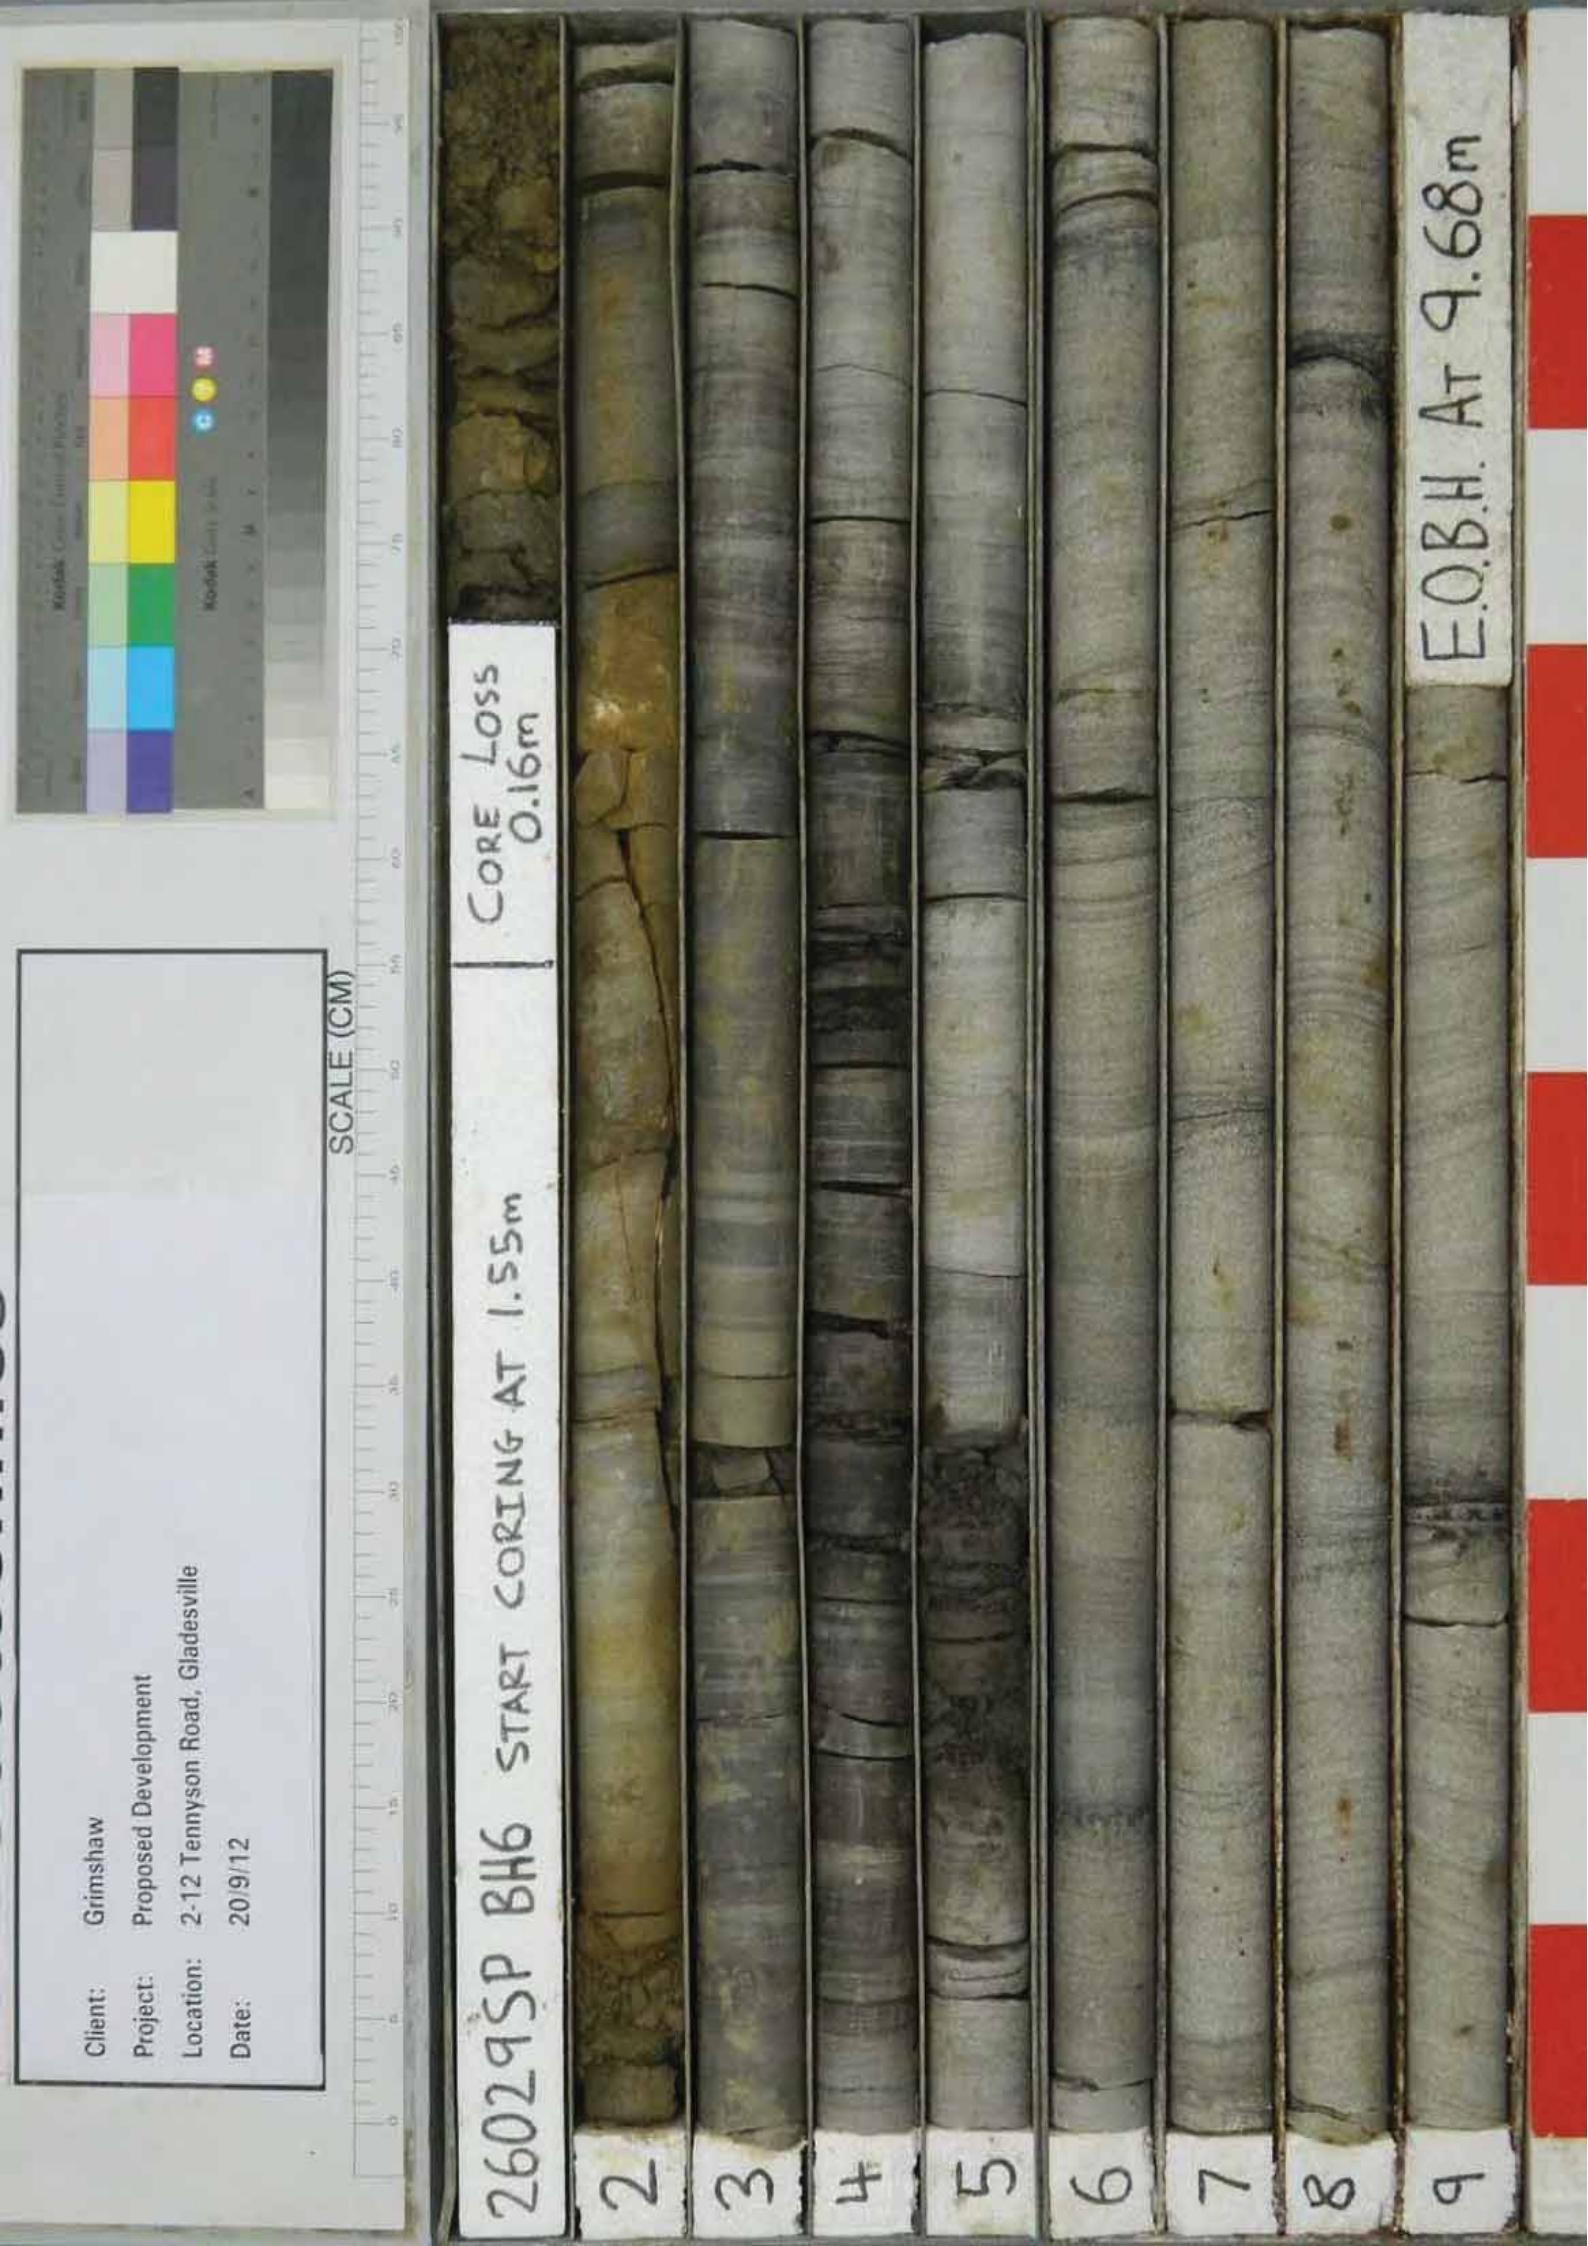
Clier	nt: Dar	csol Ltd	Pty							
Proje	ect:	PROF 2-12 ⁻	POSEI	D DEV YSON	ELOF	MENT				
Job I Date	No . 26 : 20-9	5029SP -12			Meth	nod: SPIRAL AUGER JK500		R	R.L. Surf	f ace: ≈ 32.9m AHD
					Log	ged/Checked by: R.V.C./P.W	1.			
Groundwater Record	US DB DS DS AMPLES	Field Tests	Depth (m)	Graphic Log	Unified Classification	DESCRIPTION	Moisture Condition/ Weathering	Strength/ Rel. Density	Hand Penetrometer Readings (kPa.)	Remarks
DRY ON COMPLET ION OF AUGER- ING		N = 18 4,7,11	0 -		-	ASPHALTIC CONCRETE: 60mm.t FILL: Silty sandy gravel, fine to coarse grained crushed shale, dark grey, fine grained sand. FILL: Gravelly silty clay, medium plasticity, orange brown, grey and dark grey, fine to coarse grained shale and ironstone gravel.	MC <pl< td=""><td>-</td><td>440 550 600</td><td>- HP READINGS AFFECTED BY GRAVEL</td></pl<>	-	440 550 600	- HP READINGS AFFECTED BY GRAVEL

-		-	SHALE: dark grey.	DW	L-M		LOW 'TC' BIT RESISTANCE
						LOG
