GEOTECHNICAL INVESTIGATION

FOR PROPOSED MIXED-USE DEVELOPMENT

AT 2-12 TENNYSON ROAD, GLADESVILLE, NSW

> 29 October 2012 Ref: 26029SPrpt

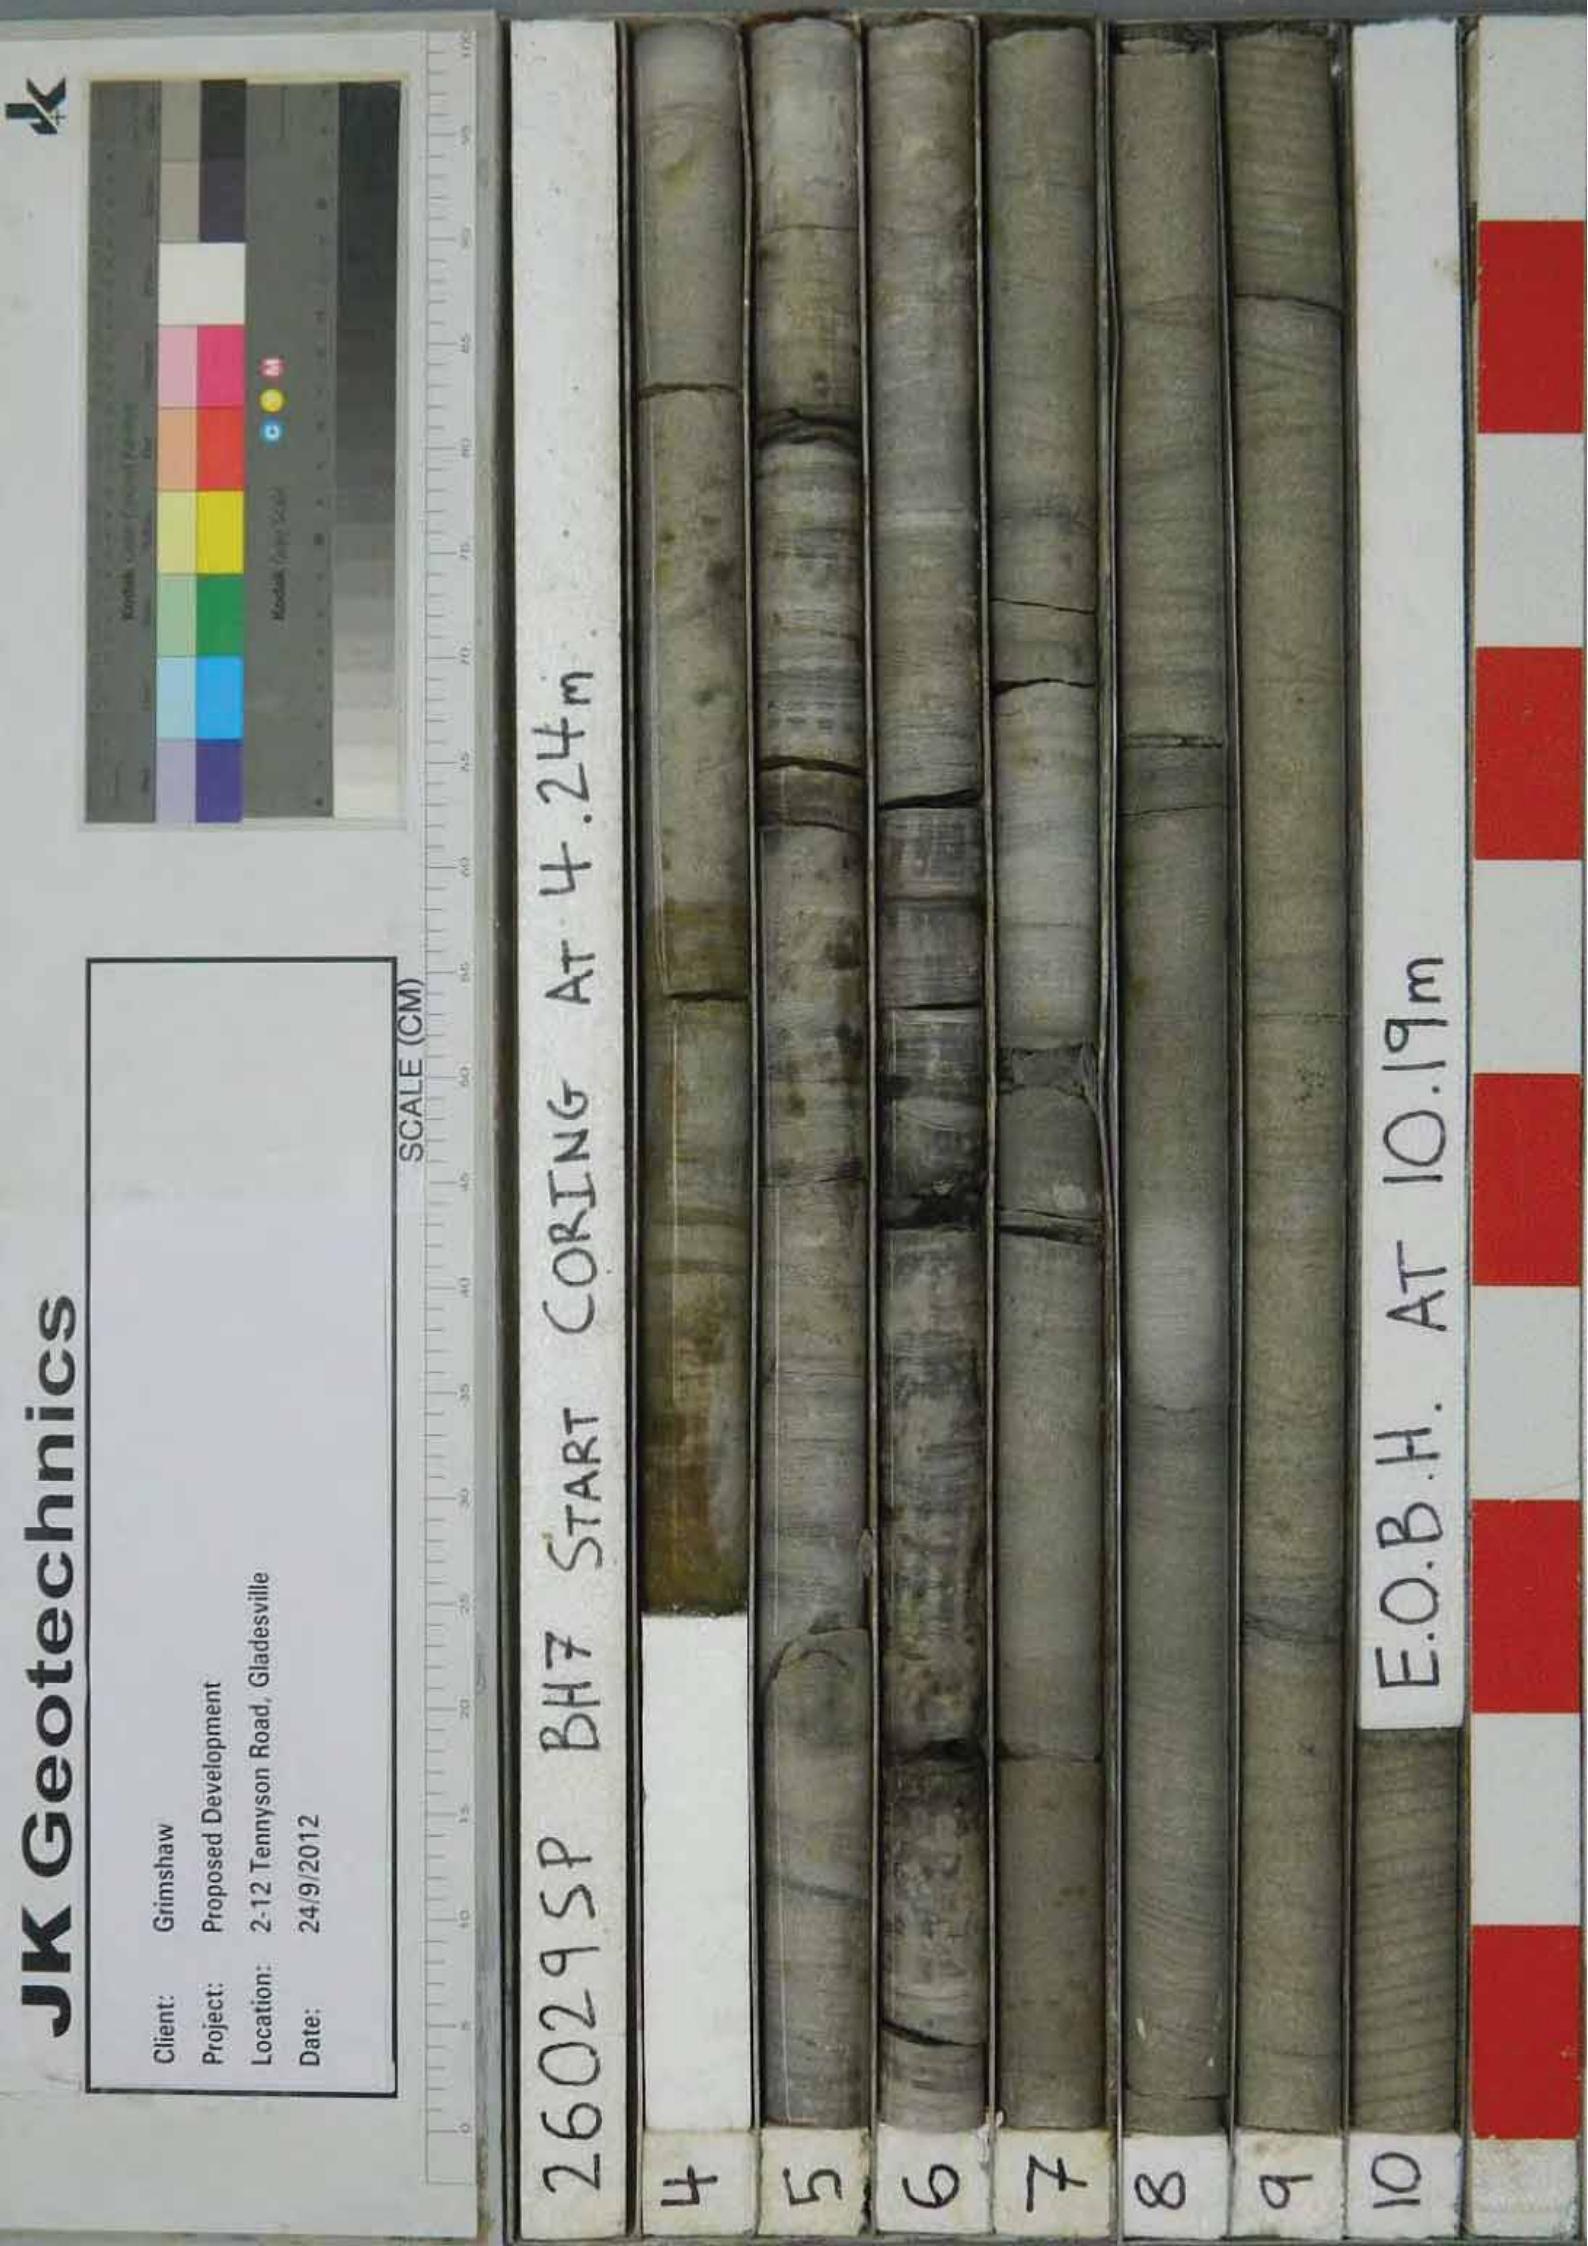
Client: [Darcsol	Ltd Pty							
Project:	: Pi n: 2-	ROPOSE			MENT				
Job No. Date: 2	. 260298 24-9-12	SP		Meth	od: SPIRAL AUGER JK305 aed/Checked by: R.V.C./P.W		F	R.L. Sur Datum:	face: ≈ 35.1m AHD
EN E								<u> </u>	
Groundwater Record ES U50 SAMPL	DS Field Tests	Depth (m)	Graphic Log	Unified Classification	DESCRIPTION	Moisture Condition/ Weathering	Strength/ Rel. Density	Hand Penetrometer Readings (kPa	Remarks
DRY ON COMPLET		0			ASPHALTIC CONCRETE: 60mm.t	M	_		APPEARS
AUGER- ING	N = 7,8,	16 ,8 1 -			medium grained shale and sandstone gravel. FILL: Silty clay, medium to high plasticity, grey and orange brown, with fine to coarse grained shale and ironstone gravel.	MC>PL	-	280 350 280	- MODERATELY TO WELL COMPACTED
					as above, but dark brown, grey and red brown.				-
	N = 6,7	16 ,9 2 -						240 400 310	-
		3 -				MC <pl< td=""><td>-</td><td></td><td>-</td></pl<>	-		-
	N = 7,14	26 ,12						290 280	-

4 -		-	SHALE: dark grey.	DW	L-M		BANDED LOW 'TC' BIT RESISTANCE
		5 - 6 - 7 -	-		REFER TO CORED BOREHOLE LOG				- - - - - - - - -
