# Gladesville Town Centre Pedestrian Access & Mobility Plan (PAMP)

**City of Ryde & Hunters Hill Council**  
*Final Report | June 2014*

The City of Ryde and Hunters Hill Council appointed Arup to prepare a Pedestrian Access and Mobility Plan (PAMP) for the Gladesville Town Centre. The project aims to identify a framework for developing safe and convenient pedestrian routes and fostering improvements in personal mobility.

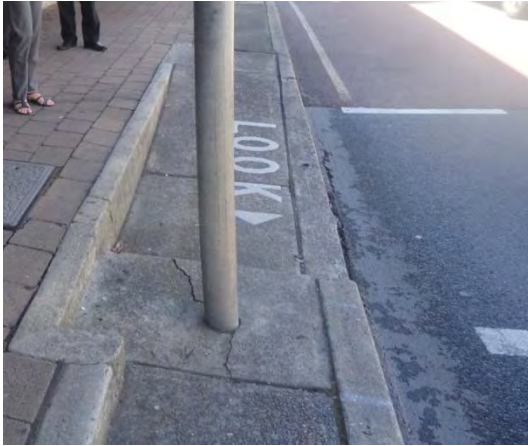
#### Footpath quality and consistency:

A number of footpaths in the study area were observed to be of a poor or inconsistent quality. Damaged footpaths act as trip hazards and detract from the pedestrian environment. Some kerb ramps along Victoria Road were observed to be non standard.

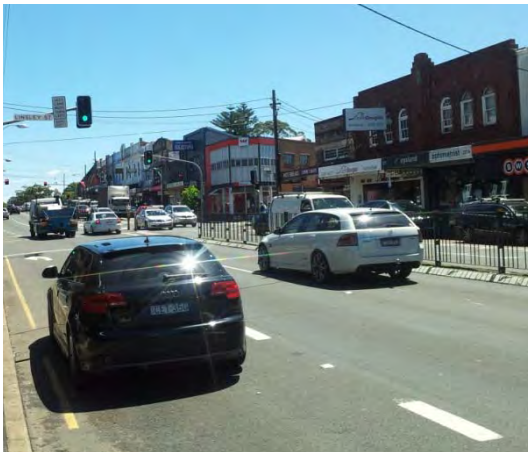
#### Wait times at intersections:

There are a number of signalised pedestrian crossings along Victoria Road. Pedestrians generally have to wait for long periods of time before they may safely cross the road. A number of intersections would benefit from more generous crossing times to allow pedestrians (particularly less mobile users) longer to cross the six lanes of Victoria Road. It is noted that any changes to the traffic signal arrangements would require sign off and approval from the RMS

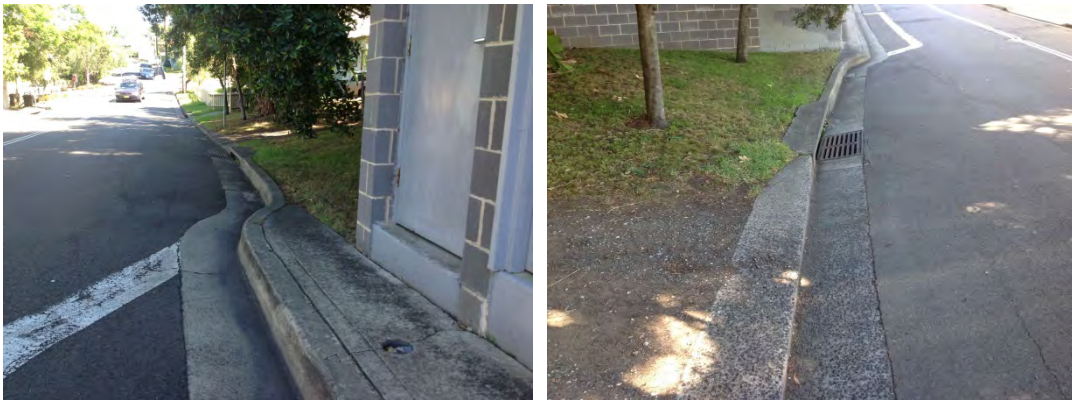
The audit identified that there was only one footpath missing along the high priority routes, located along the western side of Flagstaff Street between Cowell Street and Massey Street (see Photograph 3).

Photograph 3: Flagstaff Street, between Cowell Street and Massey Street (west side)

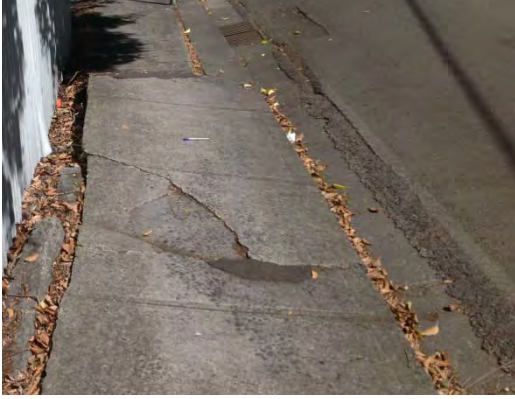
There were a number of locations throughout the study area where the footpath was identified as uneven or cracked. The footpath is generally uneven due to poor integration with manholes or poor repair after servicing. Cracks, cavities and uneven footpaths also appear due to wear, poor drainage and nearby tree roots. Some locations of where footpaths were in poor condition are shown below.

Photograph 4: Flagstaff Street, between Cowell Street and Massey Street (east side)

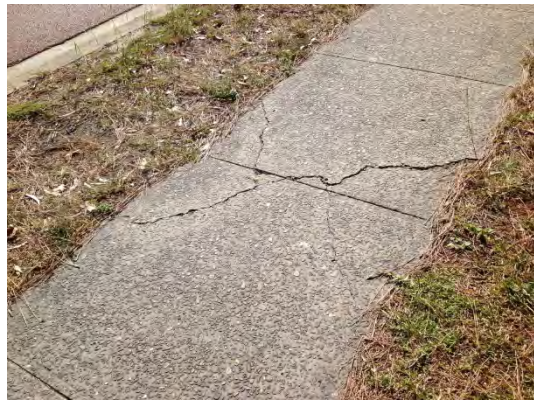
Photograph 7: Victoria Road between Manning Road and Salter Street (south side)

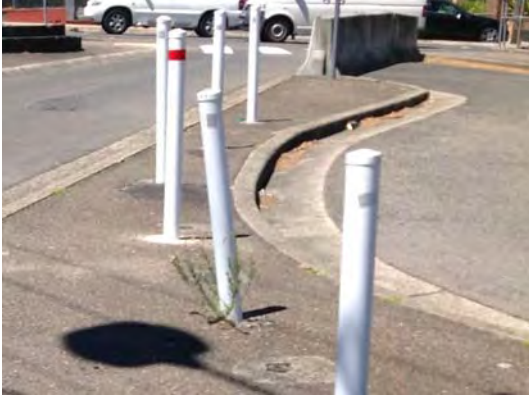
The width of the footpath was observed during the audit process against standards to the minimum required width (for DDA compliance) of 1.2m. Examples of locations where footpaths were observed to be narrow are outlined below:

Photograph 8: Wharf Road/Meriton Street

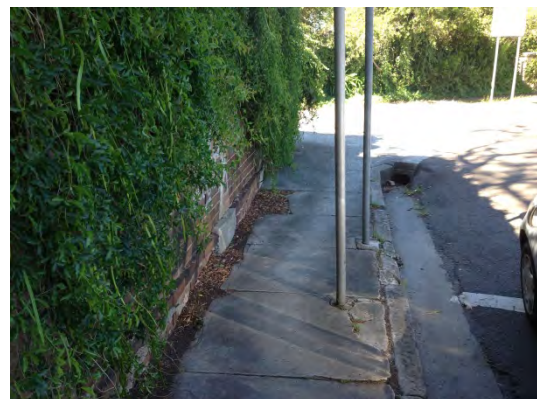
Photograph 13: Massey Street, between Massey Lane and Flagstaff Street (north side)

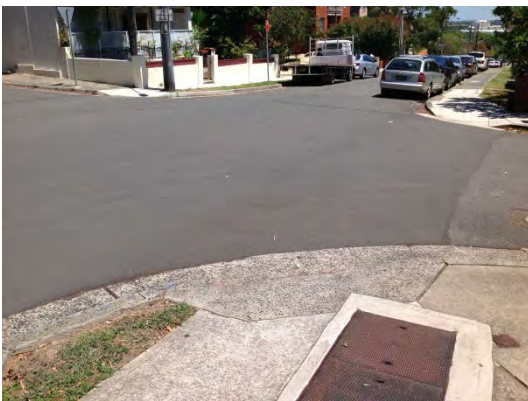
- A lip or step between kerb ramp and road
- Steep grades on kerb ramps
- Direction of kerb ramps
- Missing kerb ramps.

Photograph 14: Linsley Street, at south corner of intersection at Orr Street

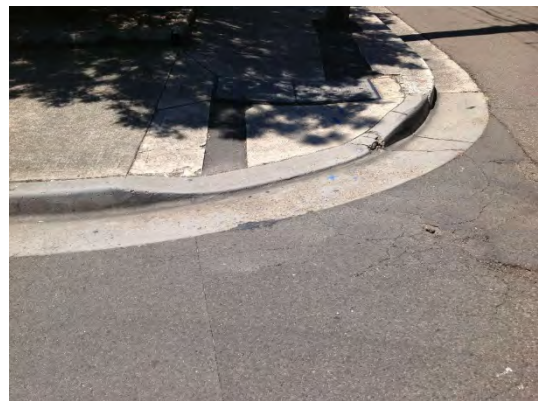
Photograph 15: Linsley Street, at west corner of intersection at Coulter Street

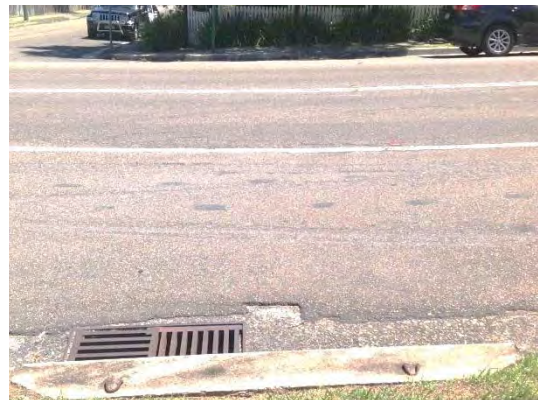
Photograph 17: Morrison Road, between Linsley Street and Ross Street (north side)

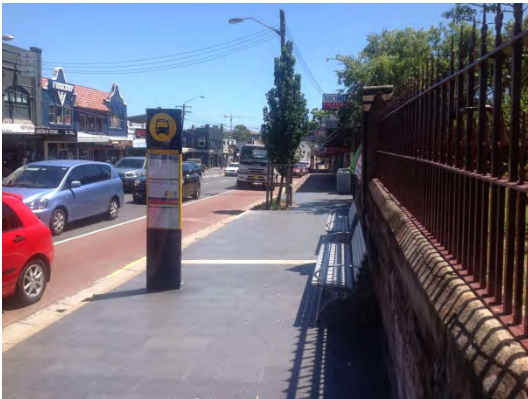
There were only a limited number of bus stops in the study area that were identified as requiring shelter and/or seating. Some examples of issues with bus stops are shown below.

Photograph 18: Victoria Road, at northeast corner of intersection at Pittwater Road

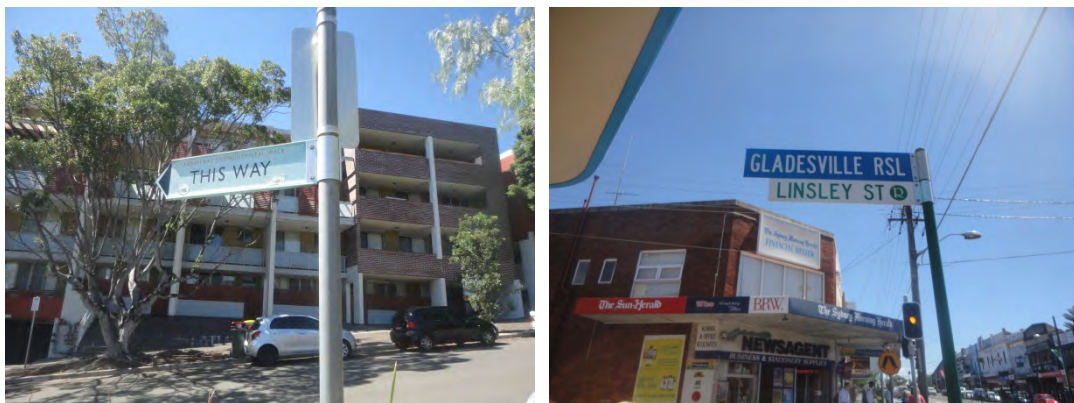
There is limited wayfinding signage present within the town centre, with some examples shown in Photograph 22.

Photograph 22: Existing directional signage in Gladesville town centre

A consistent signage strategy is recommended to be adopted across both the City of Ryde and Hunters Hill LGA's.

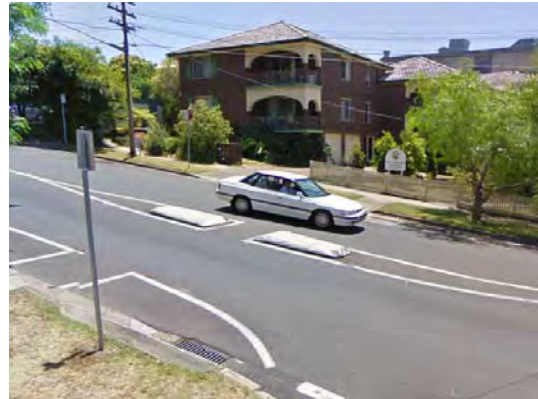
Photograph 24: Cowell Street, west of Flagstaff Street intersection

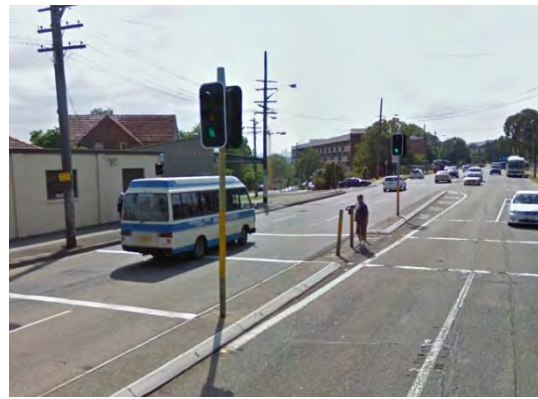
Photograph 26: Victoria Road, between Sunnyside Street and Manning Road

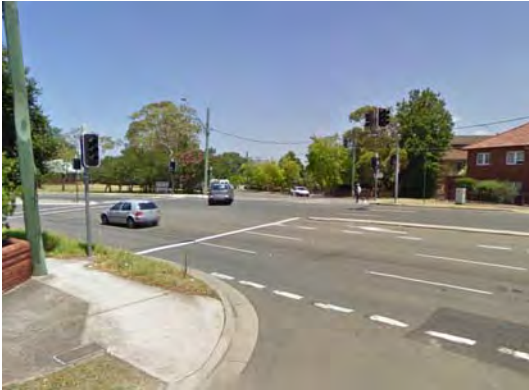
Signalised crossings are only provided along Victoria Road within the study area. The audit noted that a number of signalised intersections on Victoria Road do not contain east-west pedestrian crossings on both the northern and southern approaches. Further detail is described in Section 8.4, addressing additional issues such as waiting and crossing times.

Photograph 27: Victoria Road, between Punt Road and Meriton Street

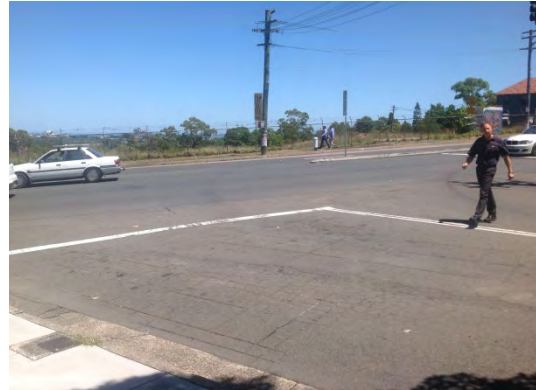
Photograph 28: Westminster Road northeast of Victoria Road intersection

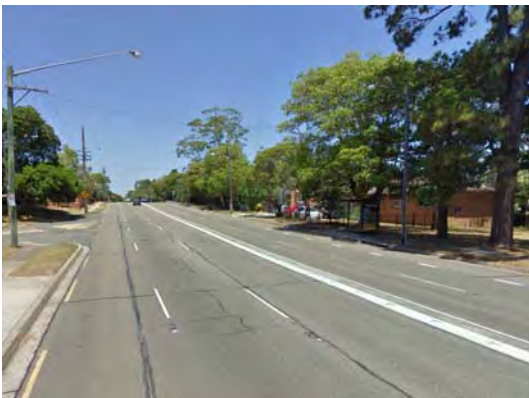
There were also a number of crossing opportunities noted in the audit and consultation. These locations have a pedestrian desire line with no current provision for pedestrian crossings (i.e. were unsafe to cross). These are further discussed in Section 8.6 of this study.

Photograph 29: Victoria Road, near Salter Street

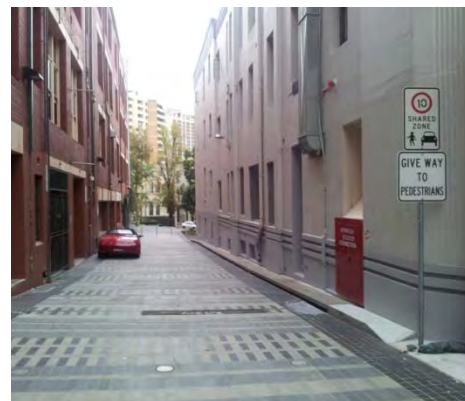
Given the proposed development will result in increased pedestrian activity along Massey Lane, it is recommended a shared zone be installed to enhance the level of pedestrian connectivity and safety. Shared zones are low speed (10km/hr) environments where drivers must give way to pedestrians at all times. The design of shared zone would be similar to that proposed for the right of way adjacent to the development.

Photograph 31 Shared Zone Examples

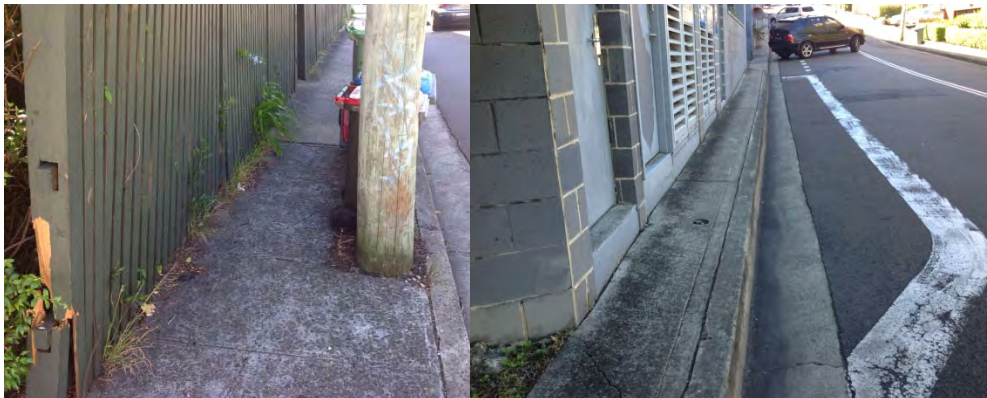
Photograph 32 Existing Footpath Deficiencies, Flagstaff Street
