City of Ryde Council

Meadowbank Station West Pedestrian Access and Mobility Plan (PAMP)

7 June 2017

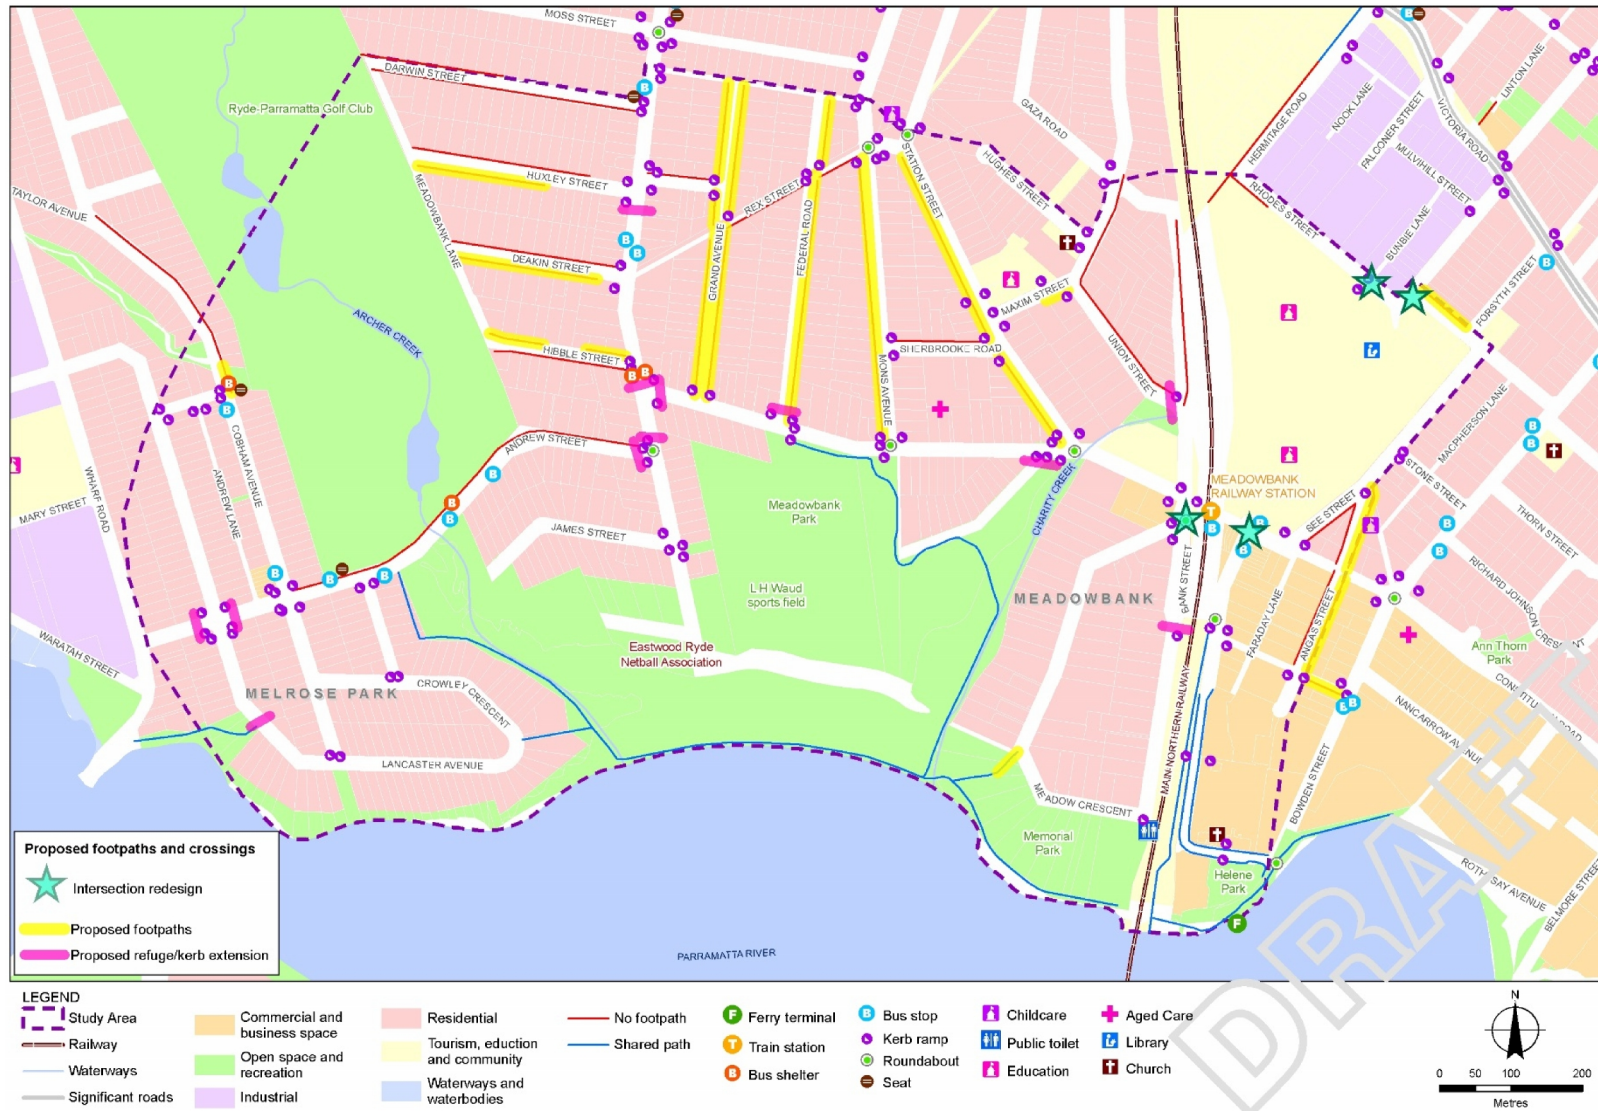
Figure 0-1 Location of Proposed Footpaths

- Bank Street, south of Meadowbank Station;
- Constitution Road West / Ross Smith Avenue intersection;
- Constitution Road / Federal Road intersection;
- Constitution Road / Adelaide Street intersection;
- Adelaide Street / Andrew Street intersection;
- Adelaide Street / Andrew Street intersection;
- Bank Street / Union Street intersection; and
- Andrew Street, west of Adelaide Street

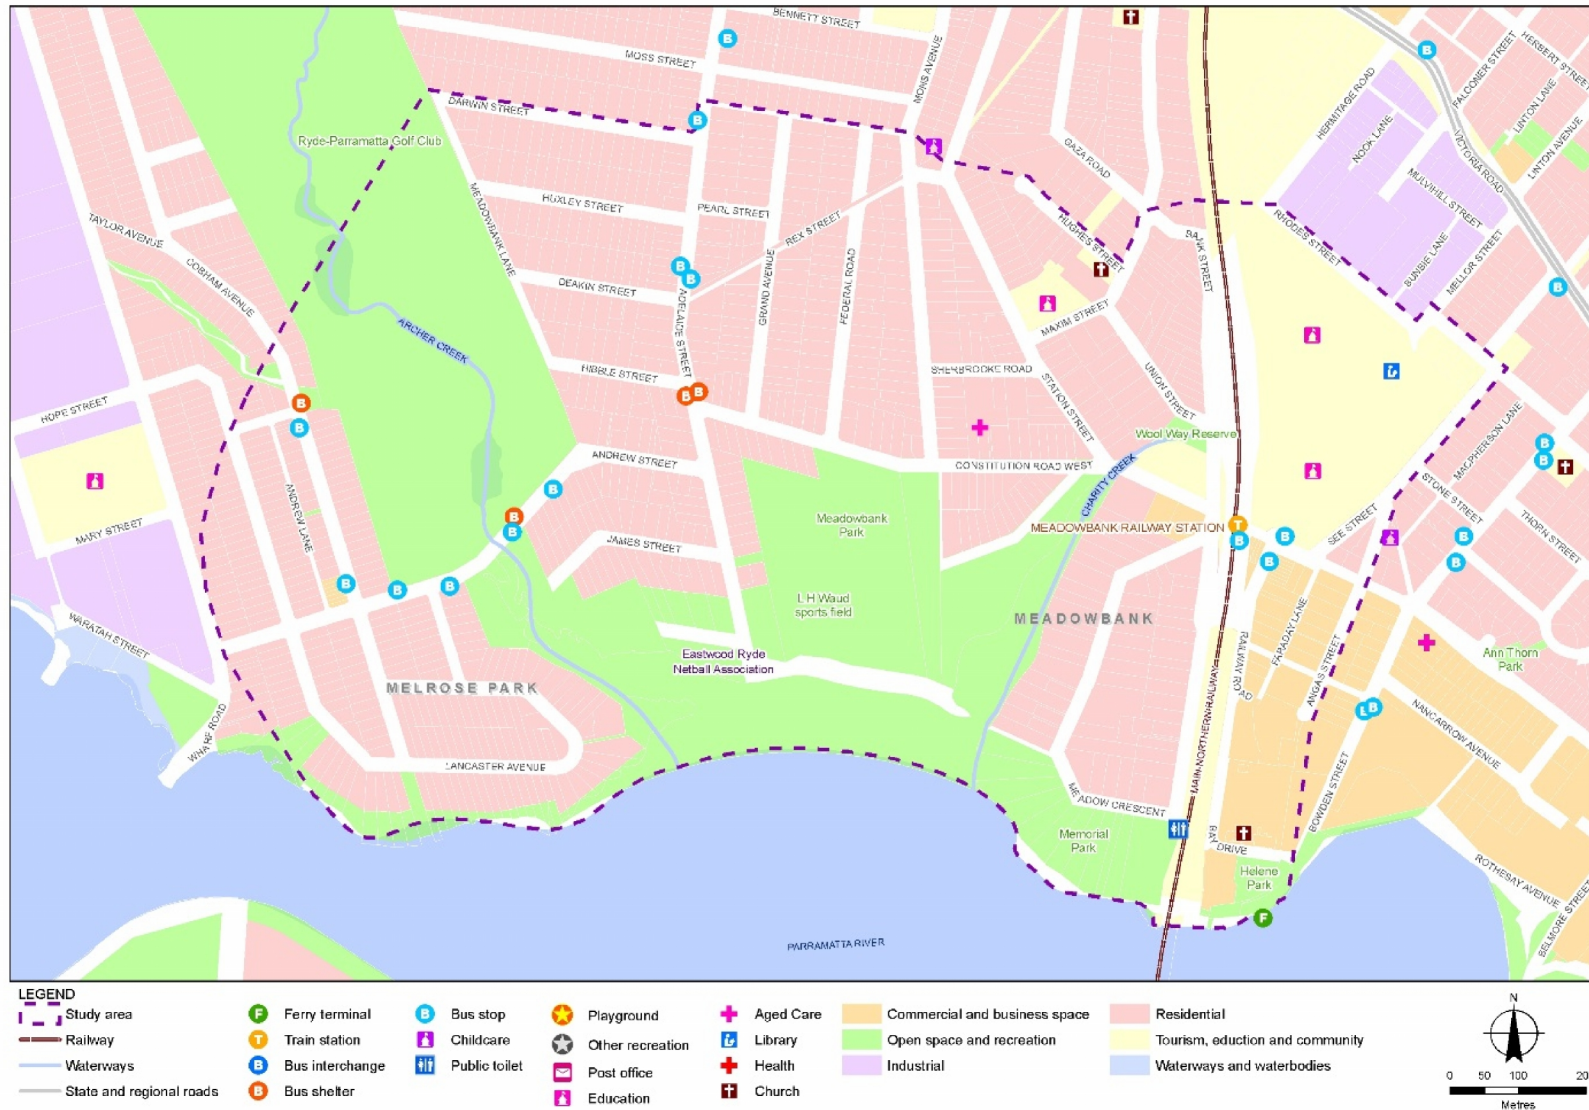
Figure 1-1 Study Area

The study mainly focuses on the pedestrian network located to the west of Meadowbank train station due to the extensive urban renewal taking place on the eastern side of the station.

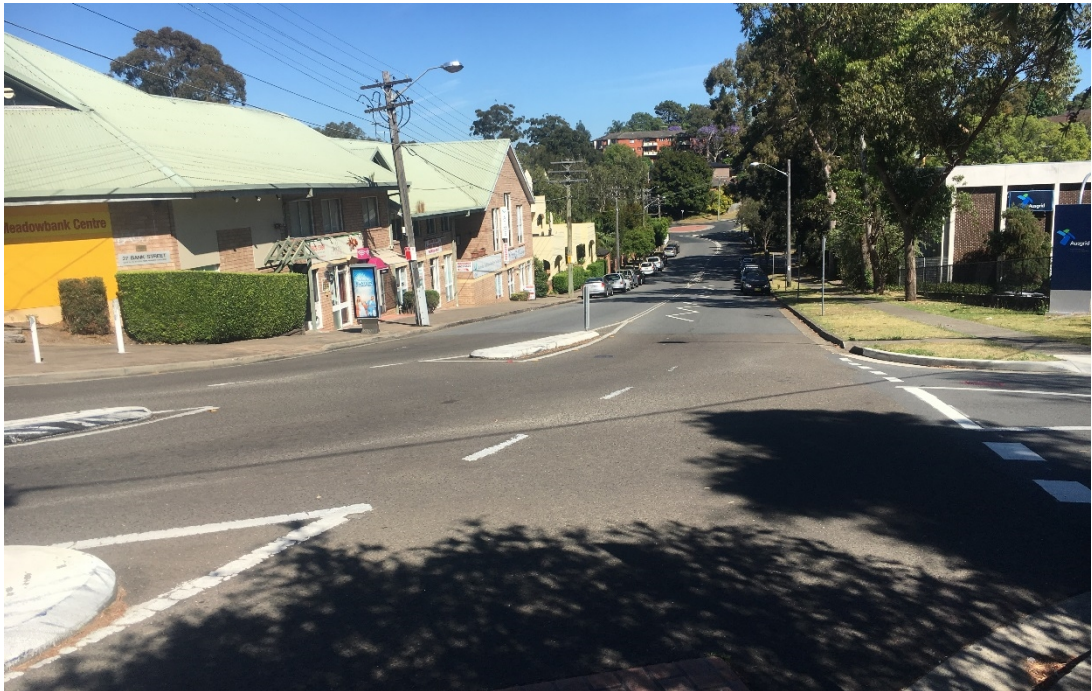
Figure 2-19 Constitution Road West, viewed westwards

Constitution Road West provides a links to the educational, retail and residential land uses.

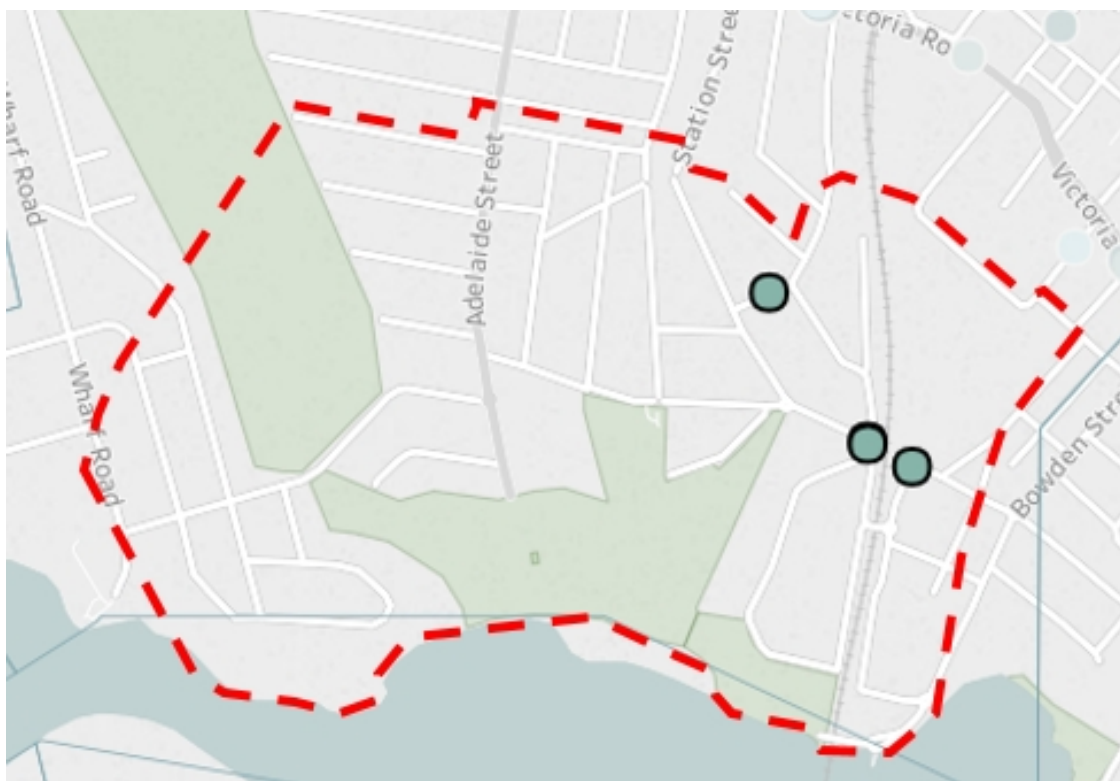
Figure 2-21 Crashes involving pedestrians between 2011 - 2015

**note that two separate incidents occurred at one location as shown on the above plan.*

It should be noted that the crash data presented is based on NSW Police reports, which generally under-represent the incidence of pedestrian and cyclist related crashes due to some of these incidents not being reported. This is due to the fact that many minor pedestrian incidents do not result in tow-away crashes where police are called and the incident therefore goes unrecorded.

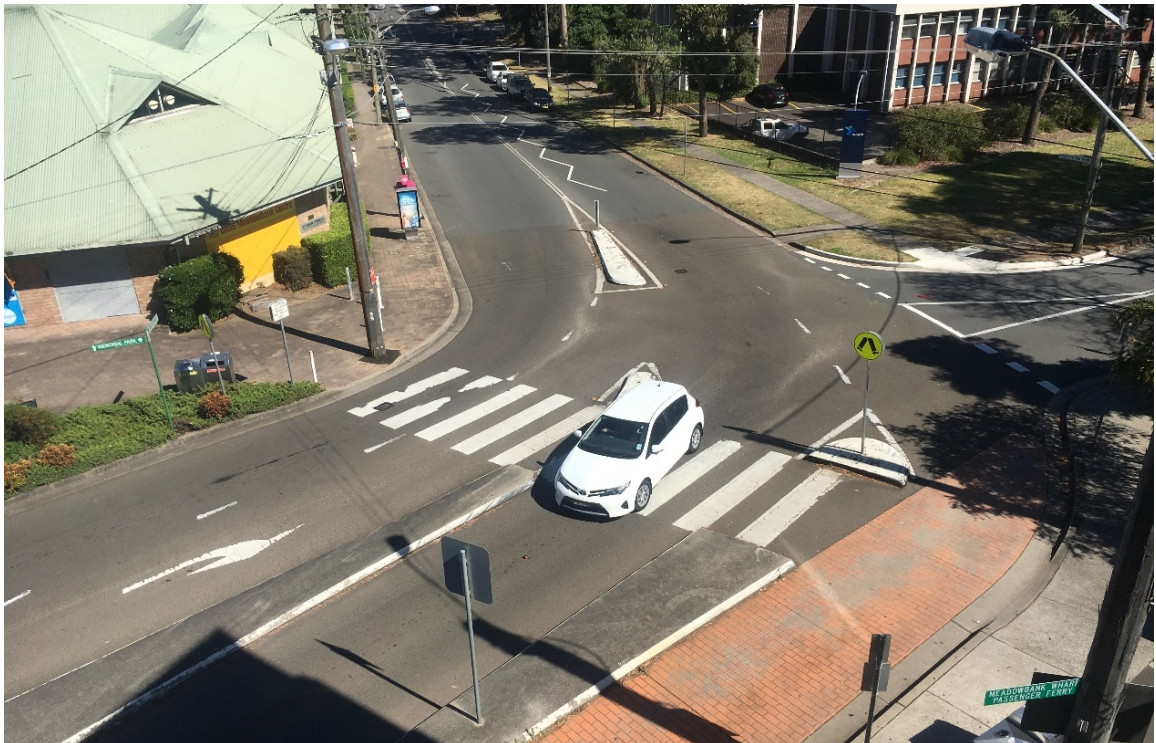
Figure 2-22 Bank Street and Constitution Road West, viewed northwards from West Ryde Parade

During the site audit, it was noted that there is pedestrian and vehicle conflict at the existing pedestrian crossing, as there were a large number of pedestrians crossing Bank Street when egressing trains at Meadowbank Station during the PM peak. This can cause long delays to traffic and result in impatient driver behaviour, which can be a risk to pedestrians.

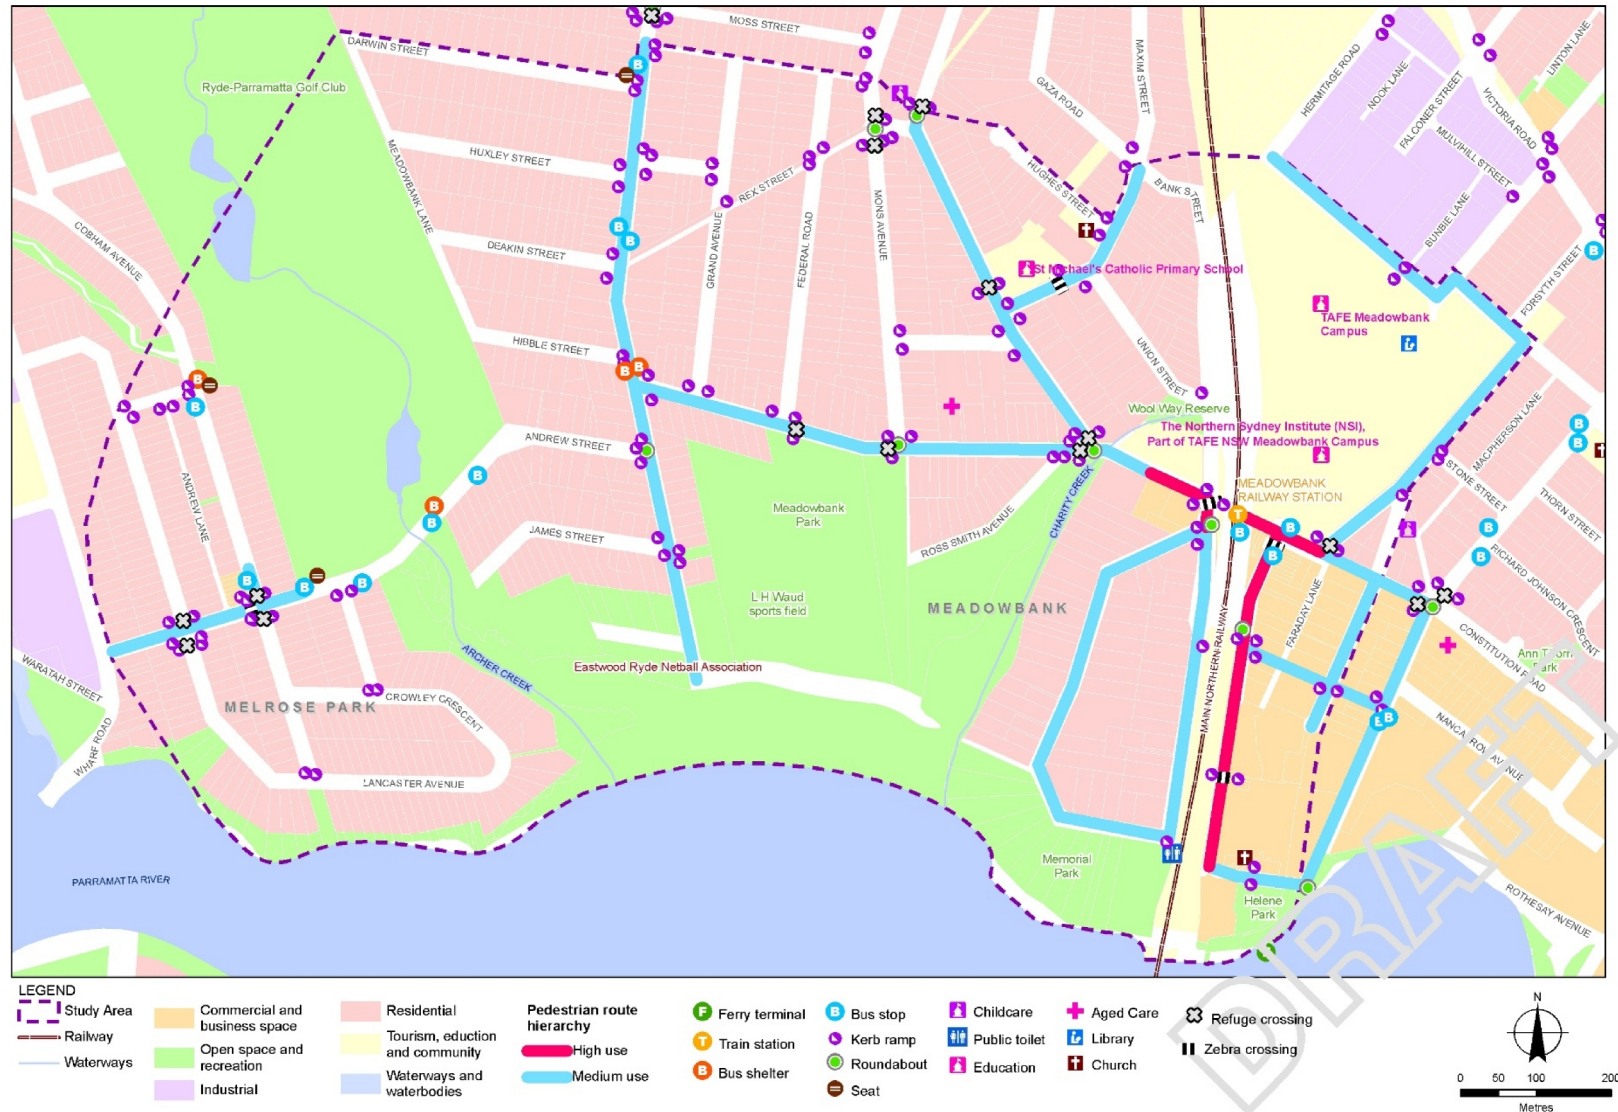
Figure 6-1 Walking Route Hierarchy

A hierarchy of pedestrian routes has been established based on observed pedestrian demand and proximity to pedestrian attractors, such as the train station, commercial land uses, schools / TAFE, and key walking routes. This walking route hierarchy was used as part of the scoring method to determine the priority for proposed pedestrian infrastructure upgrades.
